STAR ONLINE PUBLICATION

Case Number: S2008000113

Symptom/Vehicle Issue: No Start Intermittently, Vehicle Requires Multiple Keyless Push To Start Attempts To Start Vehicle

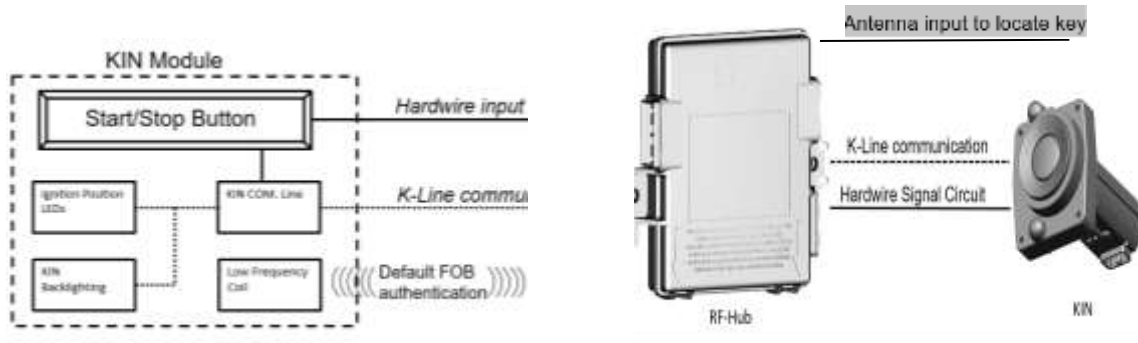
The KIN start process:

- The K-line and the Start/Stop Button hardwire signals which are used in conjunction to determine the Start/Stop Button states
- The KIN receives K-Line communication from the RF-Hub to illuminate the ignition position LEDs associated with the current ignition position
