EC16-035c

ITB17-042c

INFINITI; DTC P0456 CAUSED BY EVAP LEAK AT VENT CONTROL VALVE O-RING

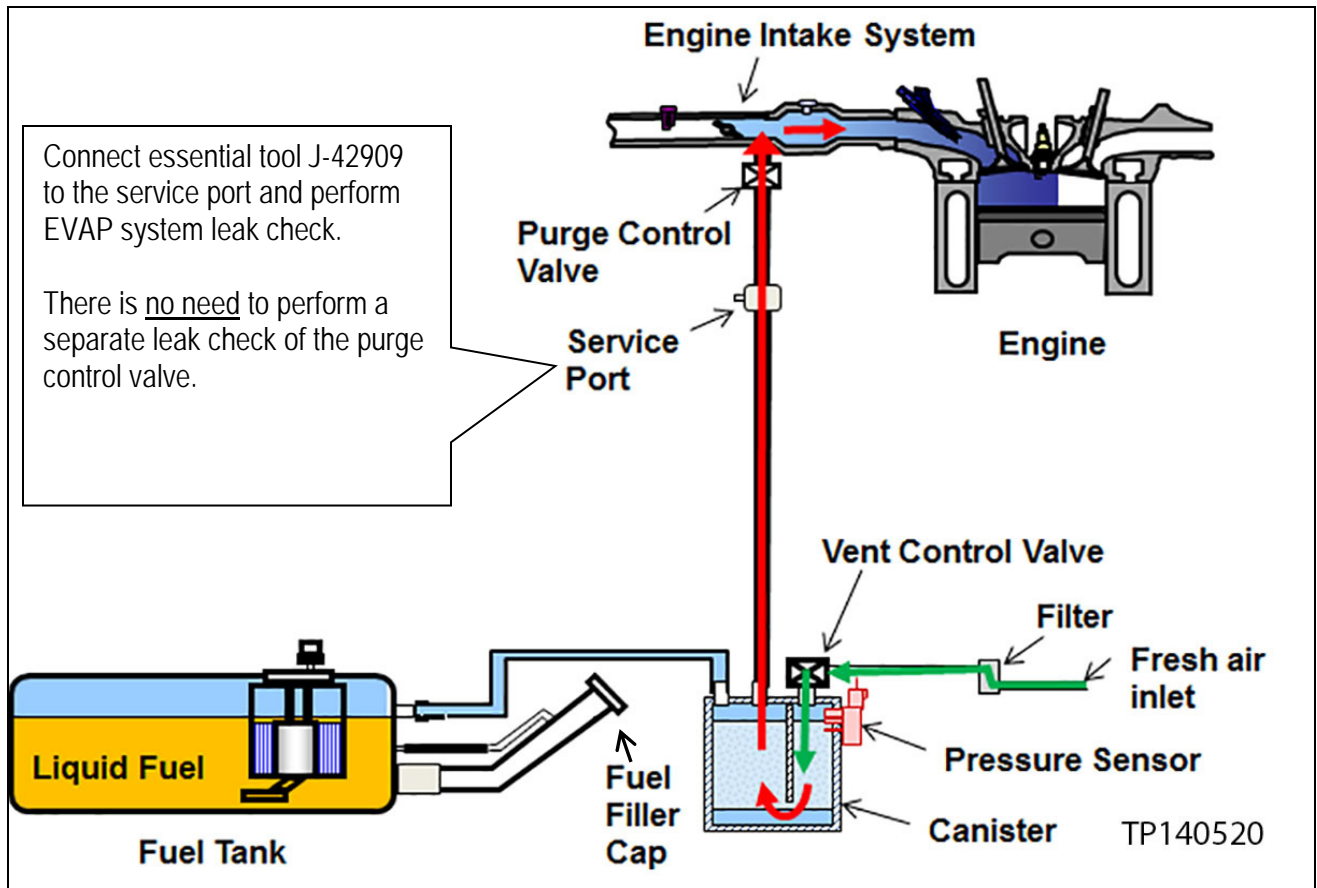
Figure 8

Models with a Service Port
(2017 and older)

EVAP System Basic Operation

- Fuel vapor flows from fuel tank into canister (light blue area)
- Vapor flows from canister through purge control valve (red line)
- Fresh air flows into canister (green line)

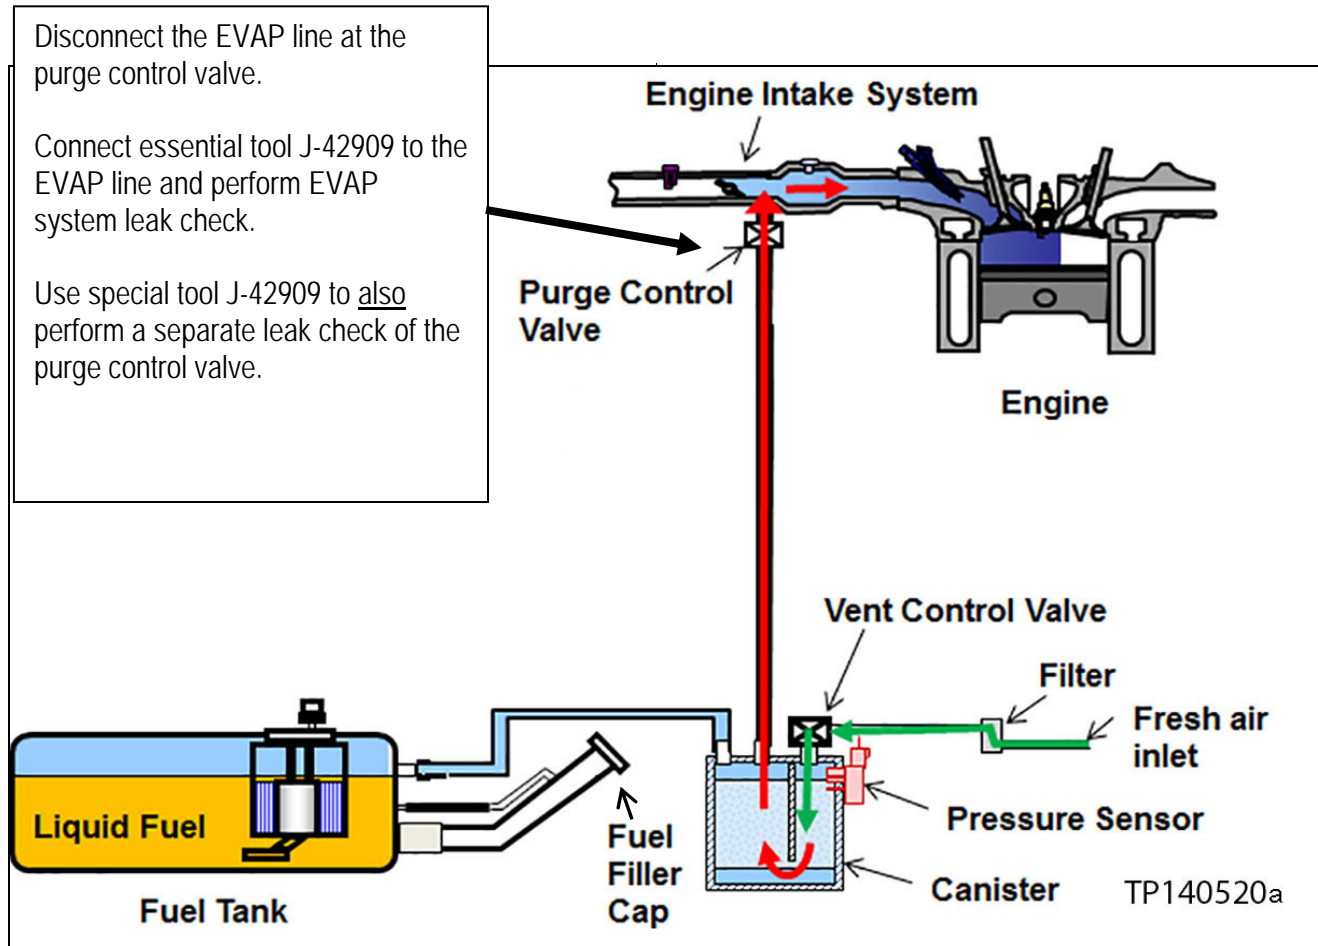
Models without a Service Port
(QX30 and 2018 and Newer)

EVAP System Basic Operation

- Fuel vapor flows from fuel tank into canister (light blue area)
- Vapor flows from canister through purge control valve (red line)
- Fresh air flows into canister (green line)
