NUMBER: 08-080-20

GROUP: 08 - Electrical

UAQ and UCQ Radio Enhancements

2020	(JL)	Jeep Wrangler
2020	(JT)	Jeep Gladiator

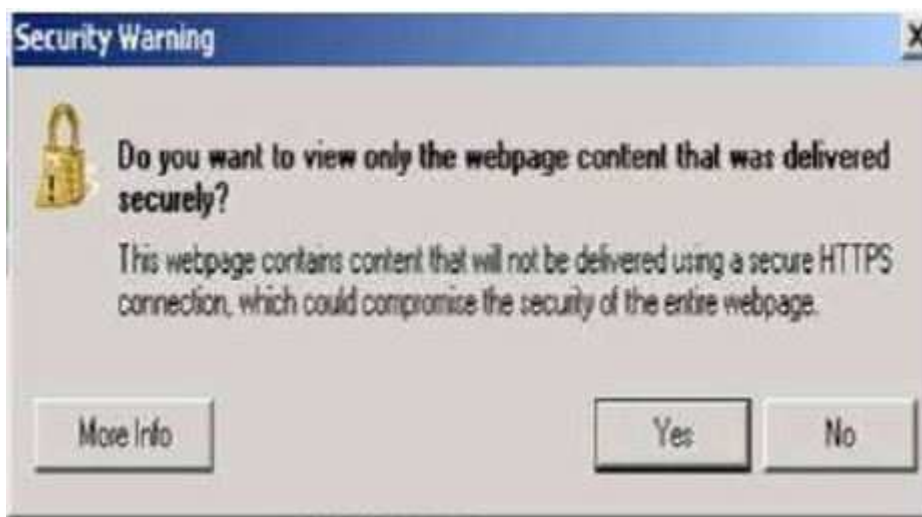
Fig. 2
Pop-Up Security Message

2. Go to DealerCONNECT>Service>Uconnect Command Center>Uconnect>More Information>Dealer software downloads to download the files.
3. If a security message appears “Do you want to view only the web page content that was delivered securely?” ([Fig. 2](#)) . Press “No” to continue.

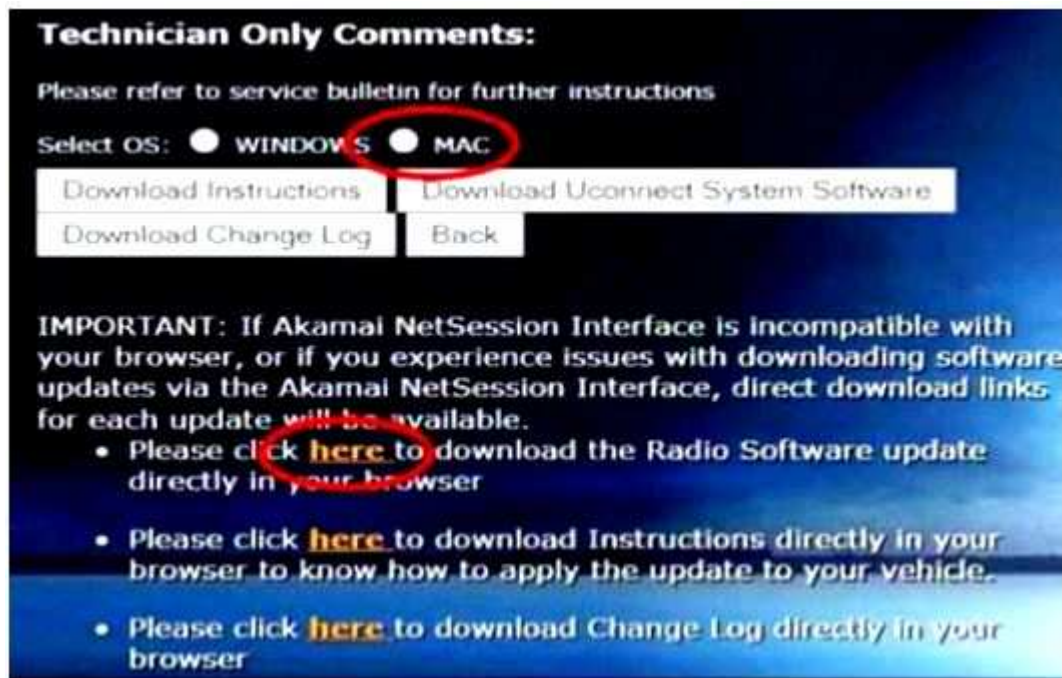
Fig. 3

MAC Download Steps

- Download the software update file to your local PC's desktop. Make sure to select the "MAC" radial button for all downloads (Fig. 3) .

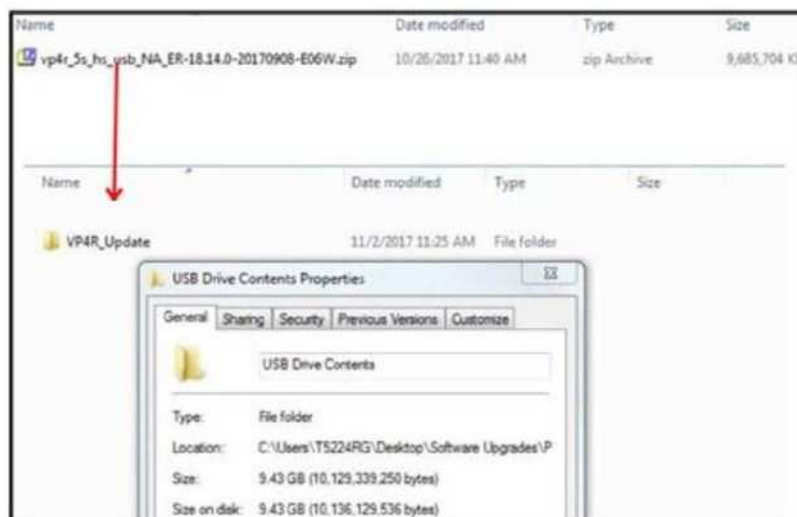
Fig. 4

Files/Folders In The USB Flash Drive

- Unzip all the files to the root folder of USB flash drive. File should not be within a zip folder. Your USB file should look like (Fig. 4) when you open it, displaying file/folder.

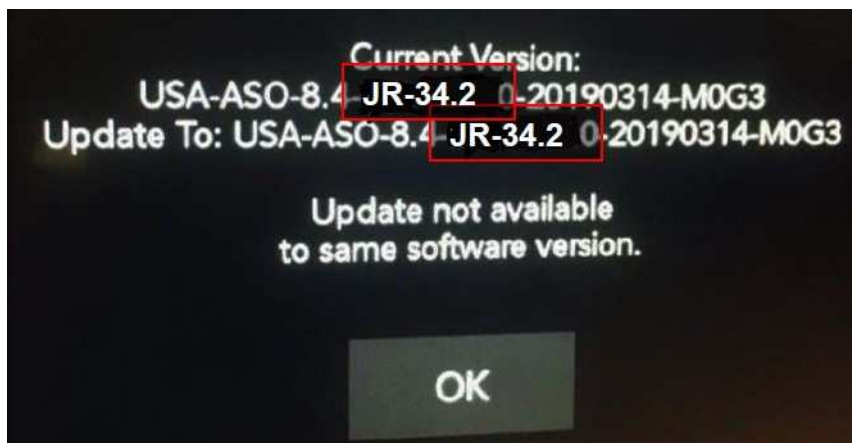
Fig. 6
Screen Displayed When Radio Software Level Is Up To Date

11. If the radio software is up to date, the screen in (Fig. 6) will be displayed. Press "OK" and remove the USB flash drive.

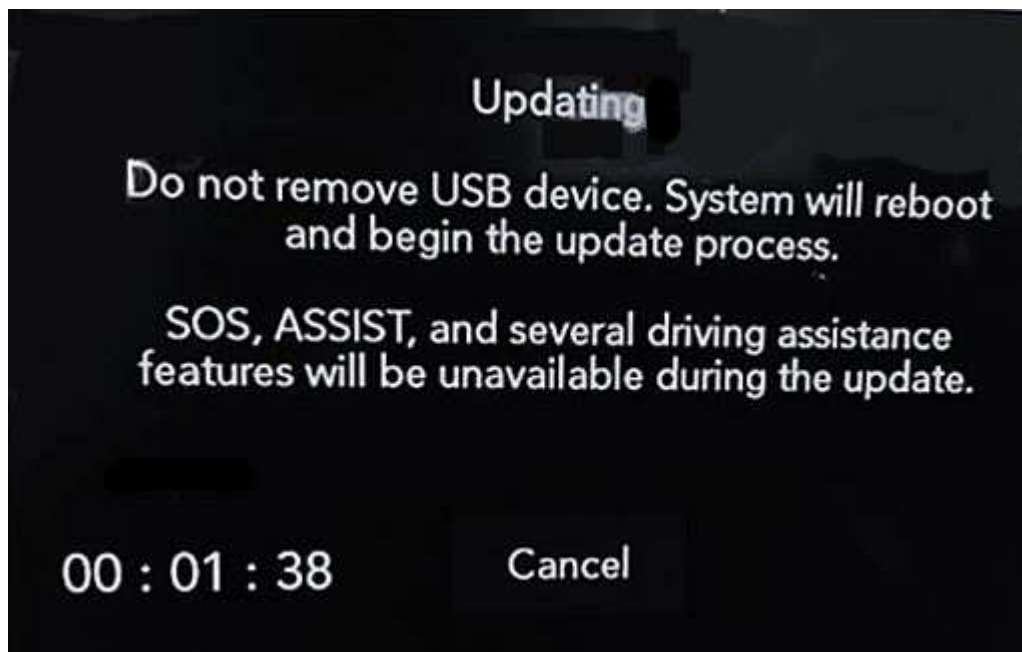
Fig. 8
Radio Update Process Begins

13. When the radio starts updating, the screen in (Fig. 8) will be displayed.

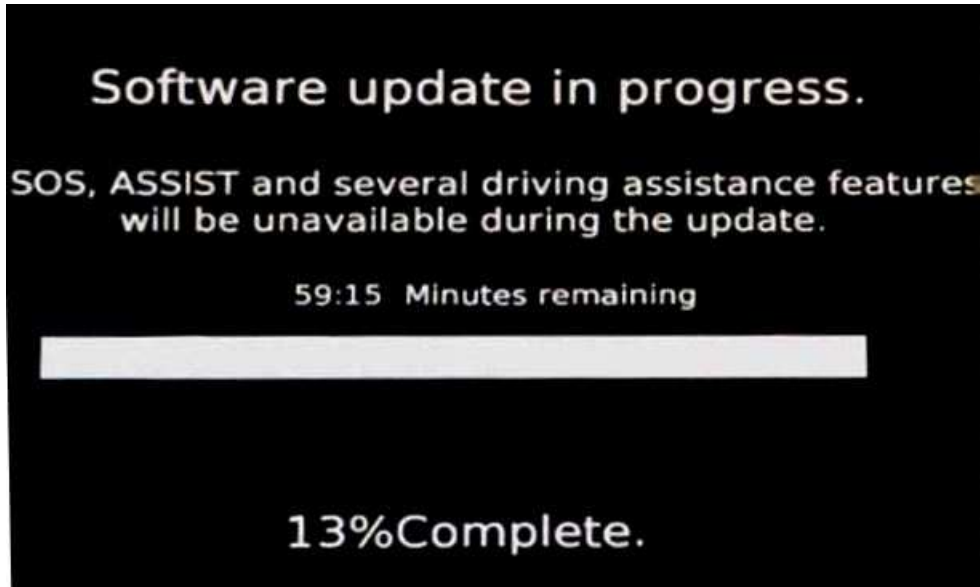
NOTE: The completion indicator may not reach 100%, even though the software update has been completed. Once the software update has finished, the radio and display screen will turn off (Fig. 9) .

Fig. 9
Software Update In Progress

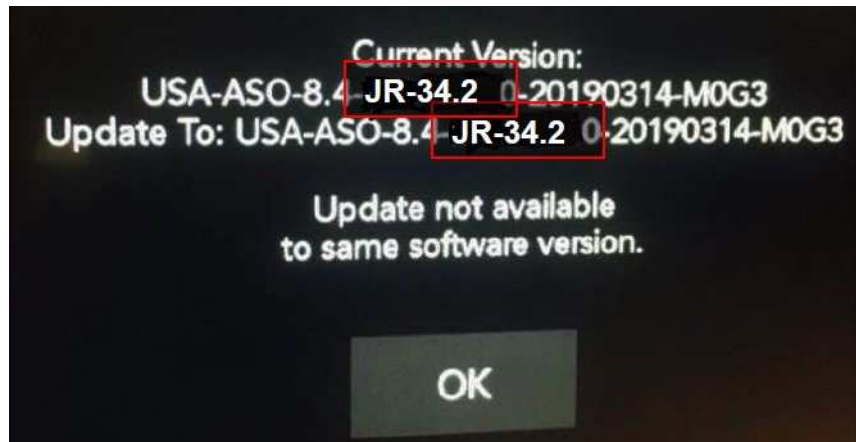
Fig. 10
Software Levels After Update

15. After the update has completed, the radio will shut down. With the USB flash drive still inserted in the USB port, turn the ignition back to the run position. If the radio has been updated correctly, the screen in (Fig. 10) will be displayed. Press "OK" and remove the USB flash drive.

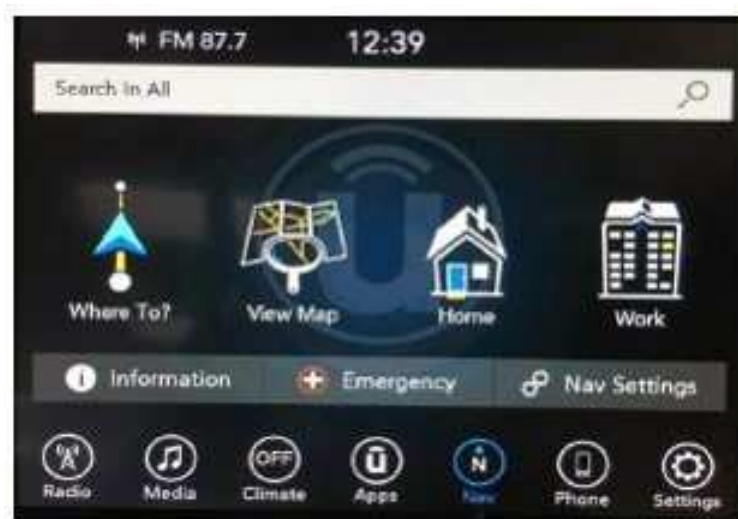
Fig. 11
Navigation Screen

16. Wait three minutes with the ignition off.
17. Start the engine. Confirm navigation does not get stuck on the "Nav Loading" screen (Fig. 11) and it actually loads the map.
