Technical Service Bulletin

GROUP FUEL SYSTEM	NUMBER 20-FL-010H
DATE OCTOBER 2020	MODEL(S) Tucson (TL) 2.0L

SUBJECT: TUCSON 2.0L DTC P0420 - ECM UPDATE AND CATALYST REPLACEMENT

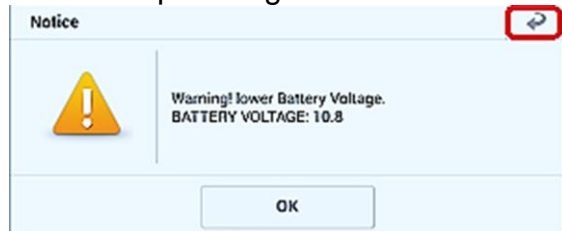
GDS Vehicle Battery Voltage Warning:

If voltage is below 12 volts as per the below GDS warning, then select **Back** and operate the vehicle in Ready mode for at least 20 minutes to ensure an adequate battery state of charge for reliable update results. Turn ignition back on, and then retry the ECU update again.
