SERVICE BULLETIN

APPLICABILITY: 2014-16MY Forester 2.5L Models

NUMBER: 07-112-16

SUBJECT: New Alternator Assembly to Address DTC P0300

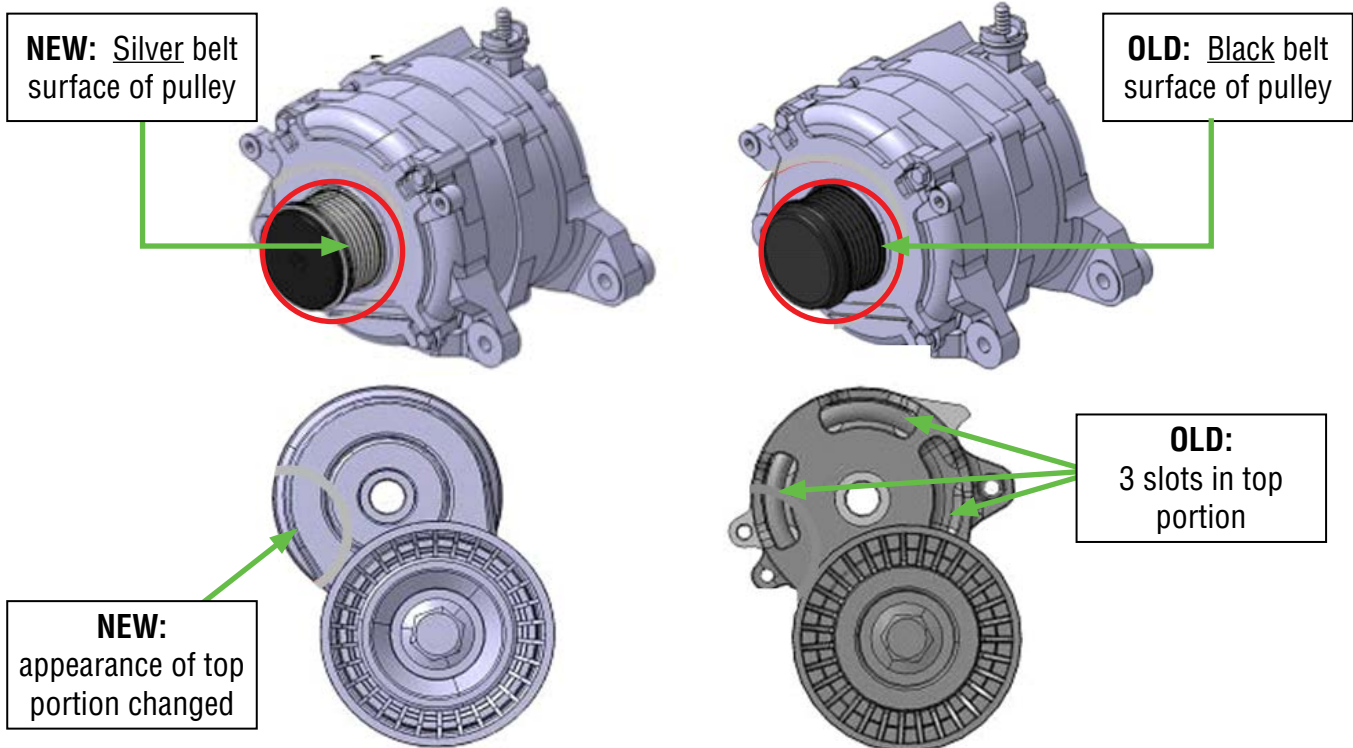
IDENTIFICATION:

This bulletin provides a procedure for diagnosis and repair of DTC P0300 which may result from fluctuation of the alternator's current output outside of the specified limits.

- When determined necessary to replace the alternator and tensioner, follow the service procedures in the applicable Service Manual. Accessory drive belt replacement is **NOT** required as part of this repair.
