SERVICE BULLETIN

APPLICABILITY: 2020MY Legacy and Outback Models **NUMBER:** 15-261-20R
SUBJECT: Reprogramming File Availability for Optimization of Gen 4 Denso CP1 Infotainment Systems **DATE:** 03/10/20
REVISED: 11/20/20

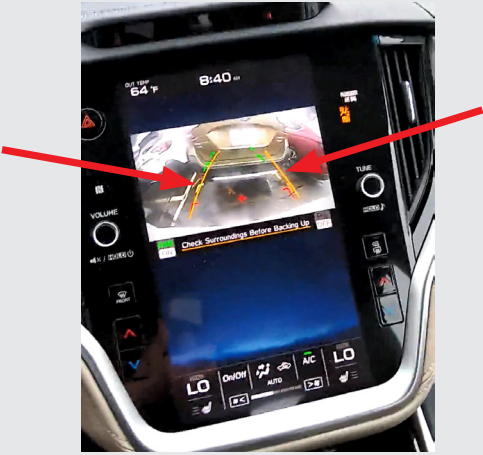
</div> <p>**NOTE: After switching the ignition off and leaving the driver’s door open more than 70 seconds, the system <i>may</i> recover after switching the ignition back on.</p>
2	<p>Delayed response of rear view camera guide lines. When the rear view camera is activated and the steering wheel is turned, there is a delay before the steering-responsive guide lines respond to the steering wheel input.</p> <div style="text-align: center;">
