# Maserati Technical Bulletin

Date: July 12th, 2016  
Bulletin No. MAS000883 – Service Campaign  
#268 Dome Reinforcement Plates Installation  
Supersedes: NA  
Section: Suspension

**MODEL: Maserati Quattroporte (M156) and Ghibli (M157)**

**SUBJECT: Dome Reinforcement Plates Installation (Service Campaign 268)**

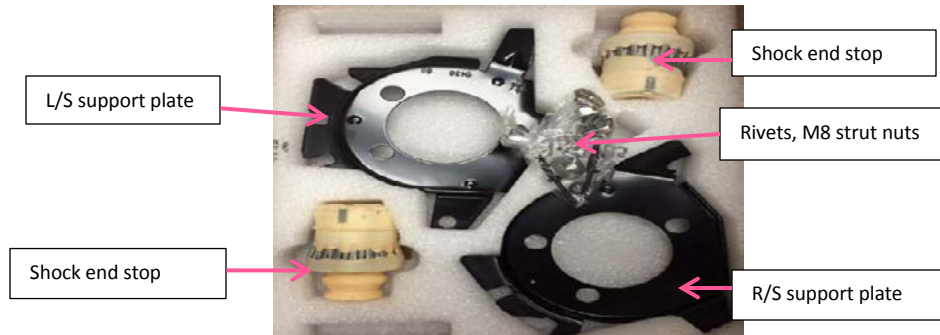
- Kit - P/N: 673005734 for vehicles without Skyhook
- Kit - P/N: 673005735 for vehicles with Skyhook
- P/N: 2018290 - “Betamate 2098” adhesive (1 tube for every 2 vehicles)
- Front Springs – Please Reference EPC for the Specific VIN
