Service Bulletin

Bulletin No.: 20-NA-199

Subject: Radio Software Version U150 Update

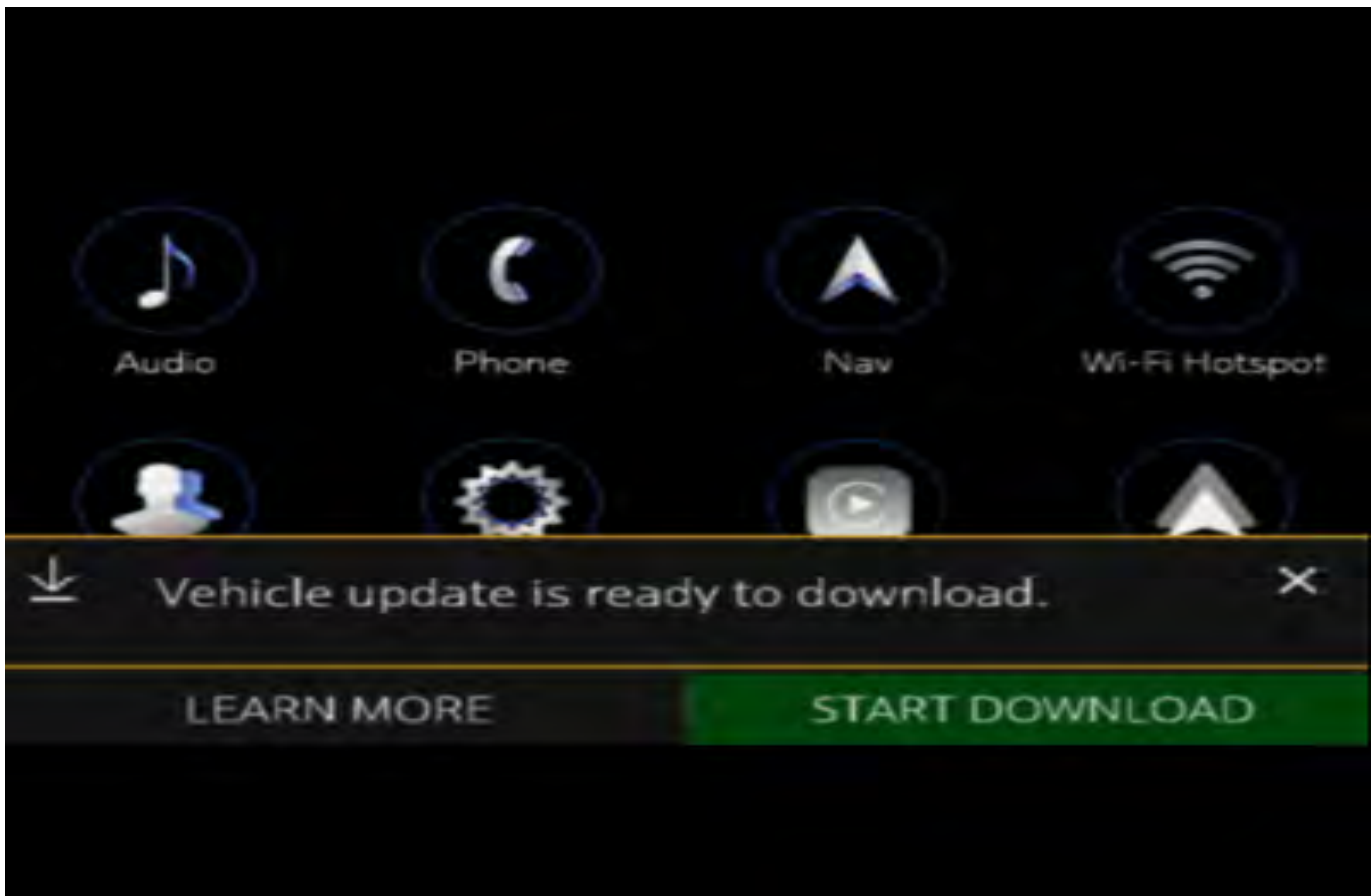
5651945

1. Verify if there is a remote package on the system and check to see which of the below pop ups show.
 - If the remote vehicle update has not been downloaded, select “Start Download,” wait for the download to complete and then follow the prompts to complete installation.

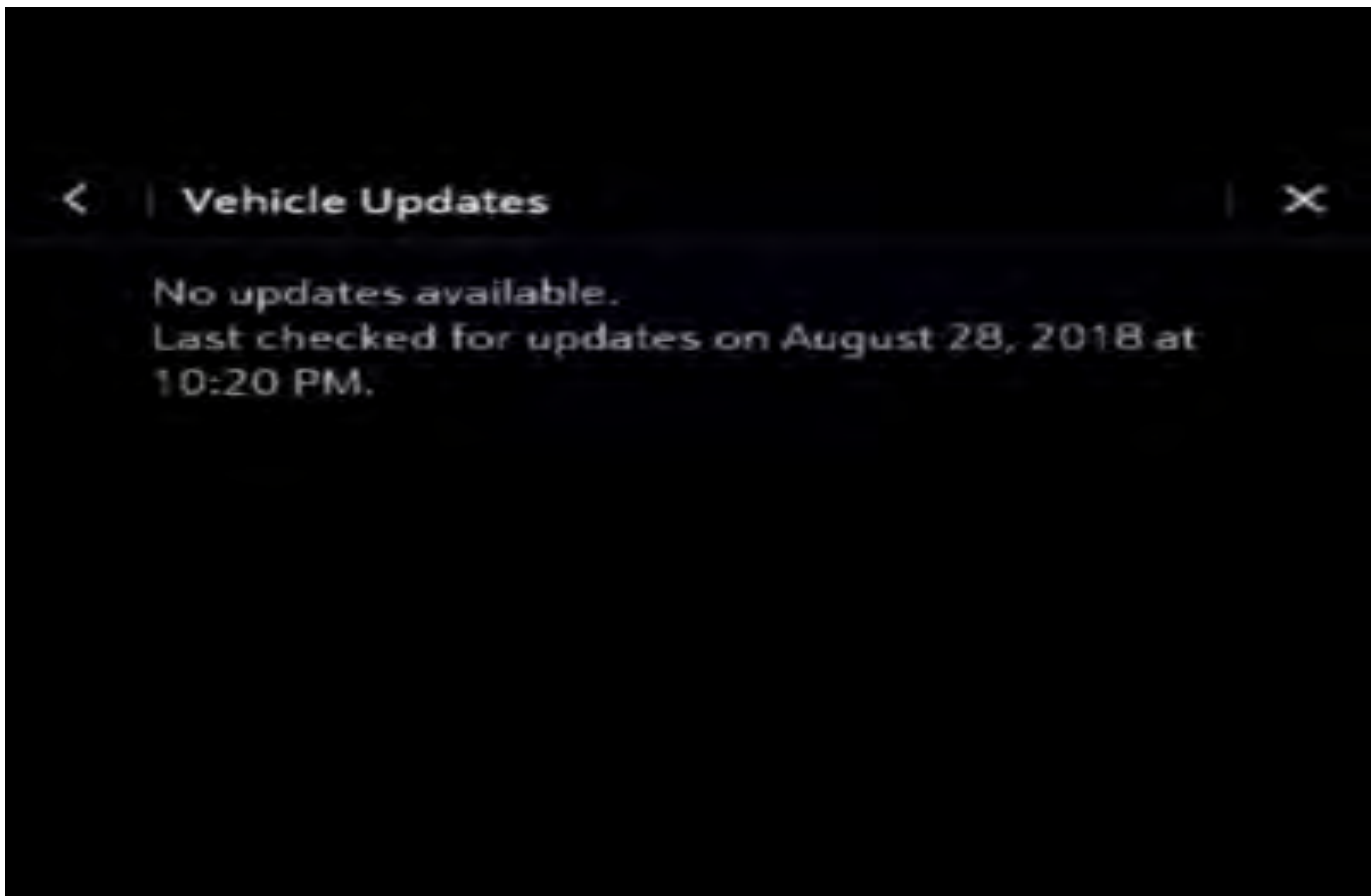
5651947

- If no "Start Download" or "Install Now" pop up is displayed, navigate to "Settings" -> "Updates." If there is a remote package on the system, it will display "Install Now" Or "Start Download." If the screen below is shown, then there is no remote update package on the system. Navigate to Settings -> About to verify the software version. If the build number is not U150 or greater, update via USB.

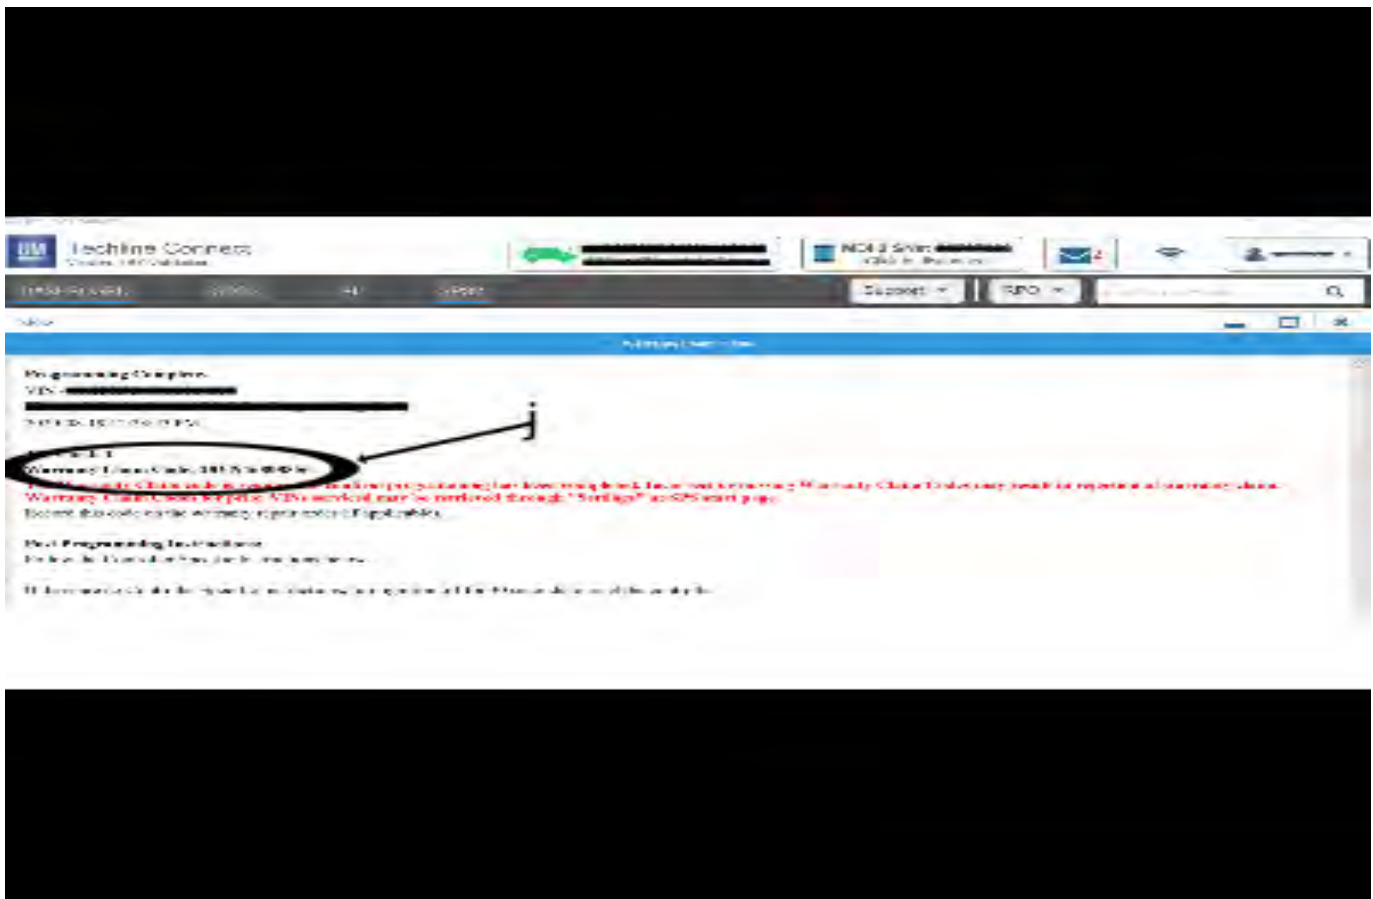
1. Start SPS, select Radio – USB File Transfer and follow the on-screen instructions.

Important: To avoid warranty transaction rejections, you **MUST** record the warranty claim code provided on the SPS Warranty Claim Code (WCC) screen shown above on the job card. Refer to callout 1 above for the location of the WCC on the SPS screen.

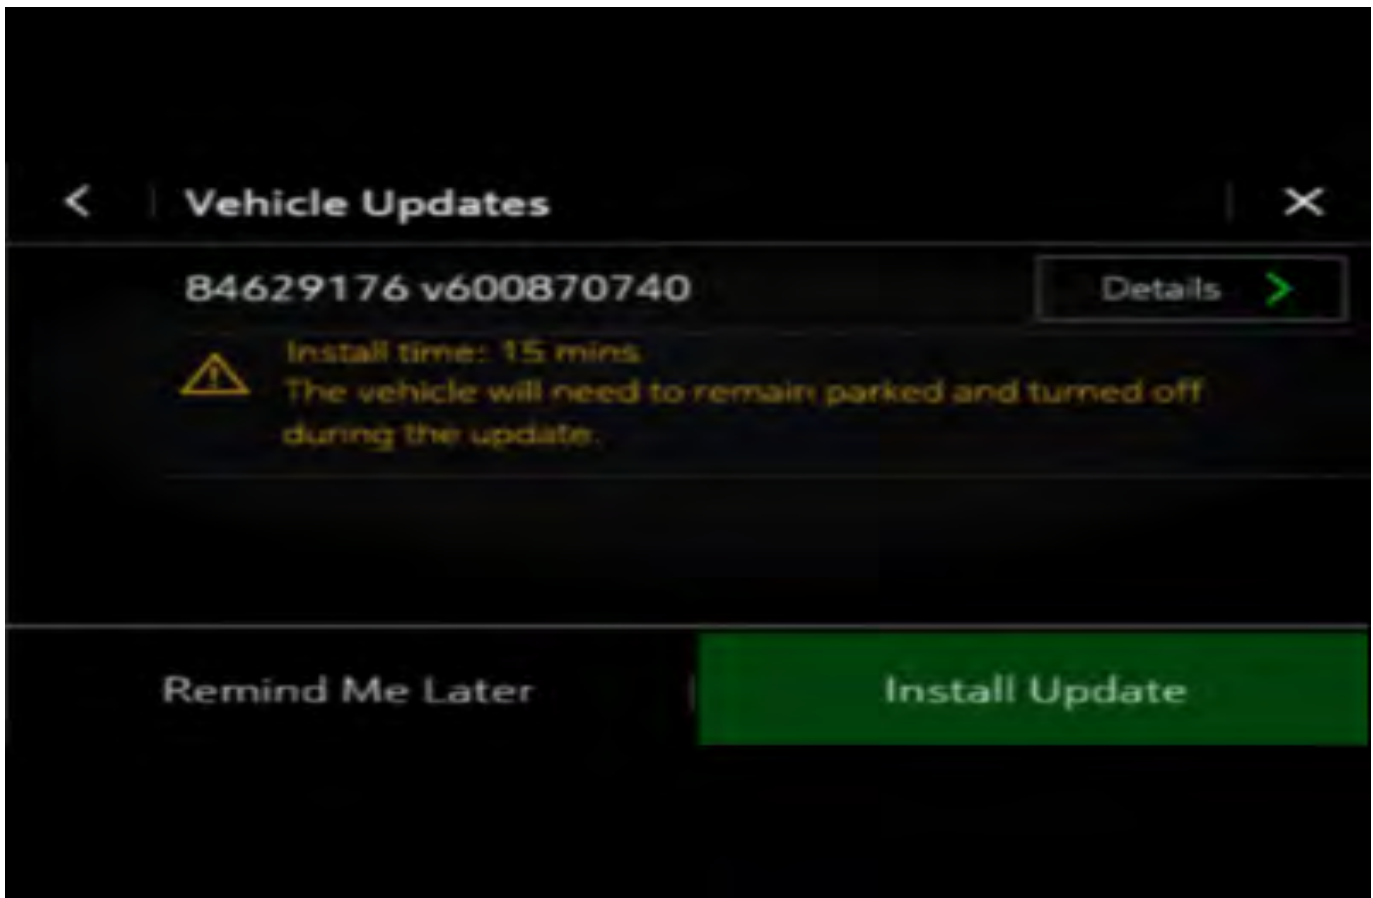
5651948

2. Record the SPS Warranty Claim Code on the job card for warranty transaction submission.
3. Insert the USB into the vehicle while in Park. On the radio screen, select "Settings" —> "Updates" or select "Learn More" on pop up after USB insertion.
4. Select Install Update.
5. Follow on screen prompts to complete the update.
