**SERVICE BULLETIN**

**APPLICABILITY:** 2020-21MY Legacy and Outback Models      **NUMBER:** 15-261-20R  
**SUBJECT:** Reprogramming File Availability for Optimization of Gen 4 Denso CP1 Infotainment Systems      **DATE:** 03/10/20  
**REVISED:** 12/18/20

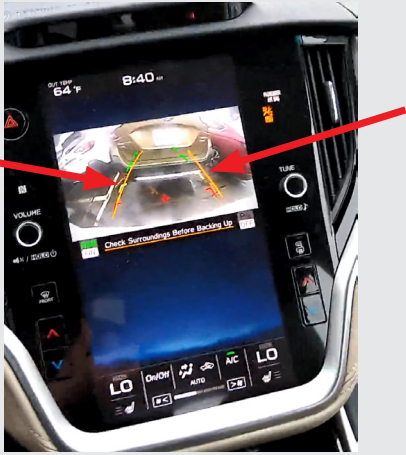
</div> <p><b>**NOTE:</b> After switching the ignition off and leaving the driver’s door open more than 70 seconds, the system <i>may</i> recover after switching the ignition back on.</p>
<b>2</b>	<p>Delayed response of rear view camera guide lines. When the rear view camera is activated and the steering wheel is turned, there is a delay before the steering-responsive guide lines respond to the steering wheel input.</p> <div style="text-align: center;">

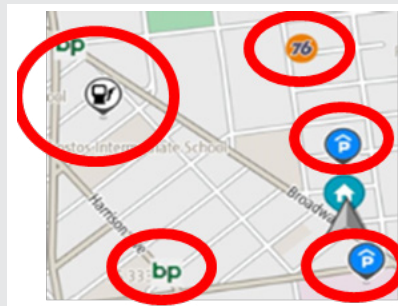
Number	New Functions and Improvements:
1	The previously selected customized map orientation setting is memorized even after ignition OFF / ON. If the customer changes the map orientation setting, the change is automatically retained.
2	Pin display of POI is now available.

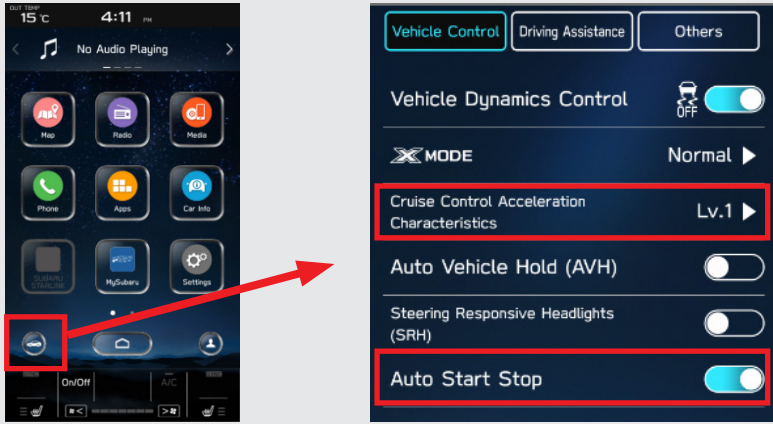
Number	New Functions and Improvements:
3	<p>In the 2D and 3D HU display mode, the vehicle position icon on the Navigation map is easier to identify:</p> <ul style="list-style-type: none"> <li>• Icon size increased from 7mm to 9mm.</li> <li>• Icon color has been changed to Dark Blue.</li> <li>• Icon position (when using route guidance) stays at the same position as when not using route guidance.</li> <li>• Icon has been re-positioned 9mm higher on the display.</li> </ul>
4	<p>The ISS (Auto Start Stop) button has been moved to the upper layer in the Car Setting menu. By touching the “Car Setting” icon, the Auto Start Stop and Cruise Control Acceleration Characteristics menus can be accessed immediately, whereas selecting “Others” in the Car Setting screen was required to access these menus.</p>

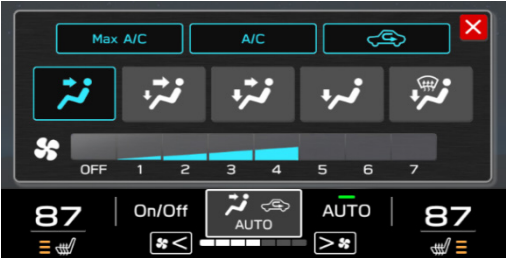
5	<p>HVAC control buttons of base grade are now larger and easier to see.</p>

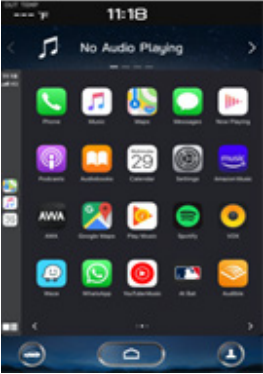
Number	New Functions and Improvements:
9	<p>CarPlay screen is now expanded from half size (horizontal) to full screen (vertical).</p>

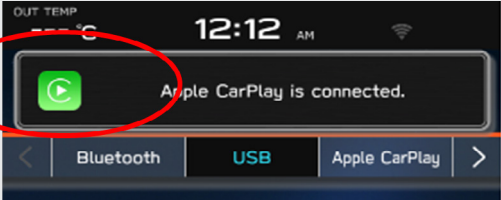
11	<p>When using route guidance with CarPlay navigation, &lt;Turn by Turn&gt; descriptions will be displayed both in the Information bar of CID and in the MID located in the center of the combination meter.</p>
12	<p>By touching the new CarPlay button located at the top of the CID, the CarPlay menu can be accessed easily.</p>

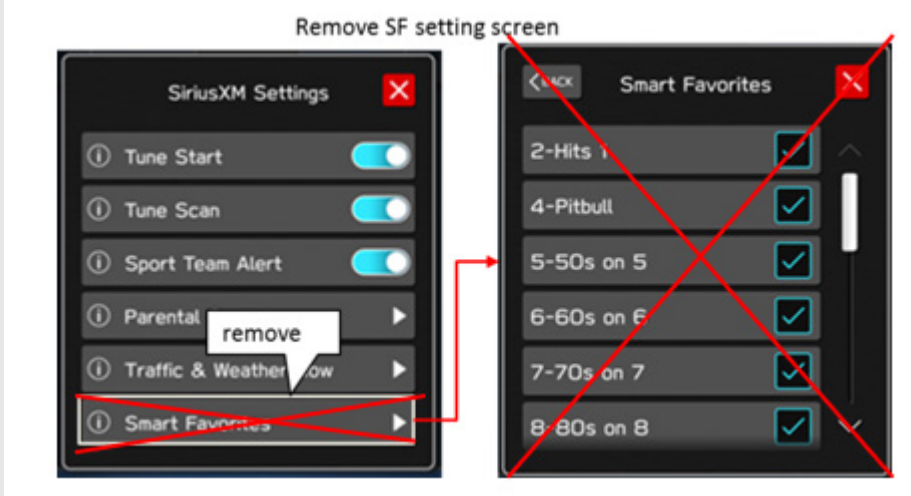
Number	New Functions and Improvements:
16	<p>1. Sirius XM Smart Favorites menu has been removed from SiriusXM Settings</p>

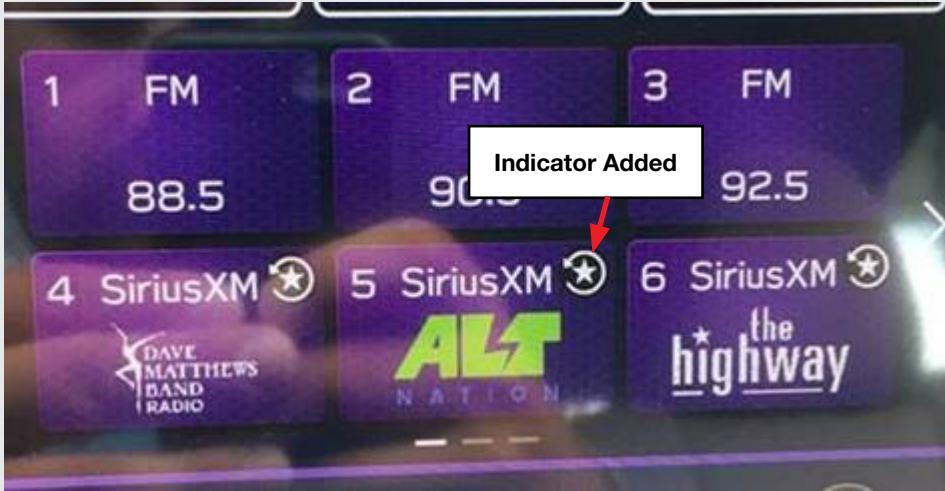
<p>2. Going forward first 10 set Sirius XM presets are now smart favorites by default</p> <p>3. Smart favorite channel has “star” added to the preset button</p>
