SERVICE PROGRAM BULLETIN

APPLICABILITY: 2020-2021MY Legacy and Outback **NUMBER:** WRI-20R
SUBJECT: Reprogramming of Denso CP1 Infotainment Units to Optimize System Performance **DATE:** 12/11/20
REVISED: 12/31/20

In the interest of customer satisfaction, Subaru of America, Inc. (Subaru) is initiating a Service Program for certain 2020-2021 model year Legacy and Outback vehicles to update the Cockpit Control Module (CCM) software to the latest version.

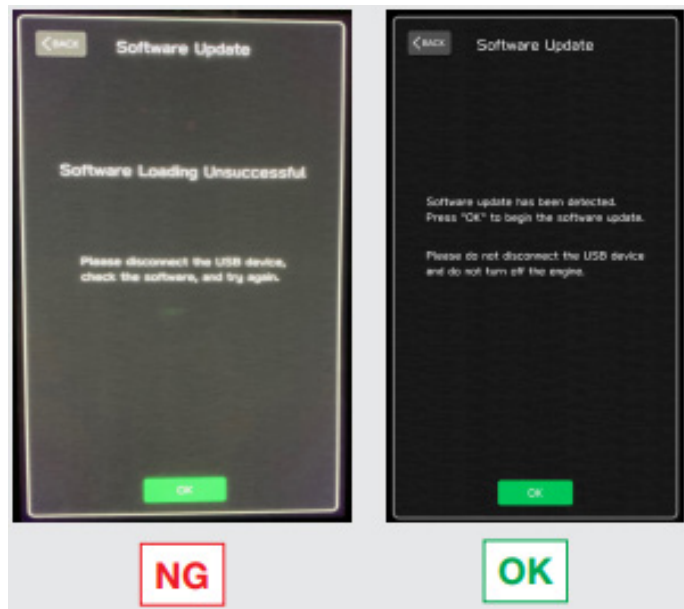
5e) Insert the H/U reprogramming USB into the USB port. When the update screen appears, confirm the message on it and if no concerns, press OK.

NOTE: If after plugging in the USB, the screen displays a Software Loading Unsuccessful message, confirm the USB device has been properly formatted and the software on the device matches the H/U being reprogrammed (example: **MID** software is being used to update a **MID** H/U).

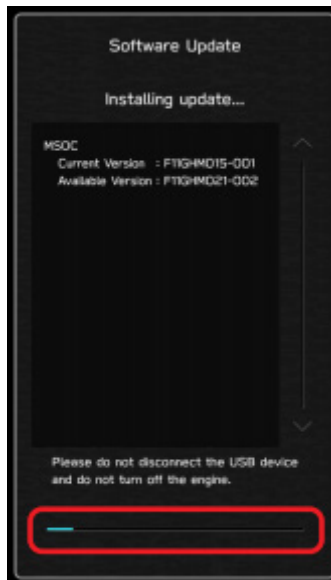
5g) Once the update begins, the screen below will be displayed with a progress bar. It takes about 15 to 20 minutes for the update to complete.

VERY IMPORTANT: NEVER turn the ignition OFF or ON while the software update is in process. To avoid any concerns with battery condition during programming, always perform the update with either the engine running (outside or with an exhaust hose attached) or with the DCA charger attached and in power supply mode.

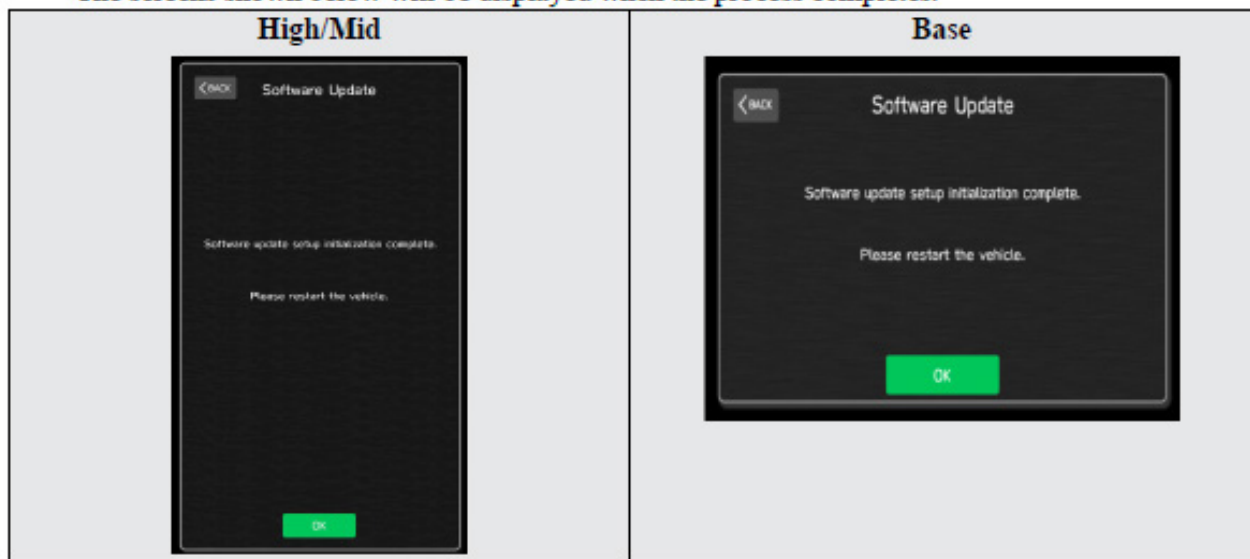
- The screens shown below will be displayed when the process completes.

1. Turn the ignition OFF, open the driver's door, close the driver's door and **WAIT** for 3 or more minutes before proceeding further.
2. Open the driver's door again and either turn the ignition ON (if a charger is connected) or start the engine.
3. Go to Dealership Mode menu again (PRESS and HOLD the RIGHT-side temperature control buttons (both up and down) and press the Tune / Scroll knob 6 times then release all to display the Dealership Mode) and select Software Update as in STEP 3 beginning on pg. 8.

IMPORTANT NOTE: If this procedure is required, contact Techline as additional action may be necessary.
