ROADSTER WARRANTY Bulletin

Campaign no.: 2011-0016
2012-0006

No. **2012-8**

- 1- Updated Throttle Body Actuator Protection**
- 2- ECM and TCM Software Updates**
- 3- Middle Side Panel Grommet Replacement (2011 Models Only)**

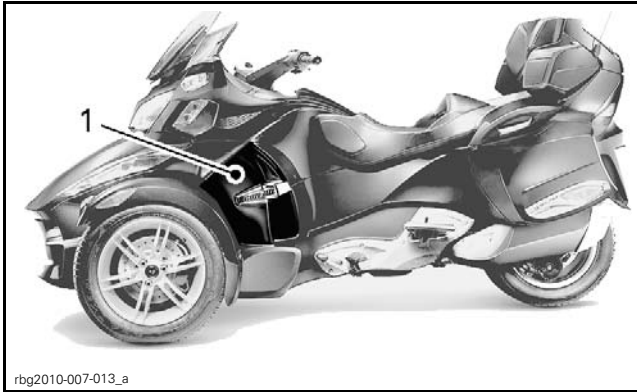
1. Middle side panel

On some 2011 vehicles, on which *2011-8 OR 2011-13 WARRANTY CAMPAIGNS* has not been performed, one of the middle side panels rubber grommets might fall off after multiple removal and installation of the panel.

1. Remove the middle side panel.
