# MULTI-MODEL (EQUIPPED WITH REAR VIEW MONITOR) *REAR VIEW MONITOR DISPLAY IS BLURRY*

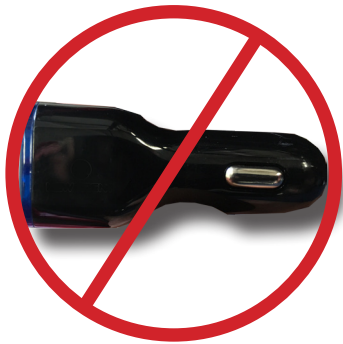
OK

Without aftermarket cell phone charger

Repairs for this concern are not covered under Mazda's warranty policy. Advise the customer not to use the aftermarket device that is causing the concern.
