CAMPAIGN BULLETIN

Left Front Combination Lamp Dealer Inventory

Reference: PC778
Date: January 12, 2021

PC778 – 2021 - ROGUE LEFT FRONT COMBINATION LAMP INSPECTION

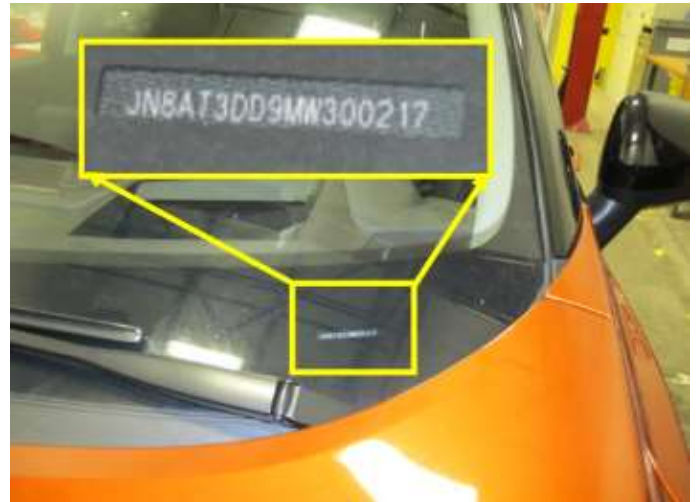
Figure 1

1. Confirm the vehicle is affected.
(Figure 1)

- Locate dash VIN plate on the left-hand side lower windshield area
- Confirm VIN on dash VIN plate is included in the quality action
