# Technical Service Bulletin

## 15 Oil leak from the cylinder head - 2.9 and 3.0TFSI only

15 21 37 2053278/6 February 16, 2021. Supersedes Technical Service Bulletin Group 15 number 21-36 dated January 29, 2021 for reasons listed below.

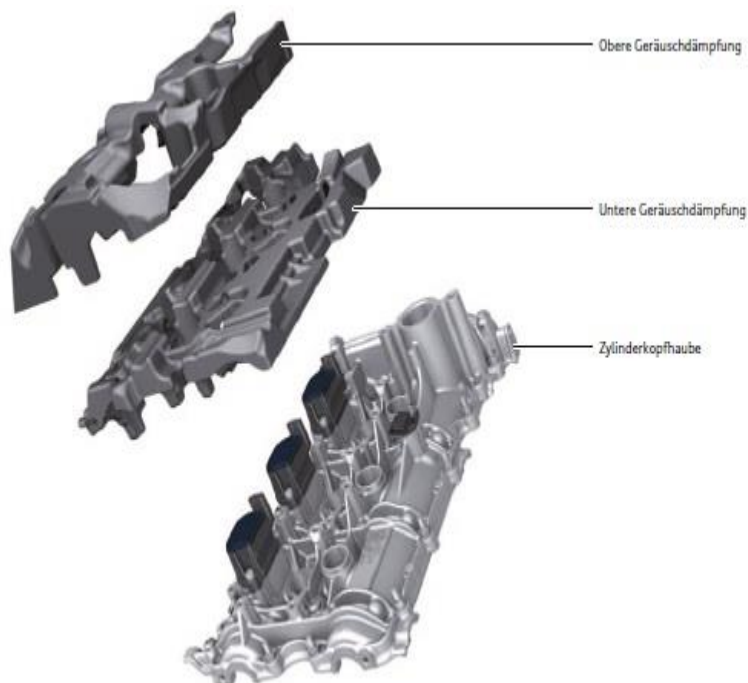
**Figure 1.** Removing the upper noise insulation.

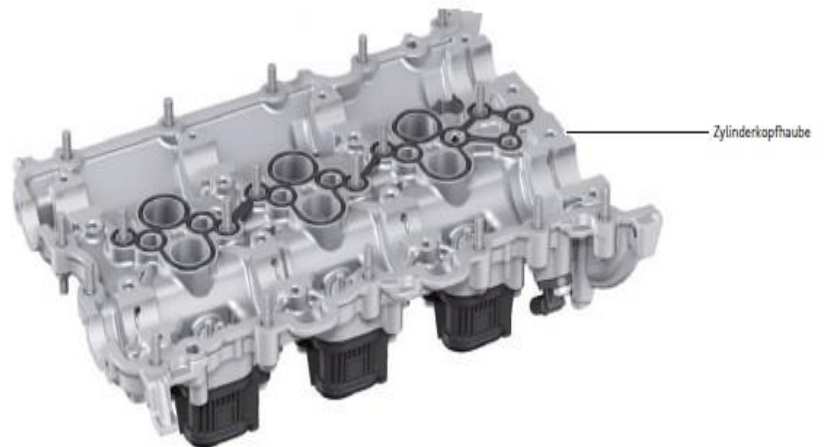
**Figure 4.** Remove the cylinder head cover and gasket.

8. Install a new seal, re-assemble the camshaft cover, clean the engine compartment, and if necessary replace the noise insulation (if it is full of oil).
