SERVICE BULLETIN

APPLICABILITY: 2017-21MY Impreza
 2018-21MY Crosstrek
 2018-19MY Legacy and Outback
 2019-21MY WRX and WRX STI
 2019-21MY Ascent
 2018-21MY BRZ

NUMBER: 15-221-18R

SUBJECT: Harman Audio / Infotainment: Harman Generation 3.0 and 3.1 Operating Tips

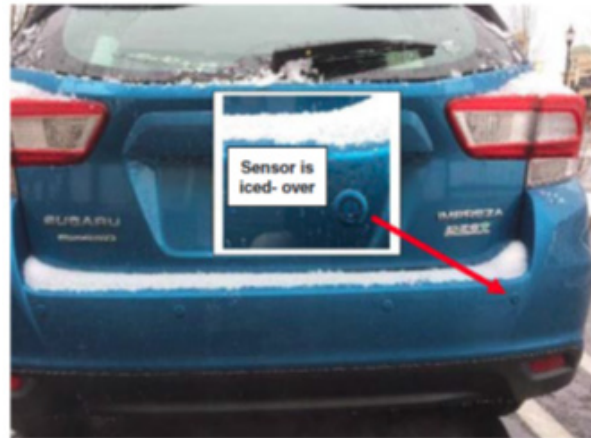
CONDITION# 1.3 On vehicles equipped with reverse automatic braking (RAB), a red area appears in backup camera display:

CAUSE: If a customer states they see a red box or area in their backup camera display, the system is most likely operating as designed. Always perform a visual check of the sensors on the rear bumper first. If any of the sensors are covered over or obstructed by ice and / or snow, the RAB system may not function properly and the red area shown in the example photo below will most likely appear.

RECOMMENDATION: When this condition occurs, the RAB system is unable to properly differentiate between what really is an obstacle and what is not. In the image below, the sensor is iced over and the red area is displayed with no obstacle present. The Owner's Manual provides a list of other potential causes for this condition to occur.

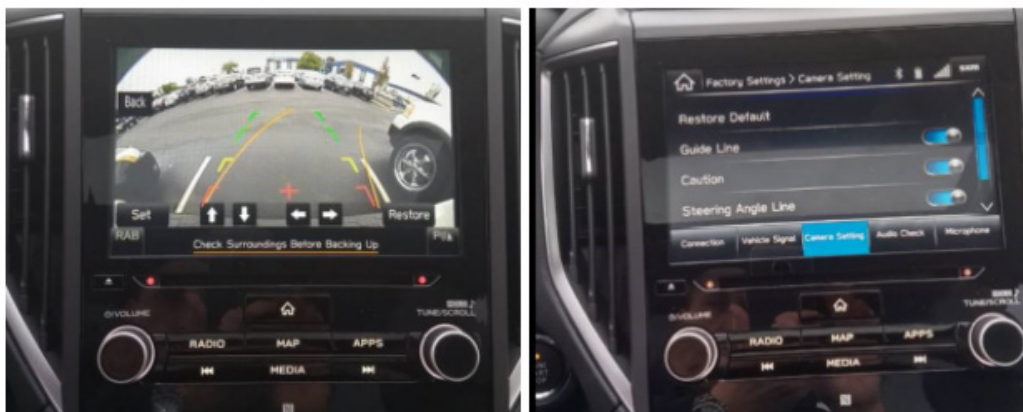
CONDITION# 1.4 Orange park assist lines on the backup camera not moving or no longer present:

CAUSE: Park assist lines position is reflecting the steering angle. If the data is not supplied to the head unit from CAN bus or the data supplied is wrong, the lines position is not changing. Park assist lines display could be turned off via head unit setup.

RECOMMENDATION: Confirm the guide line settings and steering angle line data to determine the reason for concern.

Select camera setting option to verify the CONDITION# 1.4 and use Factory Settings/Camera Setting option to verify setup:

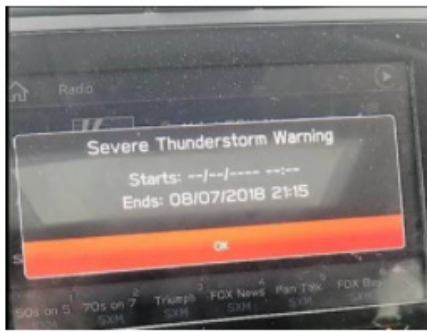
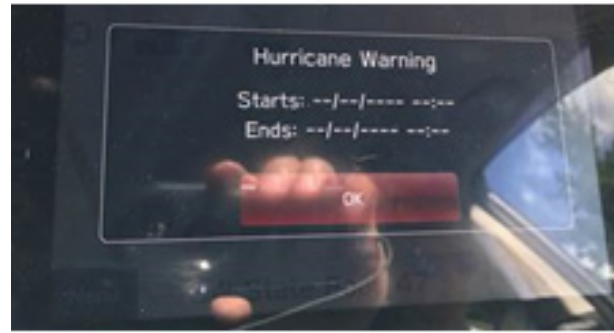
CONDITION# 5.2 Hurricane or Severe Weather warning message is displayed:

CAUSE: The head unit is designed to receive severe weather alert information from Sirius XM (SXM) and display a pop-up window with the alert message, whenever there is a signal from SXM. So far, we are only aware of HIGH grade units to have this feature available.

RECOMMENDATION: Please note when there is no date information supplied by SXM, the details (dates/ times) will be shown as --/--/---- --/-- in the alert notification message. The head unit is operating as designed when this occurs.

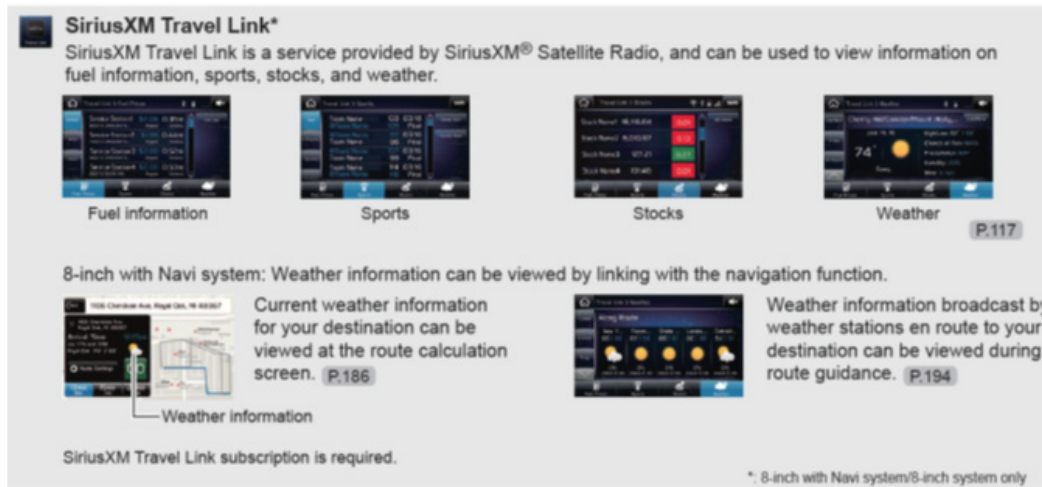
CONDITION# 5.2 Weather, Fuel Information, Sports, Stocks information do not display in the Multi-Function Display (MFD):

CAUSE: Weather forecasts, forecast temperature or highest/lowest temperature, and the chances of precipitation, etc. can be displayed in weather information. SiriusXM (sXM) services subscription is required.

RECOMMENDATION: Verify an active subscription for SiriusXM (SXM) services has been extended, after 1-year free trial period. Content using the SiriusXM® Satellite Radio Service is reset when personal information is initialized by selecting **Factory Data Reset** (Factory Data Reset) on the "GENERAL SETTINGS SCREEN".

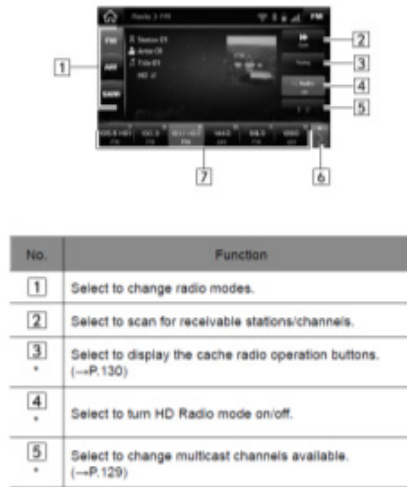
CONDITION# 5.5 Volume fades Up and Down (FM/AM HD radio):

CAUSE: Assuming radio is in HD mode the vehicle is likely traveling outside of HD coverage area causing the head unit to switch between HD and Analog mode.

RECOMMENDATION: Turn HD off as shown in the picture below.

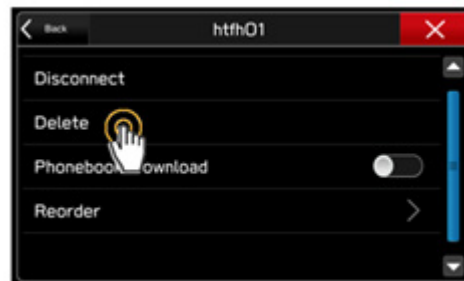
CONDITION# 8.5: New pairing not possible until Bluetooth on phone turned off and on again and phone deleted on HU side!

CAUSE: Phone does not disappear on HU side

Unpair on HU side

- > Does not disappear on phone side
- > New pairing not possible!

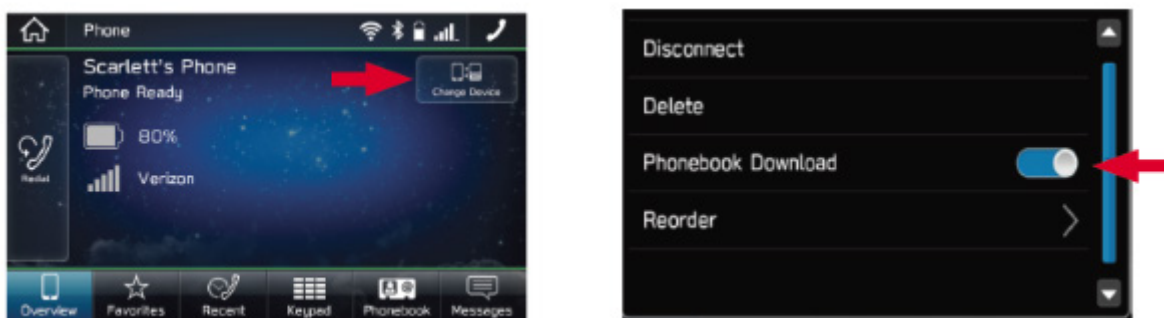
CAUSE: There have been reports received regarding phonebook downloading failure during Bluetooth Pairing. Customers report after repeated pairing attempts the condition continues.

RECOMMENDATION: We would like to refresh the steps involved in the process to prevent the issue occurrence due to the setup. If the phonebook or messages are not appearing as expected following Bluetooth Pairing, verify the Phonebook Download feature has been enabled in the head unit settings. Select the “Phone” button then press “Overview” on the head unit touch screen. Then select “Change Device” and ensure “Phonebook Download” is enabled.

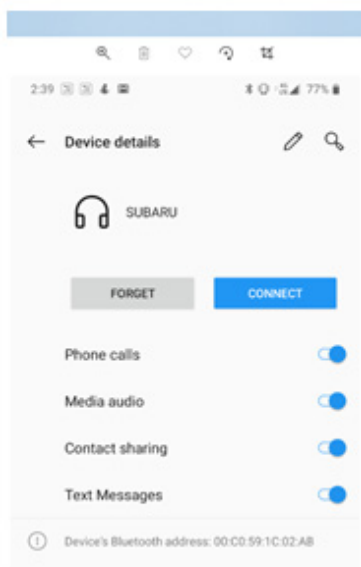
CONDITION# 8.6: Phonebook doesn't download

Select the gear icon next to your vehicle device name. Ensure all settings are enabled.

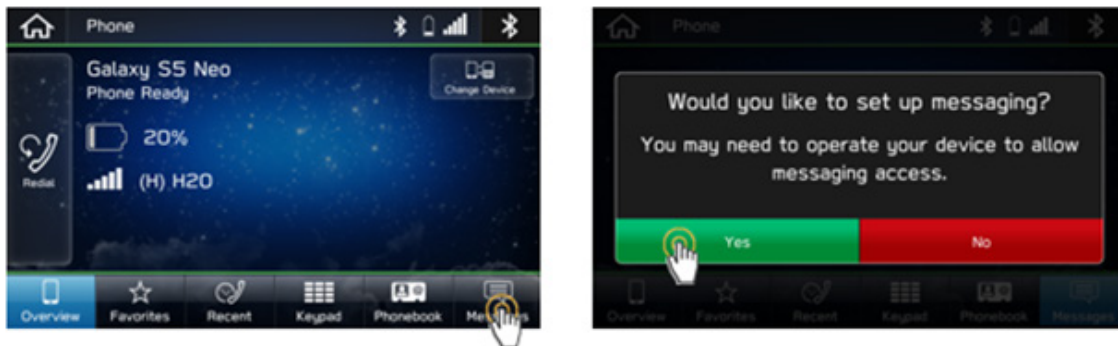
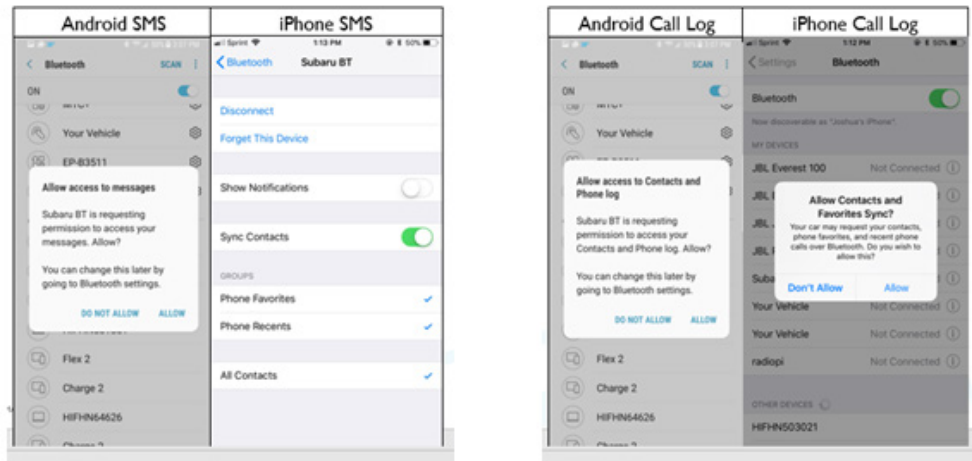
CONDITION# 8.7: Messaging doesn't work:

- If there is an access request, you have to confirm it on phone side.

Note: Some phones will show SMS access request, some will show SMS and call history access request, some only call history access request. If there are access requests, you have to confirm them on phone side (refers to phone screenshot)

- ignition cycle is required to enable SMS.

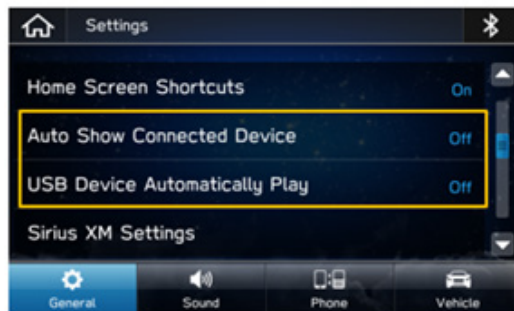
CONDITION# 8.8: Audio gets interrupted, while the phone being paired via Bluetooth with the head unit.

CAUSE: When pairing phone via Bluetooth connection will stop the radio playing and switch to media, if Auto Play is enabled.

Starting position: Settings > General

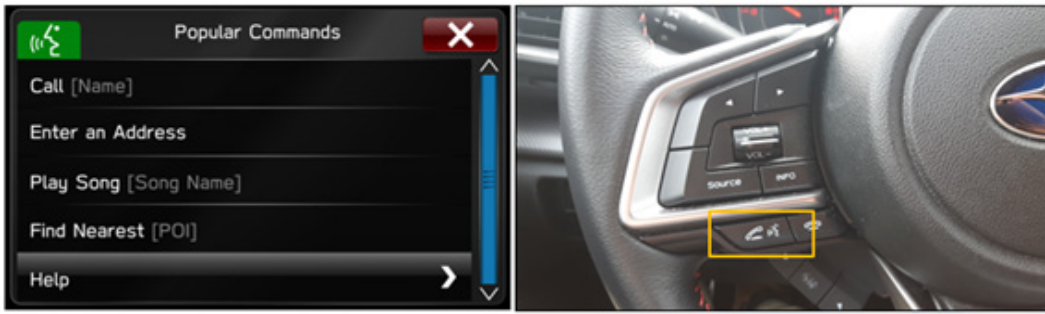
CONDITION# 8.9: Voice Recognition does not work to dial:

- » Native VR disabled when Android Auto or CarPlay on -> enables VR for phone features (Siri, Google assistant).
- » Speak in a steady flow.
- » Even little gaps between speaking can CAUSE the HU to detect a stop in speech and to process the command.
- » When giving a command be consistent with the speed in which you talk and announce your words. Be aware that you can't say call XXX-XXX-XXXX.

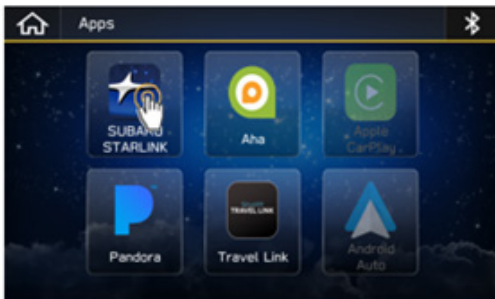
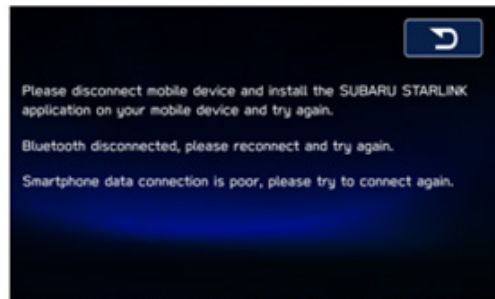
CONDITION# 8.10: Starlink issues:

2. Error screen shown in case of issues.

The error can have multiple CAUSES which should be checked in the following order:

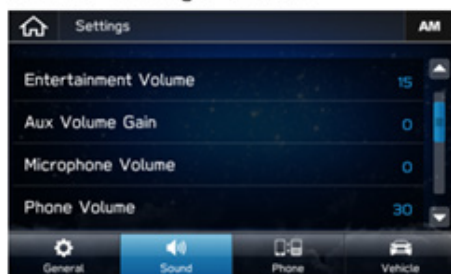
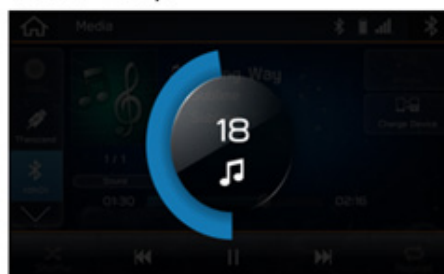
CONDITION# 9.2: Navigation guidance volume changes level on its own:

CAUSE: There are different volume focuses for different channels such as phone, navigation, microphone, etc.

A. Change value in the settings.

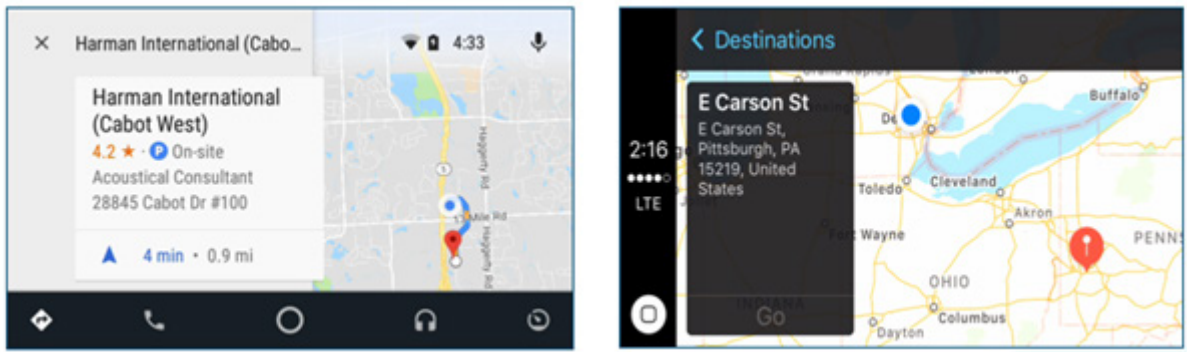
CONDITION# 9.3: NAVI stops working:

CAUSE: It is not possible to use multiple navigation applications at the same time.

» Android Auto (AA) and CarPlay cannot be used at the same time. However active routes will be saved when application is closed.

» Both AA and CarPlay close HU navigation and delete the active route.

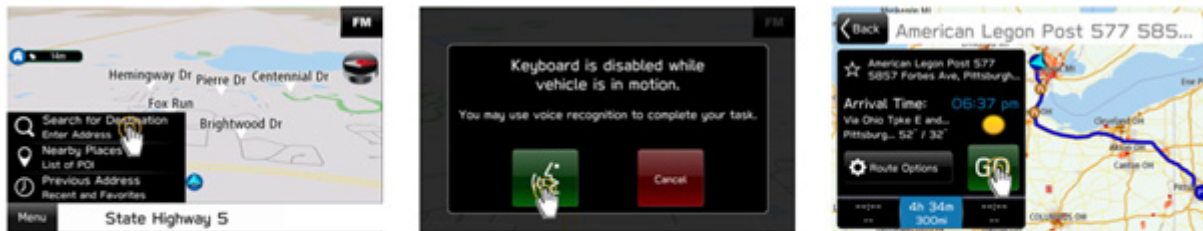
CONDITION# 9.4: How to set destination while driving:

CAUSE: Screen touch inputs are disabled during moving, so it must be performed via VR.

RECOMMENDATIONS: See screenshots below to understand how to set a destination while driving.

1. Click Search for Destination.
2. Click on VR symbol.
3. Say your address.

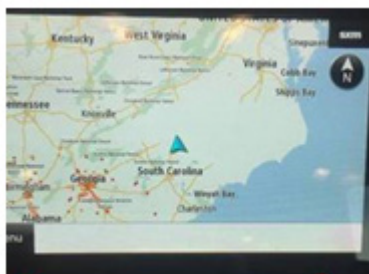
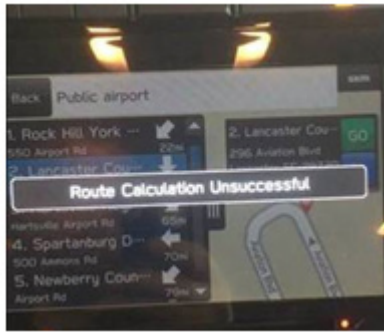
CONDITION# 9.5: Map Display “Whiteout” :

- Map display is either white (blank) or an incomplete screen (no roads) is displayed

- “Route Calculation Unsuccessful” message is displayed when trying to calculate a route

CAUSE: If a MOTA (Map Over The Air) update was performed or attempted previously, the state map data may have become corrupted. This can occur due a weak Wi Fi signal during MOTA update causing the update interrupt resulting in the data corruption.

RECOMMENDATION: Successfully updating the map data again using a strong and reliable Wi Fi signal or using USB Flash drive with the latest Map data downloaded from PC would restore missing map data.

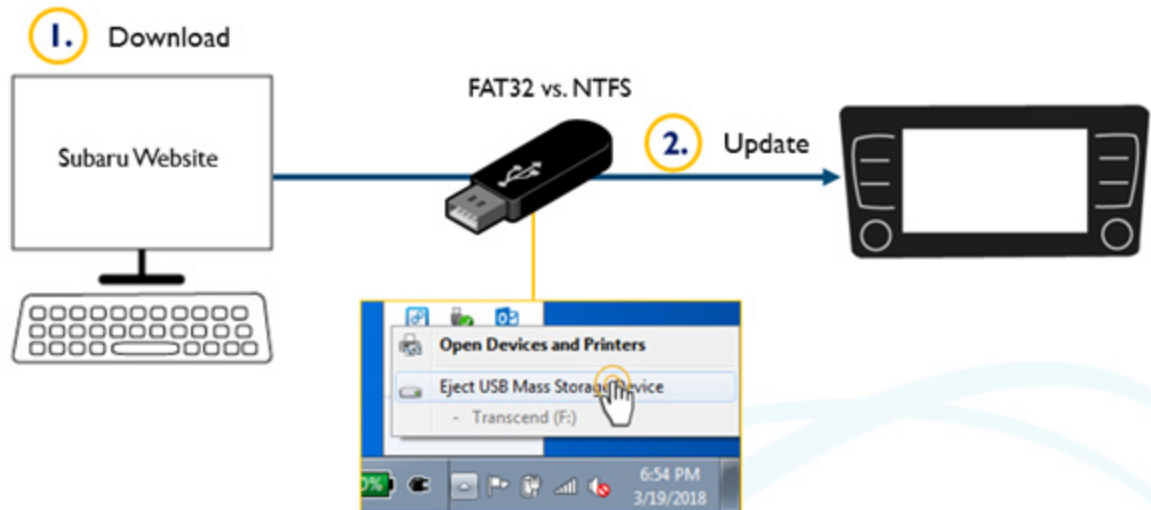
CONDITION# 12-1: Head Unit software update resulted in a failure to operate correctly.

CAUSE: based on the review of the field failures resulted from the head unit software update, we have determined TSB 15-211-17R or TSB 15-236-18R (as applicable) was not followed or followed incorrectly.

- » Engine must be idling (or GR8 connected) to start update.
- » Don't pull out USB stick during files download and during update.
- » Only backup camera works during the update.
- » When power is cut off during update, don't remove USB stick or phone => update resumes after turning power back on.
- » Black/blank screens are not necessarily an issue:
 - There can be a black/blank screen when turning power on again -> HMI is missing (leave in state for 15min, update is still running) > in most of the cases it is not an issue!
 - At the initial start of the update and for the boot loader update the HU is reset – HU starts restarting automatically (after a couple of seconds)
- » After update > HU restarts automatically.
- » To complete the update the customer has to follow pop-ups that appear after download of the update.
