Field campaign

Topic	Bentayga - Control Unit for Fuel Pump (SC 20/05)
Market area	China 796 VW Import Comp. Ltd (Vico), Beijing (6796),United Kingdom E01 Bentley UK (6E01),United States E05 Bentley USA and rest America (6E05)
Brand	Bentley
Transaction No.	2058764/2
Campaign number	EB47
Note	
Type	Field Campaign
US code

Bentayga

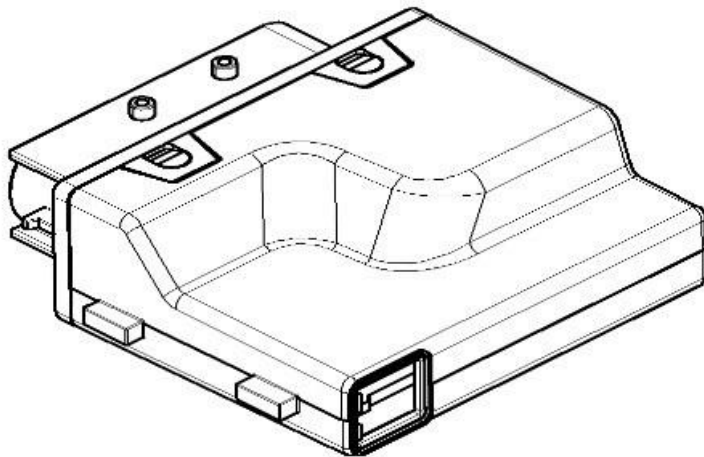
Fuel pump control unit 4M0 906 093K has been superseded by fuel pump control unit 4M0 906 093N, however, this change is not currently applicable to Bentley. A small quantity of "N" level control units were mistakenly issued as spare parts and have subsequently been fitted to Customer vehicles.

On vehicles with the "N" level part installed the Customer may complain of noise from the rear seat area, it is possible that fuel pumps may become noisy during operation. At present no other symptoms or faults are expected.

Correct level fuel pump control unit(s) should be installed – 4M0 906 093K.

If the part number on the fuel pump control unit(s) is 4M0 906 093 N or the control unit cannot be identified, proceed to replace with control unit 4M0 906 093 K. Should the original control unit(s) be identified as 4M0 906 093 K no further action is required.
