SERVICE BULLETIN

ITB19-009a

INTELLIGENT KEY DOES NOT WORK AFTER BATTERY REPLACEMENT

APPLIED VEHICLES:
 2019 QX50 (J55)
 2019 Q50 (V37)

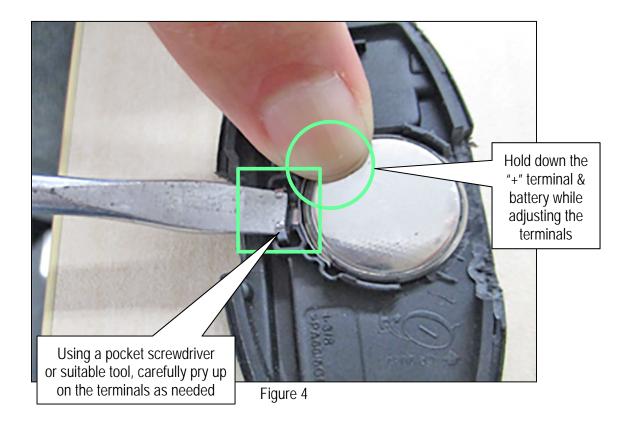
If the battery side of the Intelligent Key is held by pinching down on the terminals while removing the battery, it is possible to bend the terminals down far enough that they will not touch the contacts on the other half of the Intelligent Key.

If the terminals are found to be bent down, pry them back up so that they will come in contact with the other half of the Intelligent Key's contacts.
