## SERVICE BULLETIN

**APPLICABILITY:** 2020MY Legacy and Outback  
**SUBJECT:** Denso Gen 4 Cockpit One (CP1) Infotainment System Operating TIPS

**NUMBER:** 15-259-20R  
**DATE:** 02/19/20  
**REVISED:** 03/24/21

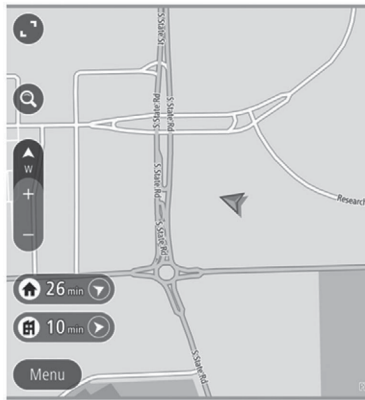
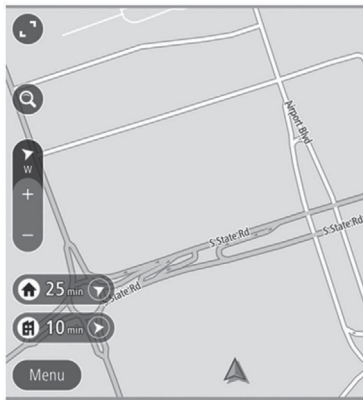
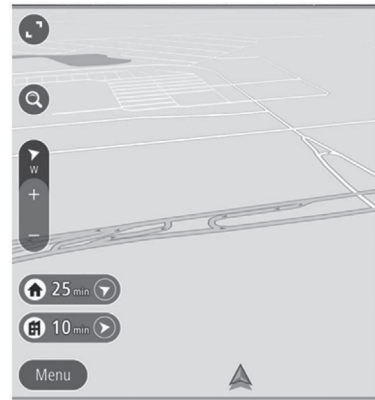
**CONDITION #1a:** During Navigation operation, the map orientation can be changed between 2D north-up, 2D heading-up and 3D.

The map orientation defaults to 2D north-up, 2 mile scale whenever the ignition is cycled off-on.

This is a normal operating characteristic.

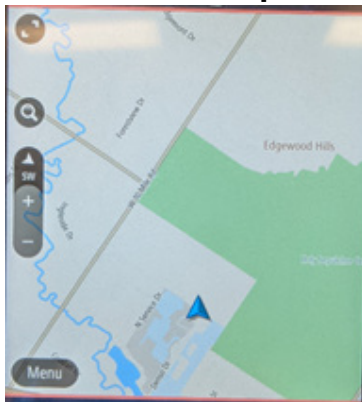
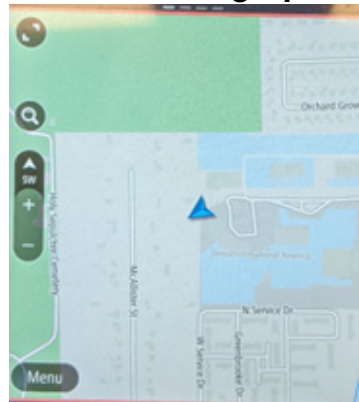
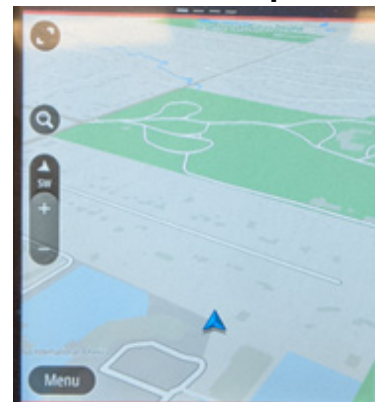
**CONDITION #1b:** Navigation issues due to street names not shown.

Street names are not shown.

Please note street names only appear in 2D north-up and 2D heading-up. **Street names are not shown in 3D heading-up map orientation mode.** This is TomTom User Interface constraint for CP1.0 system. So this operation is characteristic.

Just a reminder there are three map orientation modes: 2D north-up, 2D heading-up and 3D heading-up.

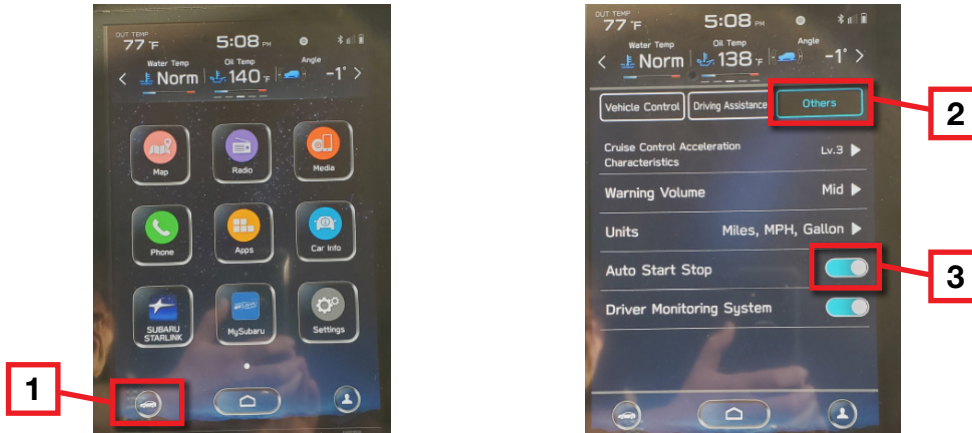
**CONDITION #4:** Engine Auto Start-Stop operation defaults to “ON” following the ignition cycle off-on.

There may be times when this feature needs to be deactivated. Follow the sequence provided below to deactivate Auto Start-Stop:

1. Touch the Vehicle Icon on the Home screen
2. Touch the Others tab on top
3. Move the Auto Start-Stop slider to OFF.

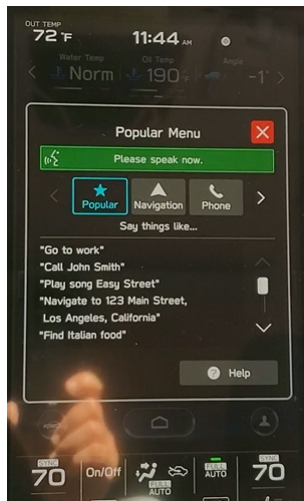
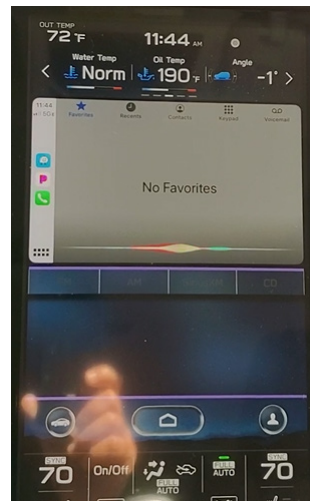
**CONDITION #6:** Voice Recognition (VR) operation is inconsistent when using Apple CarPlay or Android Auto applications.

**REMINDER:** To start Siri / Google Assistant, while using CarPlay / Android Auto press and HOLD (**long** press) the Talk switch on the steering wheel.

The same is true when using the voice to text function. To start Siri/ Google Assistant, press and HOLD the Talk switch on the steering wheel. This will initiate change-over from the native on-board VR system to Siri / Google Assistant.

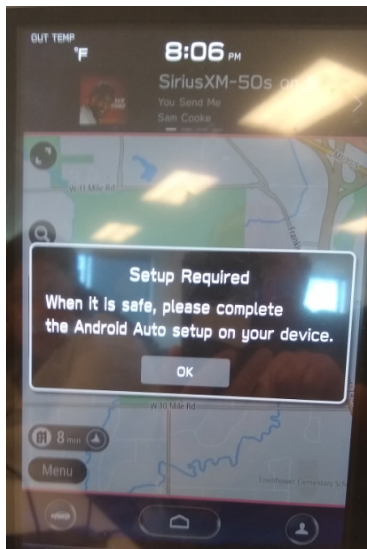
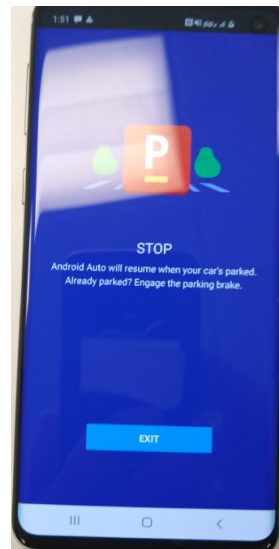
**CONDITION #8:** Android Auto does not launch.

**CAUSE / NOTE:** The vehicle must be stopped and the electric parking brake (EPB) must be ON to complete the initial pairing process between the CP1 / Gen 4 Infotainment system and the phone using the Android Auto application. When connecting a phone to the USB port, follow the messages on both the CP1 display and the phone screen. See below an example.

This is a normal operating characteristic. It is a good practice to confirm an undamaged, genuine cable is used to connect the phone as well as the making sure the phone is set to accept connection with a new vehicle.

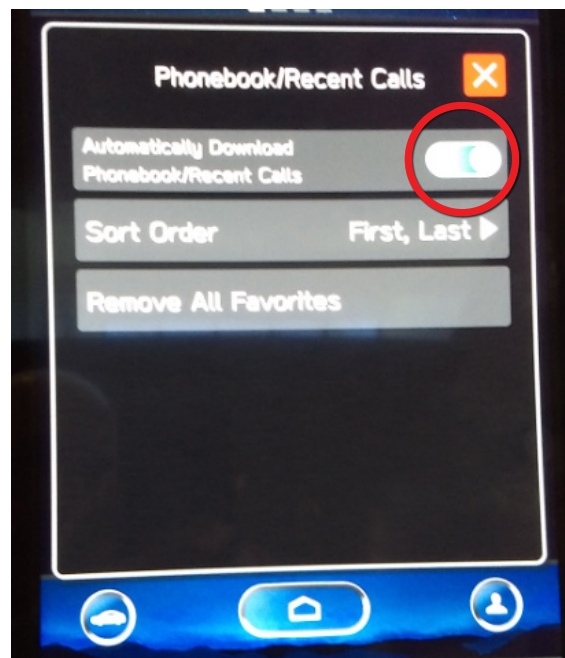
Home > Settings > Phone > Phonebook/Recent Calls

**CONDITION #10:** User is unable to download Phonebook Contacts.

When assisting with questions about the phonebook download process, start by verifying the option is enabled in the CP1 / Gen 4 Infotainment system using the following screen shot as a guide.

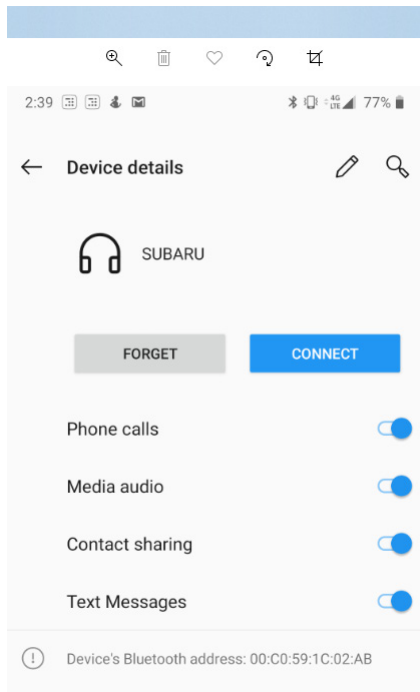
- **Android Device**

If the customer still cannot access the phonebook or messages, check the phone's Bluetooth settings to ensure all related sharing settings are enabled.

Select the gear icon next to your vehicle device name. Ensure all settings are enabled.

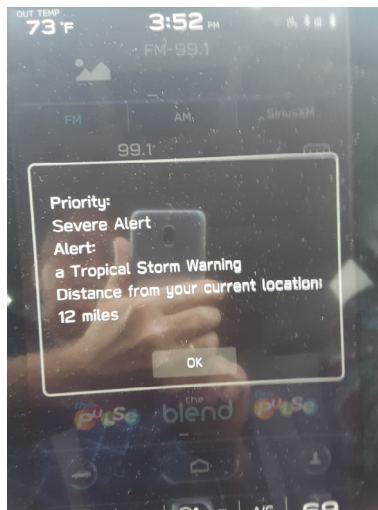
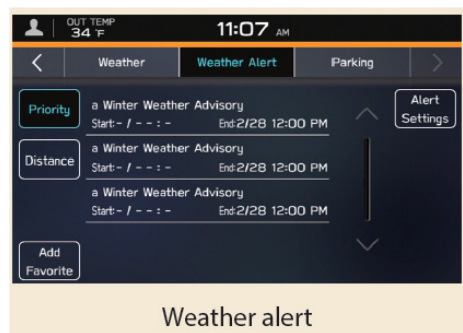
Weather alert

**CONDITION #16:** Weather Alert message

The Denso CP1 system is designed to receive severe weather alert information from Sirius XM (SXM) and display a pop-up window with the alert message as shown below.

Denso implemented SXM Weather Alert settings within the Gen 4 CP1 controls. These settings control all alert types as well as the ability to completely turn the alerts off. Unlike Gen 3 Harman, the settings for Weather Alert in Gen 4 Denso are in the SiriusXM Travel Link menu (Applications). See the Gen 4 screenshots below.

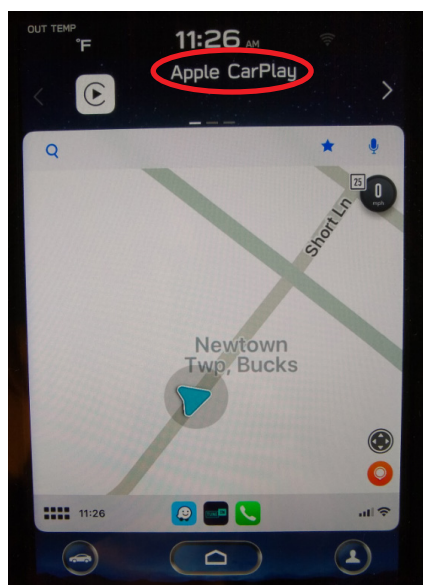
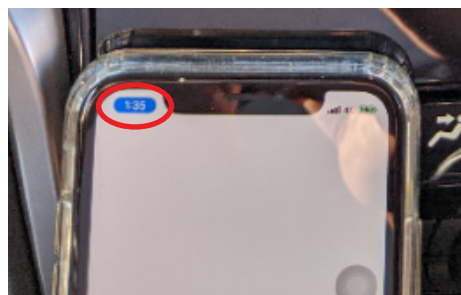
- **WAZE application has started on iPhone (iPhone clock with blue background to indicate enabled notification mode with the vehicle audio source forced to switch to Apple CarPlay):**

**NOTE** This information will be helpful when explaining why the radio or CD stop playing when the Waze app was started. The head unit projects what the iPhone is pushing to it. Hardware replacement will NOT fix the concern of a crashing phone app. In cases like this, frequent iPhone reboots or restarts (especially after recent iOS update) or updating or reinstalling the application on the phone were suggested. Check the comments in iTunes store as this may be a known concern with the app.

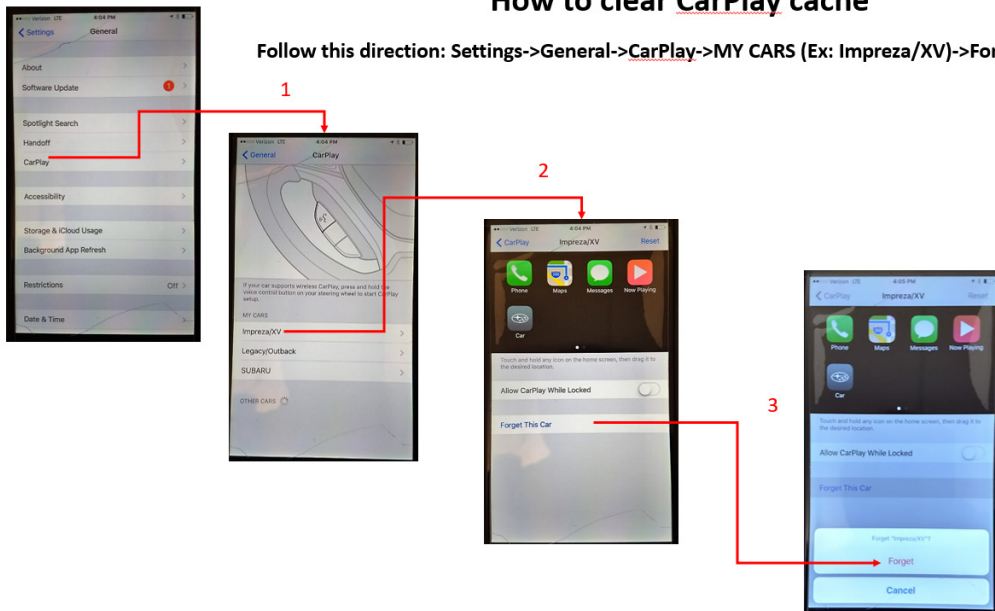
**How to clear CarPlay cache**

**CONDITION #18:** No Audio during CarPlay

Follow this direction: Settings->General->CarPlay->MY CARS (Ex: Impreza/XV)->Forget This Car
