David J. Johnson
 Director
 Service Engineering Operations
 Ford Customer Service Division

March 31, 2021

SUBJECT: NEW VEHICLE DEMONSTRATION / DELIVERY HOLD
Customer Satisfaction Program 21B03 - Supplement #1
 Certain 2020 Model Year Super Duty F250-F600 Vehicles Equipped with a 10R140
 Transmission - Number One Planetary and Ring Gear Assembly

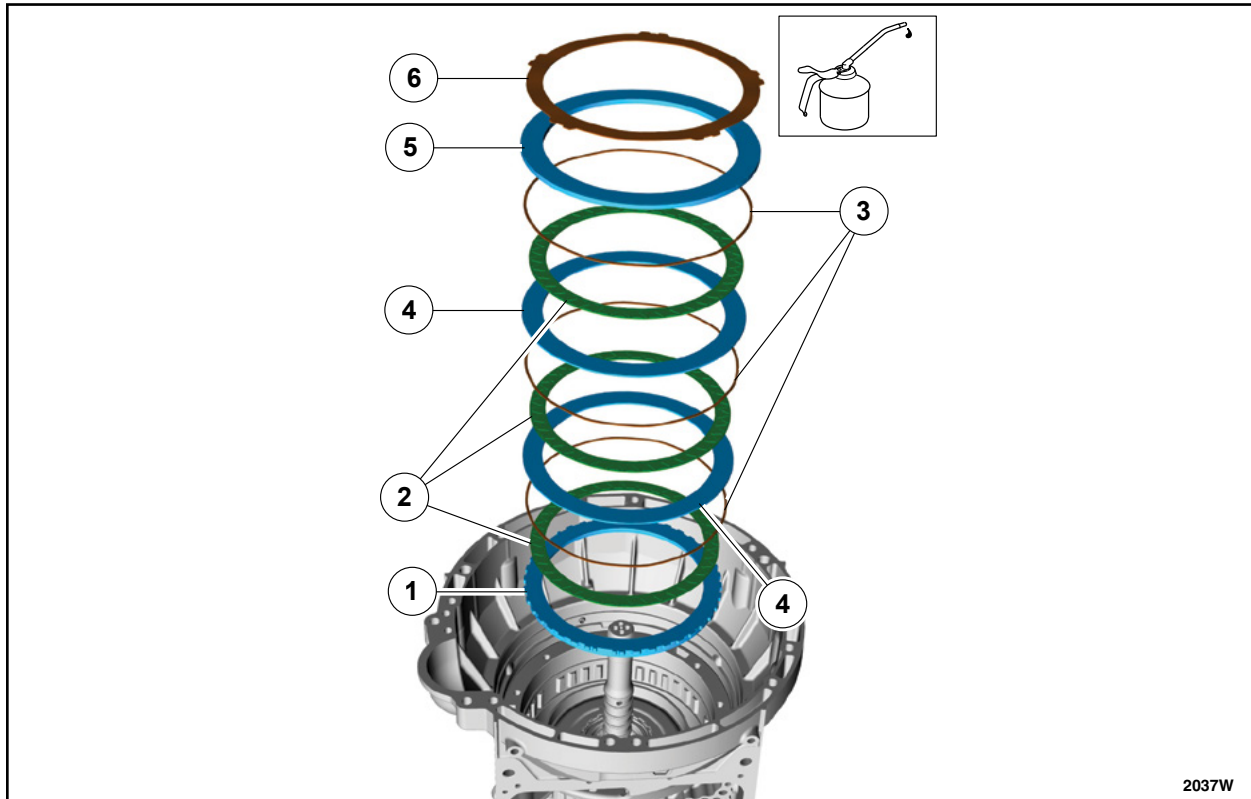
FIGURE 17

1. Pressure Plate.
2. Friction Plates.
3. Separator Springs.
4. Steel Plates.
5. Apply Plate (select fit).
6. Wave Spring.

19. Soak the A clutch plates in clean transmission fluid and then install the A clutch assembly.
See Figure 17.
