Classification:  
 RS19-005A

Reference:  
 ITB19-024A

## DTC B00A0-00 STORED

<b>APPLIED VEHICLES:</b> 2009-2013 FX (S51) 2013 JX35 (L50) 2014-2021 Q50 (V37) 2014-2018 Q50 Hybrid (HV37) 2017-2021 Q60 (CV37) 2019-2021 QX50 (J55)	2011-2013 QX56 (Z62) 2014-2020 QX60 (L50) 2014-2017 QX60 Hybrid (L50H) 2014-2017 QX70 (S51) 2014-2021 QX80 (Z62)
--	--

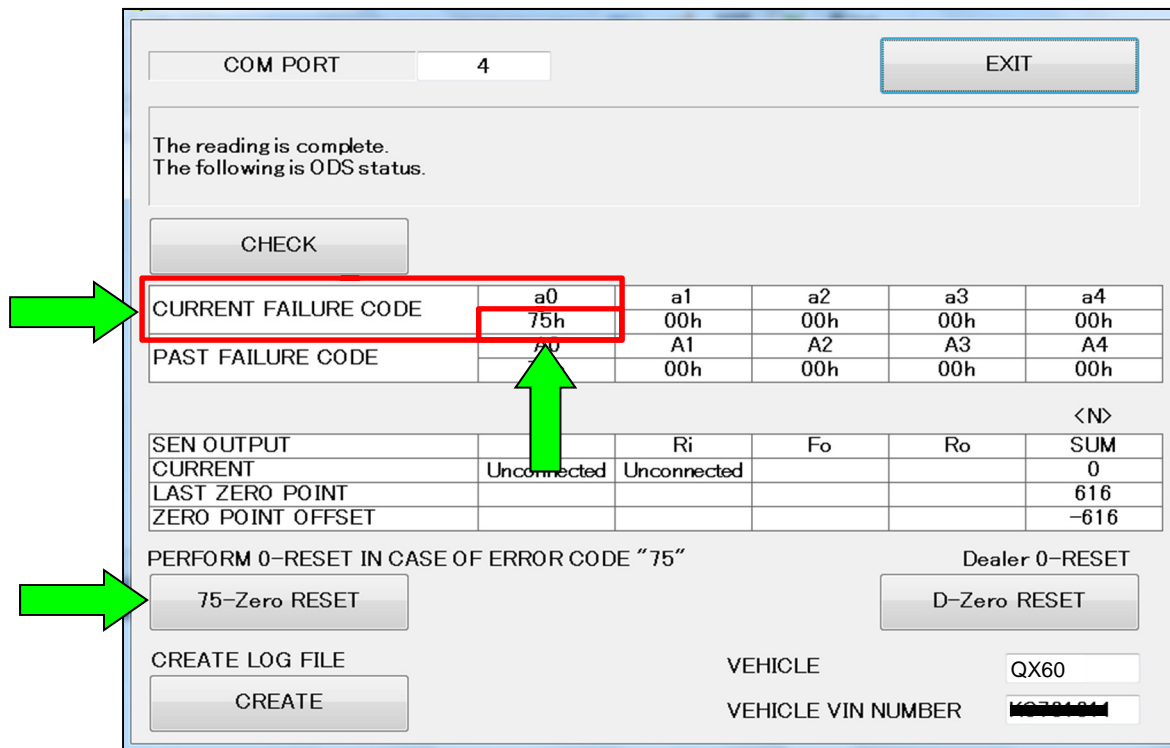
Figure 6

11. Check for code 75h to show under CURRENT FAILURE CODE.

- If code 75h shows under CURRENT FAILURE CODE, go to step 12.
- If code 75h does NOT show under CURRENT FAILURE CODE, STOP HERE.  
This bulletin does not apply. Refer to ASIST and the ESM for further diagnostic assistance.

12. Select 75-Zero RESET.

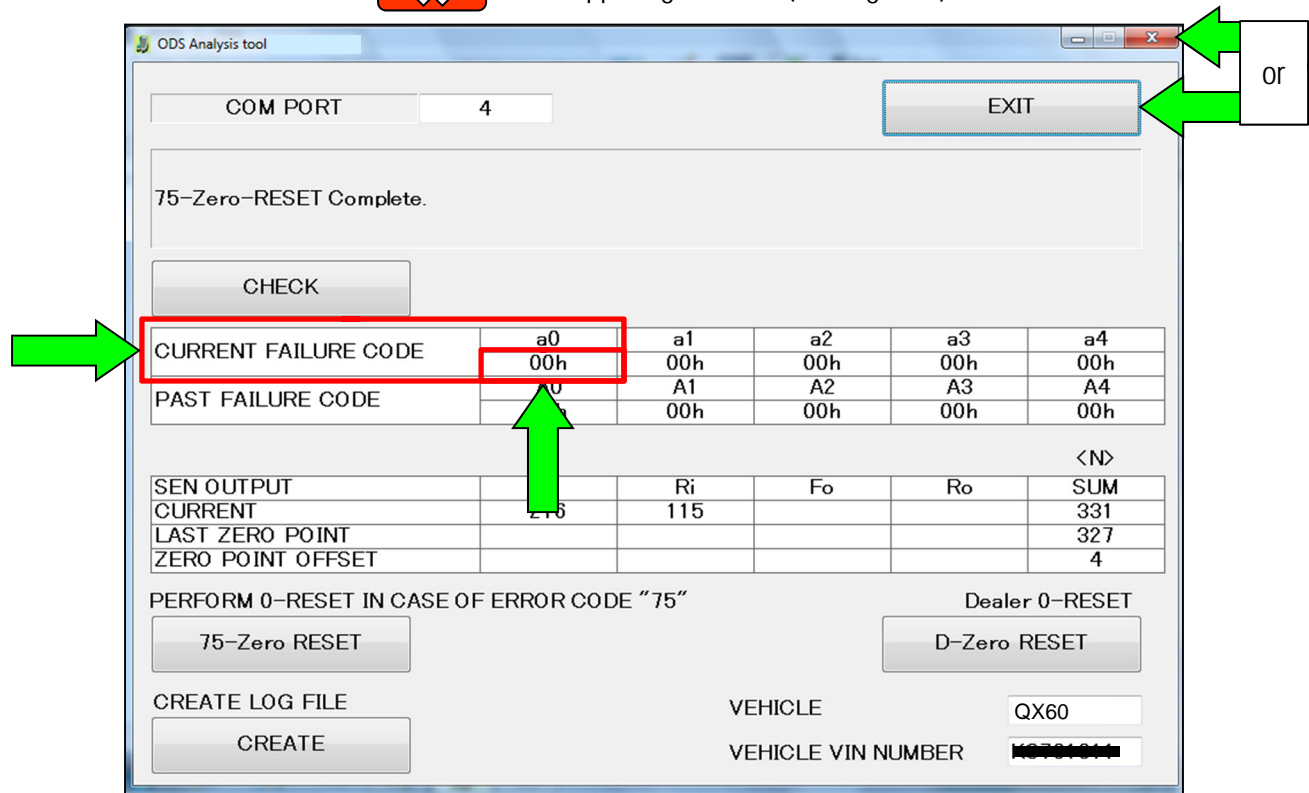
16. When the screen in Figure 9 displays, the 75-zero reset process is complete.
  - Verify code 75h is not displayed under **CURRENT FAILURE CODE**.
17. Select either **EXIT** or the

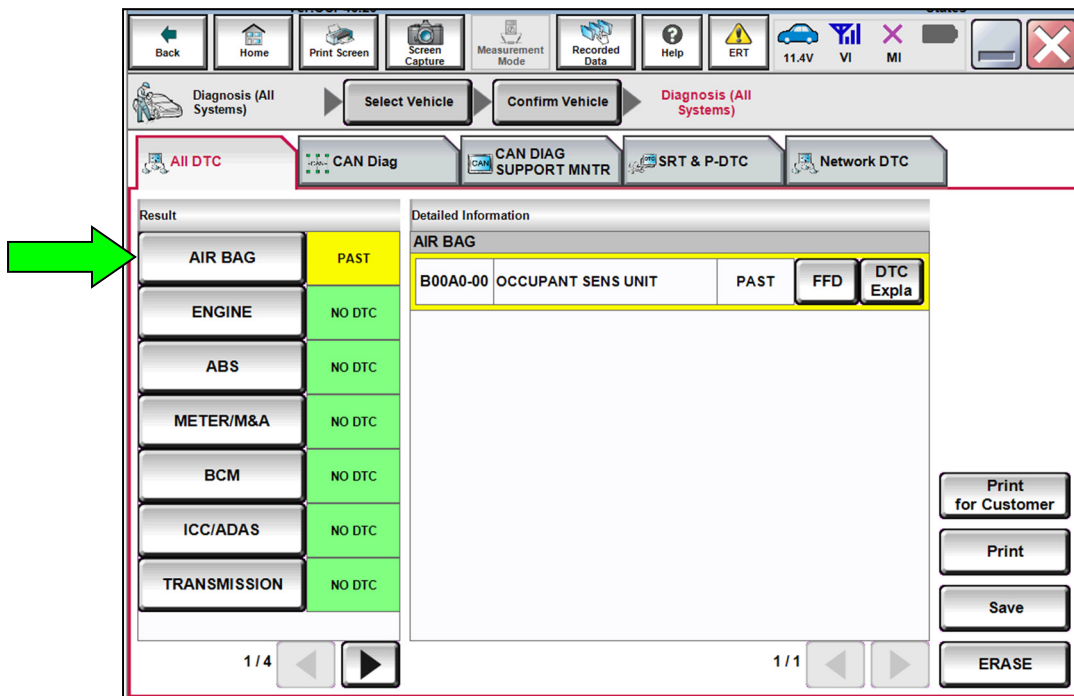
Figure 12

- DTC B00A0-00 should be the only DTC displayed.

23. Select ERASE.

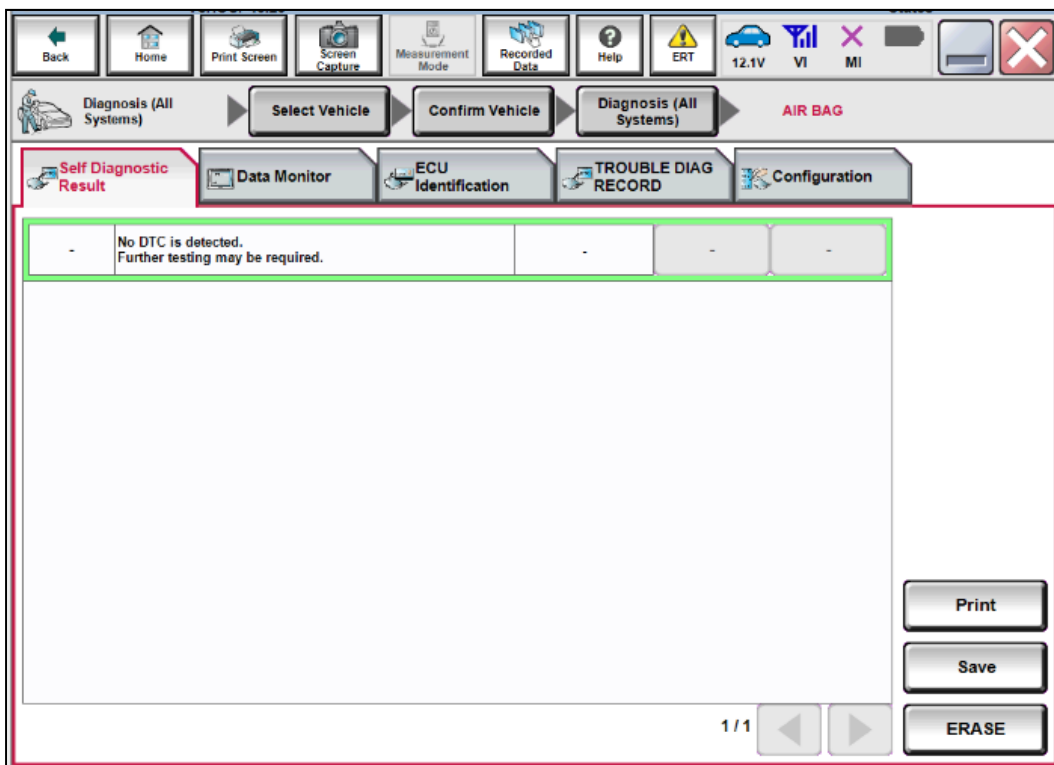
- After selecting **Close**, the screen in Figure 16 should display (the DTC is erased).
