# SERVICE BULLETIN

Classification: RS19-004A	Reference: NTB19-071A	Date: March 5, 2021
------------------------------	--------------------------	------------------------

## DTC B00A0-00 STORED

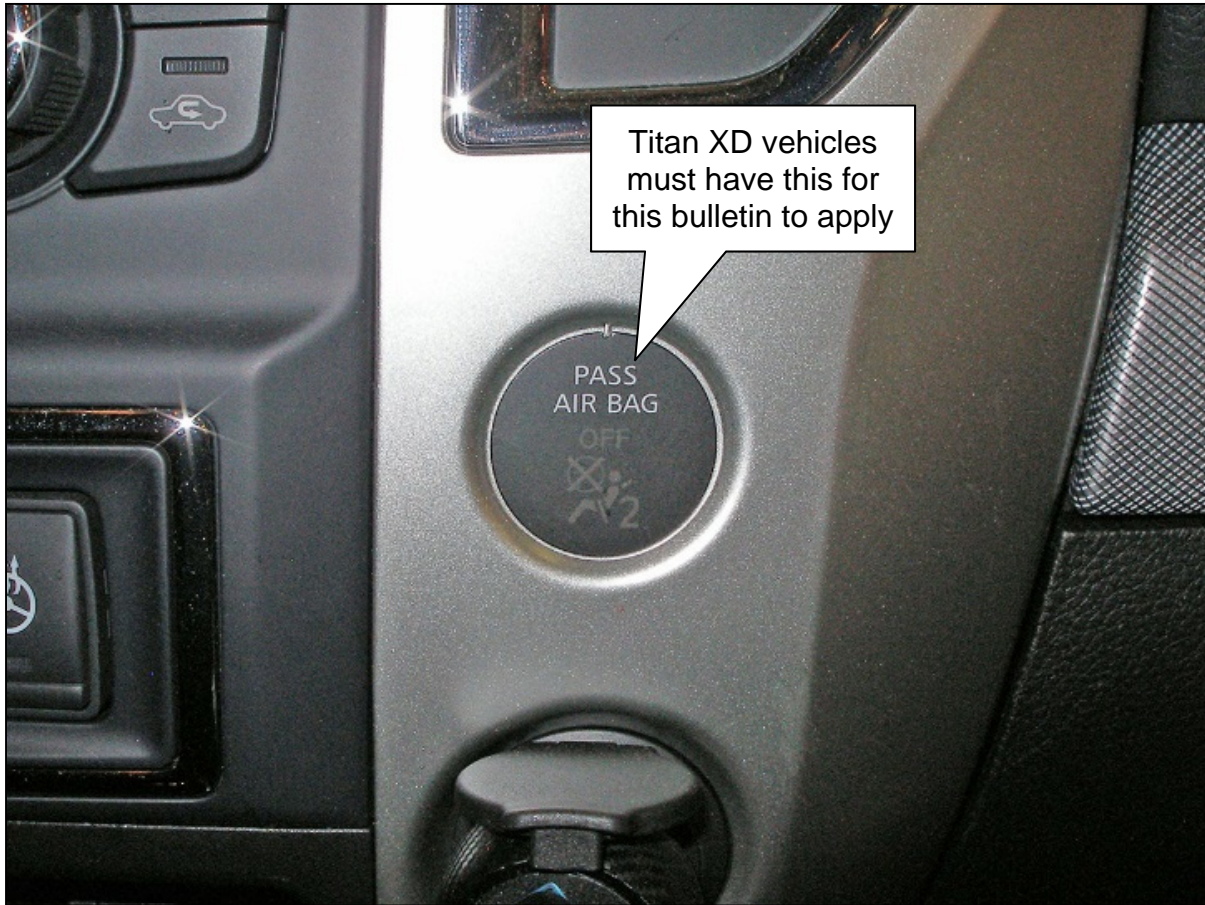
Figure 3

- Titan vehicles: This bulletin applies to ALL Titan vehicles.
- Titan XD vehicles: This bulletin does NOT apply to all Titan XD vehicles. This bulletin applies to Titan XD vehicles equipped with OCS, as indicated by the presence of a front passenger air bag status light (see Figure 3).
