# SERVICE BULLETIN

Classification: AT21-003A	Reference: NTB21-023A	Date: March 19, 2021
------------------------------	--------------------------	-------------------------

## 2021 ROGUE; DTC P0780 STORED IN THE TCM

**APPLIED VEHICLES:** 2021 Rogue (T33)

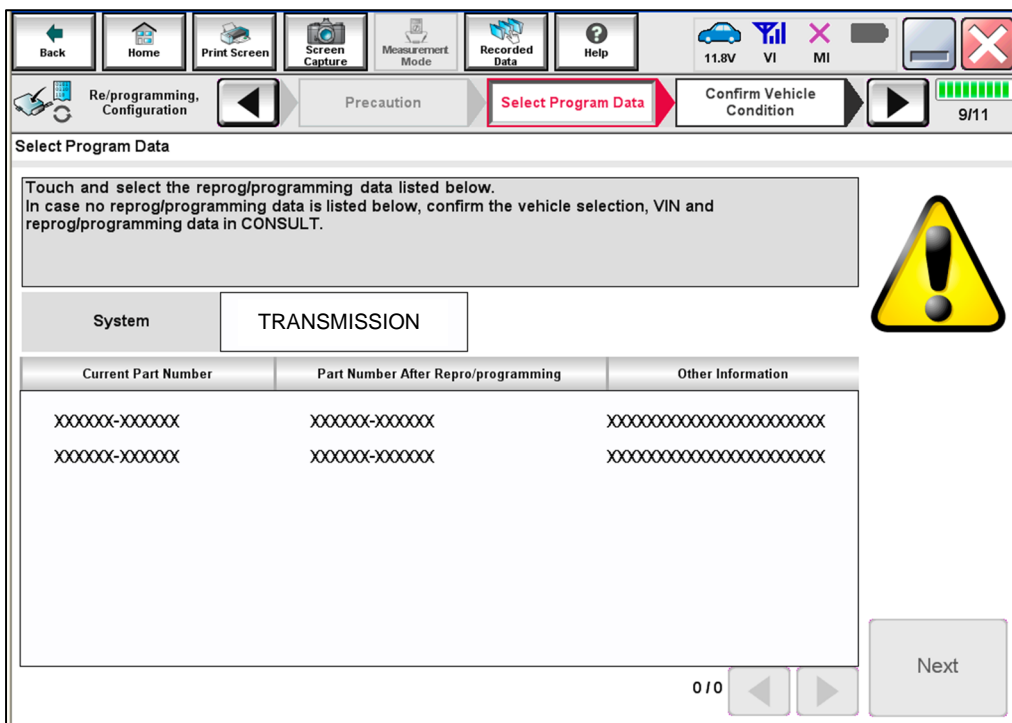
**Figure 11**

- If more than one new P/N is available, the screen in Figure 11 displays.
- Select and use the reprogramming option that does **not** have the message “Caution! Use ONLY with NTBXX-XXX”.
- If you get this screen and it is blank (no reprogramming listed), it means there is no reprogramming available for this vehicle. Skip to step 25 on page 13.

16. Follow the on-screen instructions to navigate C-III plus and reprogram the TCM.

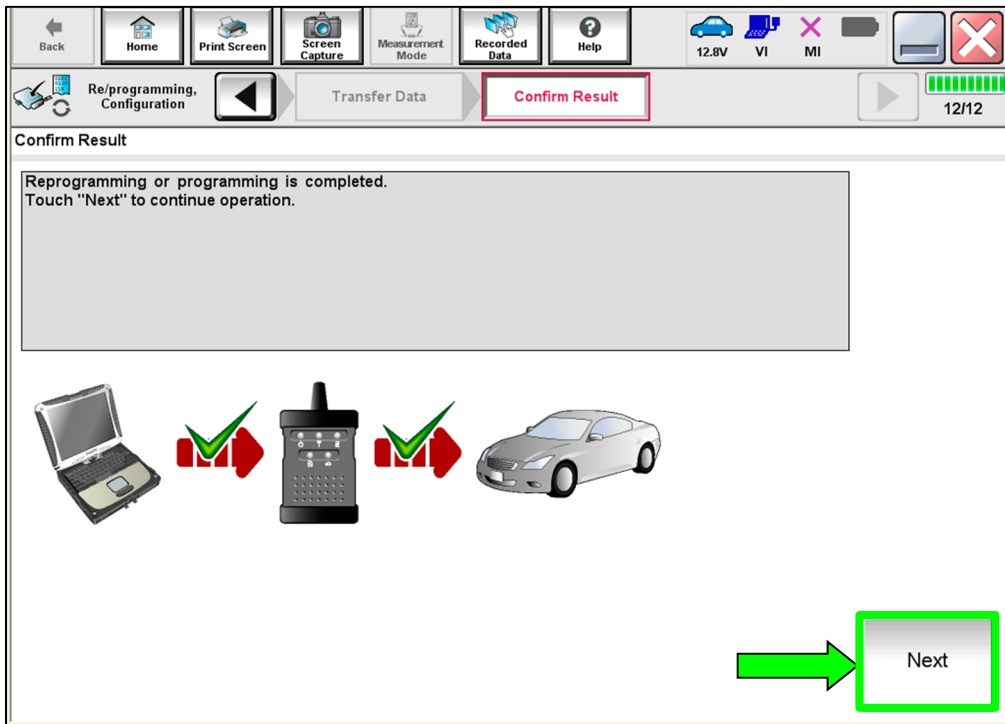
**NOTE:** When the screen in Figure 14 displays, reprogramming is complete. If the screen in Figure 14 does not display (indicating that reprogramming did not complete), refer to the information on the next page.

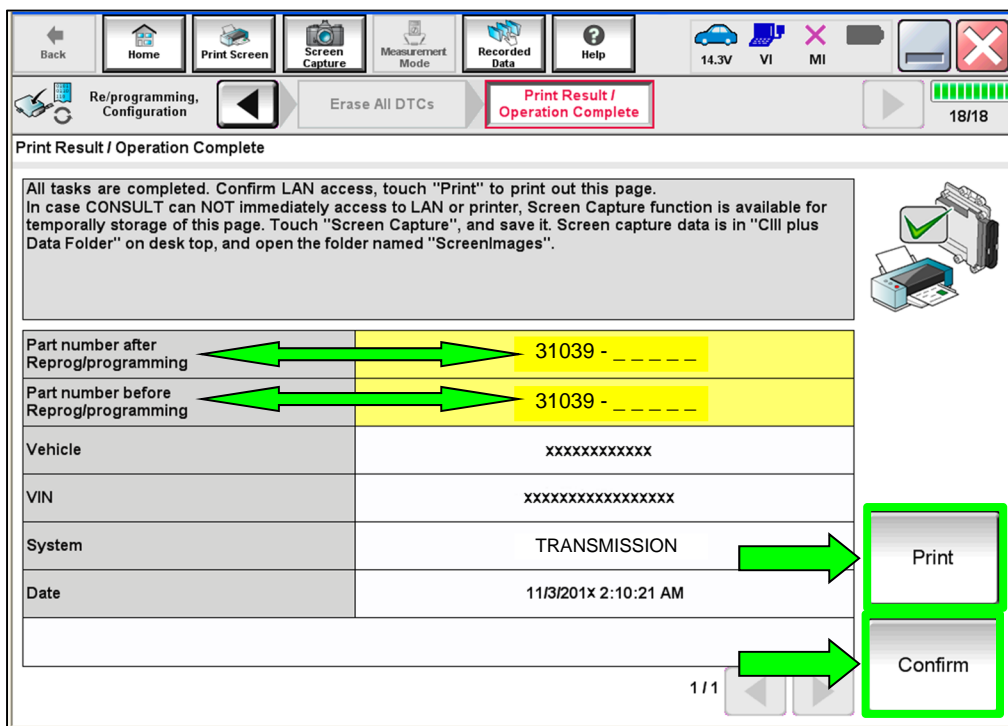
20. Follow the on-screen instructions to **Erase All DTCs**.
  - Press and hold the ignition button for 5 seconds to turn the ignition OFF.
  - When the entire reprogramming process is complete, the screen in Figure 17 will display.

21. Verify the before and after part numbers are different.

22. Print a copy of this screen (Figure 17) and attach it to the repair order for warranty documentation.
