SERVICE BULLETIN

KS13-052B
 NTB13-109B
 March 12, 2021

2013-2015 ALTIMA AND PATHFINDER; ONE OR BOTH INTELLIGENT KEYS LOST PRIOR TO CUSTOMER DELIVERY

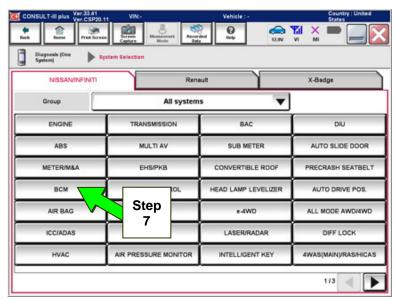
Figure 4

Select **BCM**, then wait for System Call to complete.

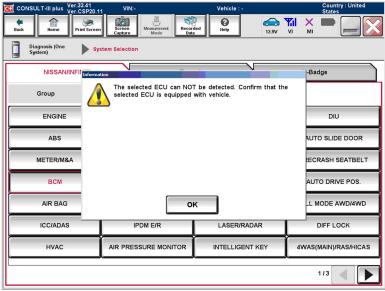
Figure 6

- If the screen in Figure 5 displays, the BCM is not in Transit Mode.
 - a) Select Home.
 - b) Replace the lost Intelligent Keys.
 - c) Register both replacement Intelligent Keys using CONSULT-III (C-III) plus.
 - d) Once successfully registered, this procedure is complete.
- If an error message indicates the ECU cannot be detected (see Figure 6), the BCM is in Transit Mode.
 - a) Replace the BCM.
 - Replace the lost Intelligent Keys and have the new ones available before proceeding to the next step.
 - c) Contact TECH LINE for Intelligent Key registration procedure guidance.
