EL12-070

## 2011-2013 QX56; WATER DROPS IN REAR COMBINATION LAMP

**APPLIED VEHICLES:** 2011-2013 QX56 (Z62)

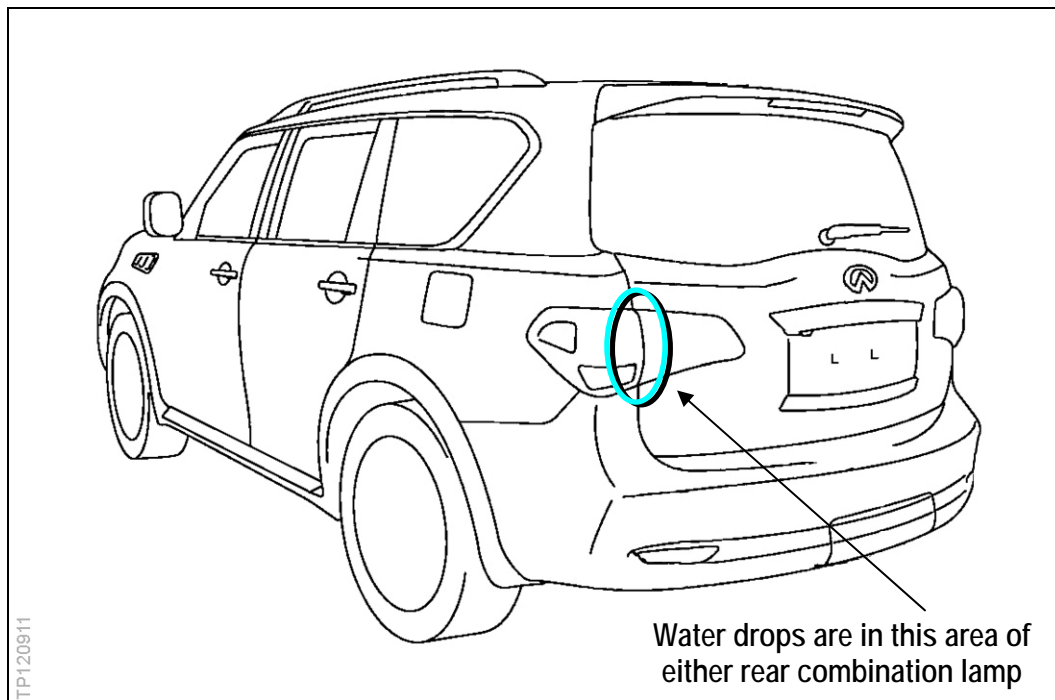
Occasionally, after a rain or a car wash, customers may notice water drops in the overhanging part of the rear combination lamp lens.

- This is a normal condition.
- The water drops should disappear over time when the lamp is in a dry environment.
- Refer to the images on page 2 for examples of a normal water drop condition.
- **Do not** replace any parts for this condition.
