Dealer Inventory Inspection

May 9, 2013

2013 Nissan Altima and Maxima Rear Member

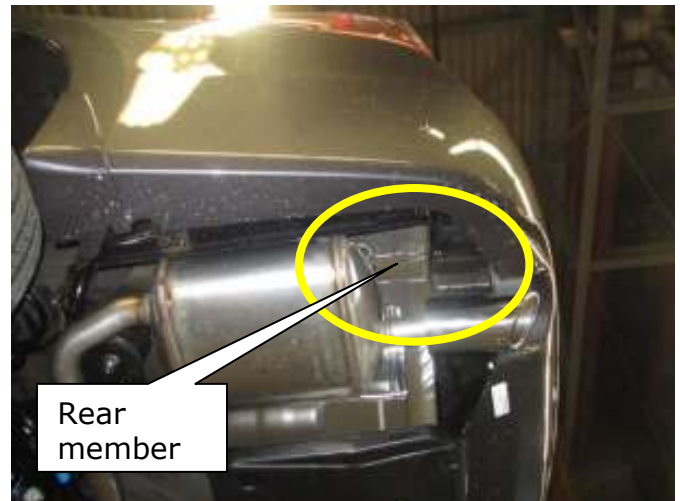
Figure 1

1. Locate drivers' side rear member shown in figure 1 and figure 2.
2. Inspect for a raised emboss on the outside of drivers' side rear member shown in figure 3.
 - If emboss is present on the outside of rear member, shown in figure 3. Go to step 3.
 - If emboss is not present take a picture of driver side rear member, then go to step 3.
3. Repeat instructions for passenger side.
 - **If emboss is present** on the drivers' and passenger side rear members shown in figure 3. No further action is needed and use warranty Op Code **PC2311**.
 - **If emboss is not present** on either drivers' or passenger side rear member, please send a picture with the following information to below email address for further instructions.
nafgasupport@nissan-usa.com
 - Send the following information.
 - Picture
 - VIN #
 - Which side rear member
 - Dealer Name
 - Dealer Code
 - Contact person
 - Phone number

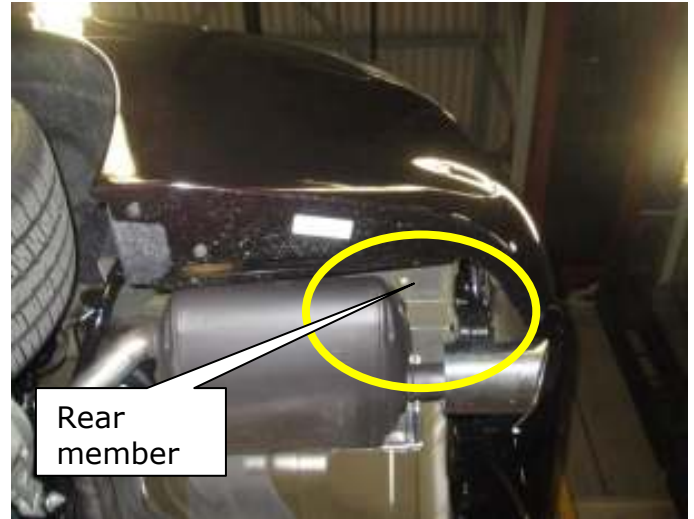
Figure 1

1. Locate drivers' side rear member shown in figure 1 and figure 2.
2. Inspect for a hole on the bottom of drivers' side rear member in the **seam-sealed area** shown in figure 3.
