SERVICE BULLETIN

| Classification: EC13-021 | Reference: NTB13-110 | Date: December 17, 2013 |

2014 TITAN AND ARMADA; MIL “ON” WITH P117A AND/OR P117B STORED

APPLIED VEHICLES: 2014 Titan (A60)
2014 Armada (TA60)

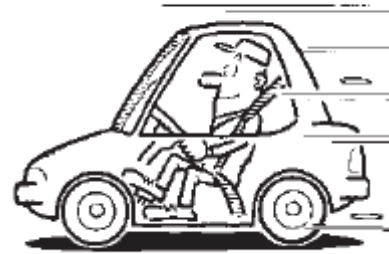
Figure A

- Take the vehicle for a 10 minute drive in order to meet the following Idle Air Volume Learn (IAVL) conditions:
 - Engine coolant temperature: 70 -100°C (158 -212°F)
 - Battery voltage: More than 12.9V (At idle)
 - Transmission: Warmed up

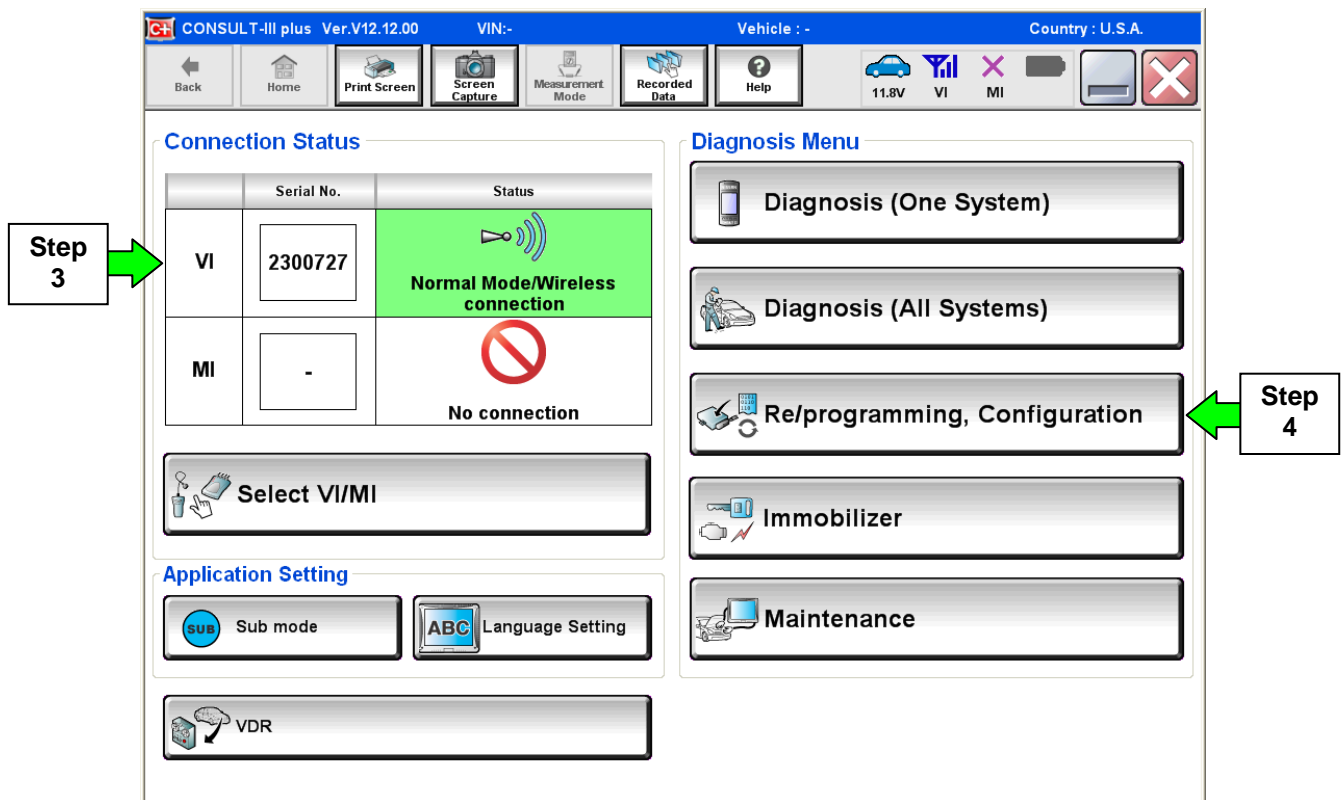
Figure 1

1. Connect the CONSULT PC to the vehicle to begin the reprogramming procedure.
2. Start C-III plus.
3. Wait for the plus VI to be recognized.
 - The **Serial No.** will display when the plus VI is recognized.
4. Select **Re/programming, Configuration**.

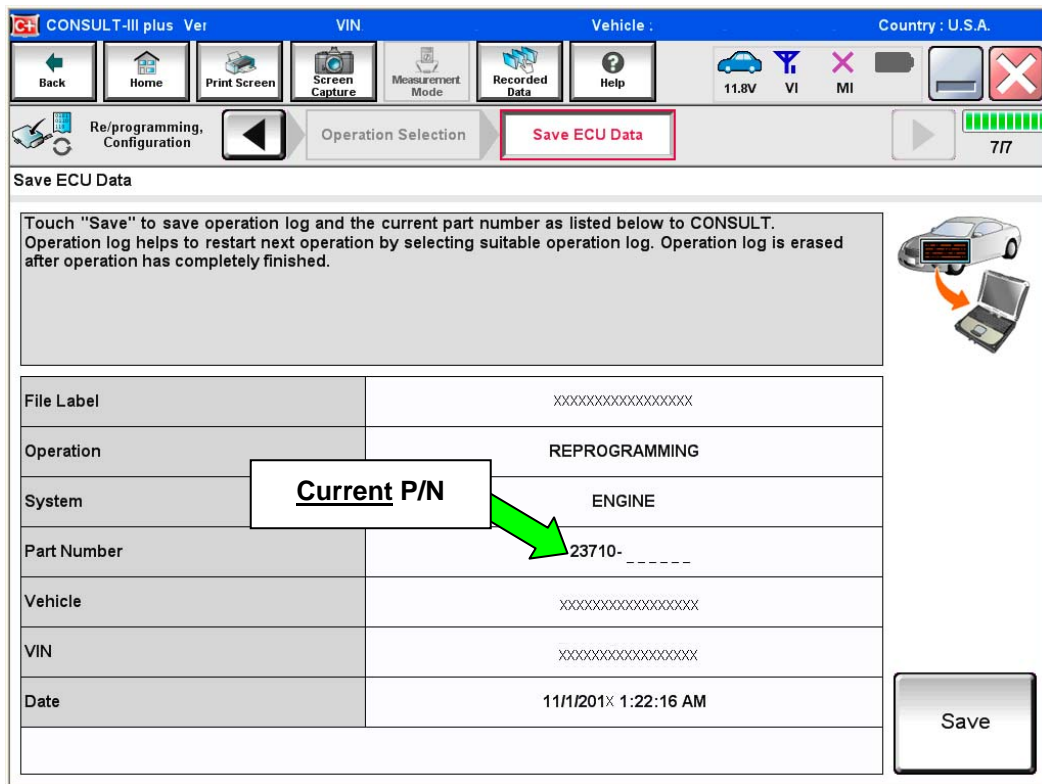
Figure 2

6. When you get to the screen shown in Figure 2, confirm this bulletin applies as follows:

A. Find the ECM **Part Number** and write it on the repair order.

NOTE: This is the current ECM Part Number (P/N).

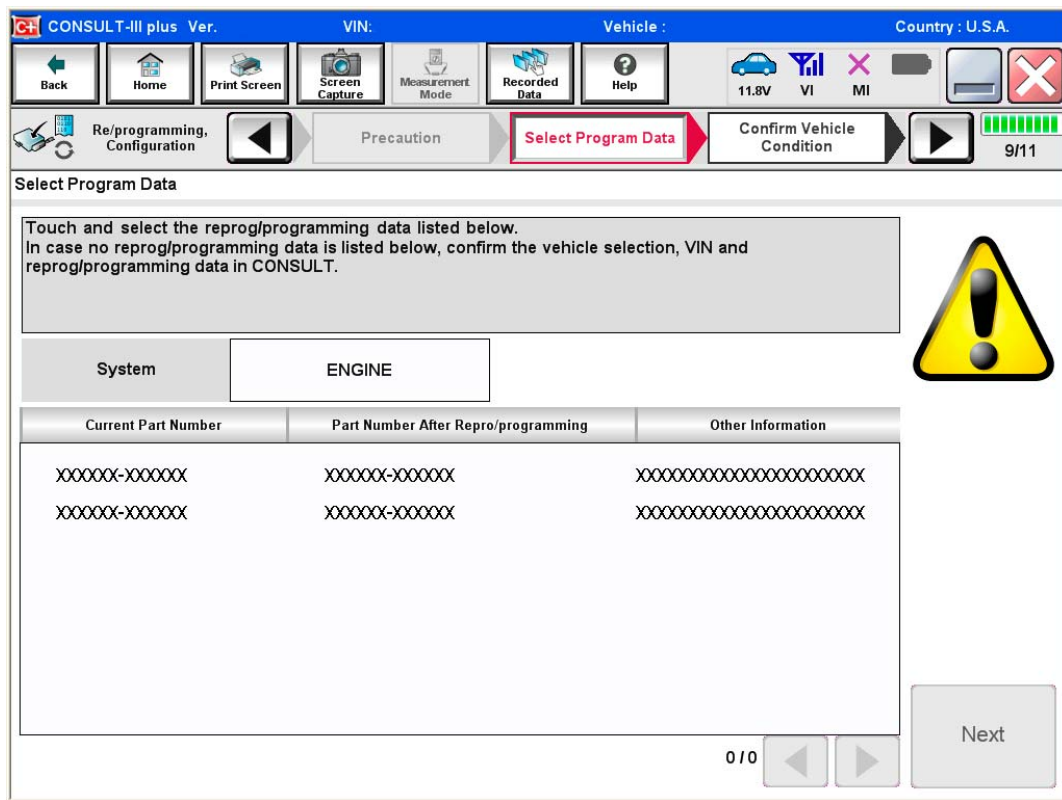
- In some cases, more than one new P/N for reprogramming is available.
 - In this case, the screen in Figure 3 displays.
 - Select and use the reprogramming option that **does not** have the message “Caution! Use ONLY with NTBXX-XXX”.
- If you get this screen and it is blank (no reprogramming listed), it means there is no reprogramming available for this vehicle.

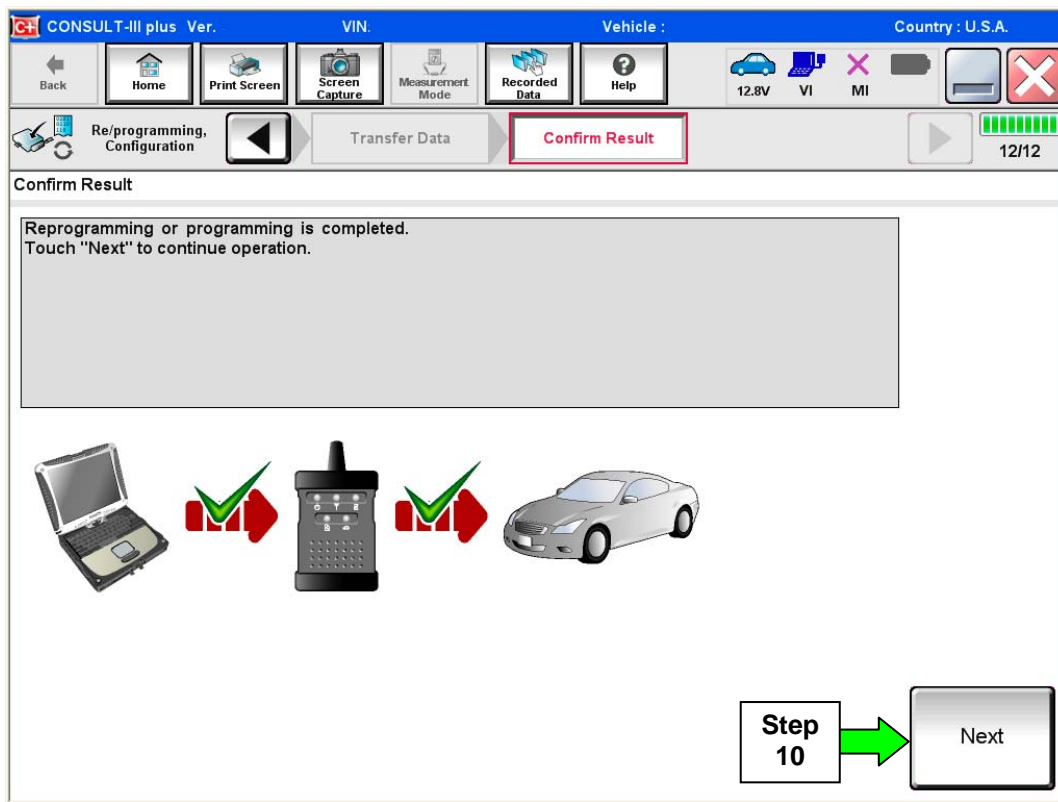
8. When the screen in Figure 4 displays, reprogramming is complete.

NOTE: If the screen in Figure 4 does not display (reprogramming does not complete), refer to the information on page 7.

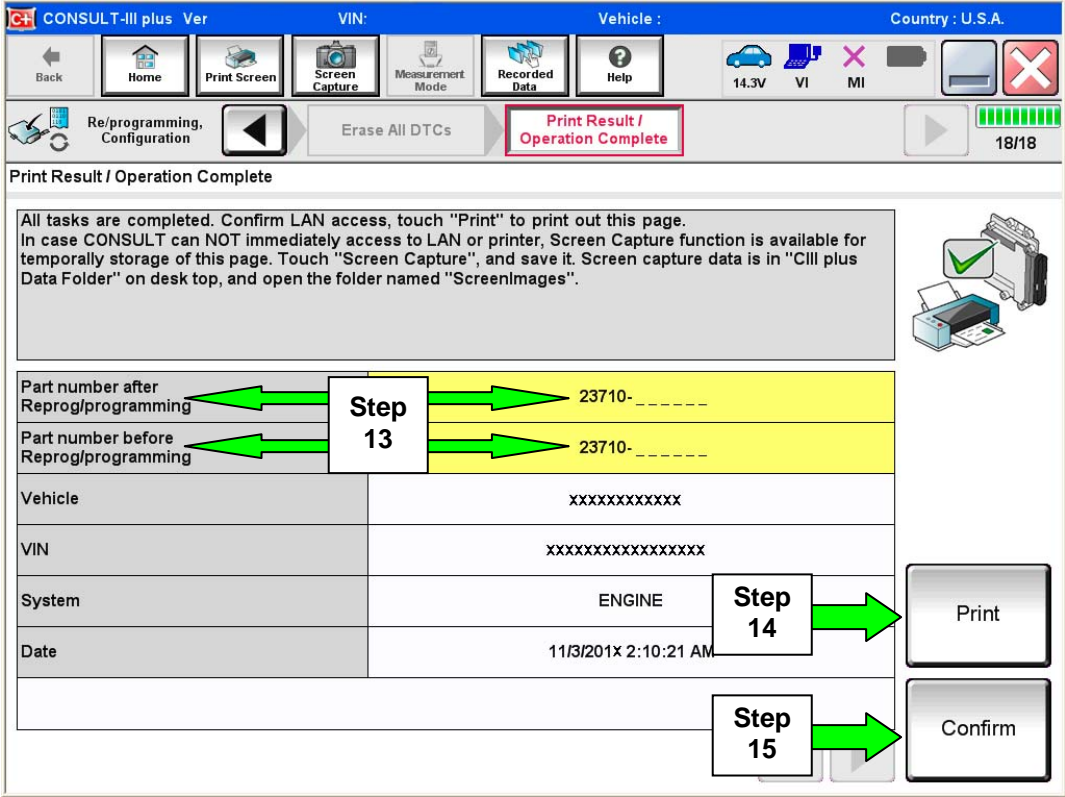
- 12. When the entire reprogramming process is complete, the screen in Figure 7 will display.
- 13. Verify the before and after part numbers are different.
- 14. Print a copy of this screen (Figure 7) and attach it to the repair order for warranty documentation.
- 15. Select **Confirm**.
