NISSAN BULLETIN

2014 Nissan Altima and Maxima Floor Support Weld Dealer Inventory Inspection

Reference: PC256
Date: December 19, 2013

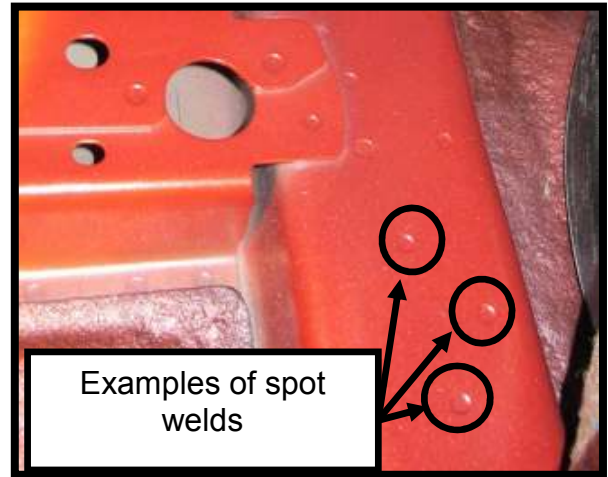
Figure 9

11. Inspect driver side metal floor support bracket welds.

- Count each visible weld to ensure a minimum of 21 welds are present on the top of the metal floor support bracket.
- Refer to arrows identifying black highlighted spot welds in Figures 10, 11 and 12.
- Location of welds will vary from vehicle to vehicle.
