EC14-014

2013 JX35 AND 2014 QX60; IDLE QUALITY IN DRIVE AND A/C ON

APPLIED VEHICLES: 2013 JX35 (L50)
2014 QX60 (L50)

APPLIED ENGINE: VQ35 (6 cyl)

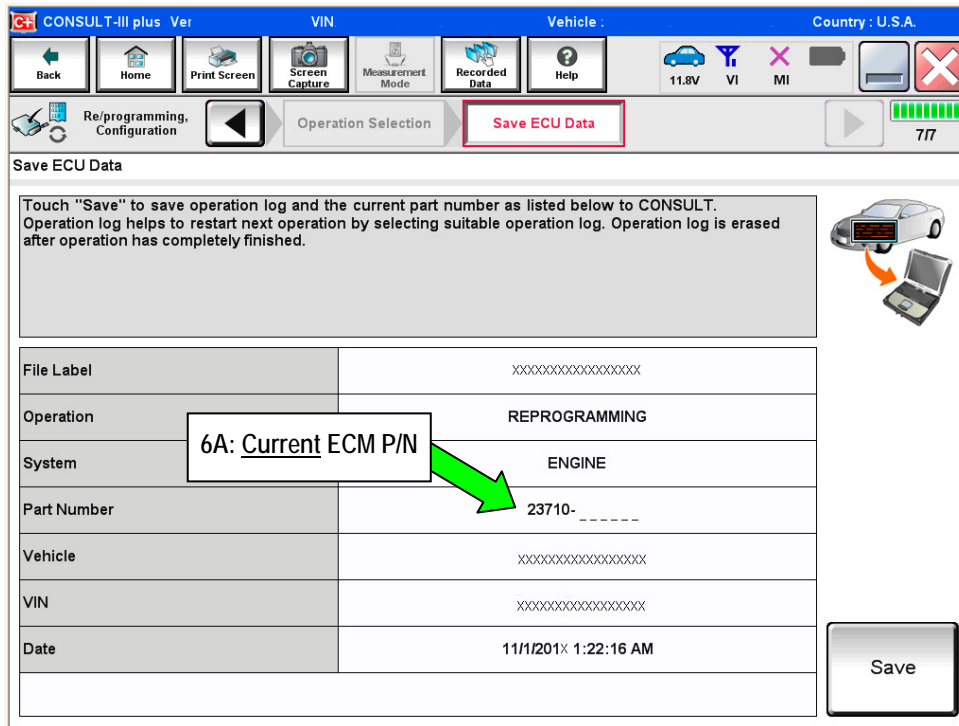
Figure 2

A. Find the ECM Part Number and write it on the repair order.

NOTE: This is the current ECM Part Number (P/N).

B. Compare the P/N you wrote down to the numbers in the **Current ECM Part Number** column in **Table A** below.

- If there is a match, this bulletin applies. Continue with the reprogramming procedure.
- If there is not a match, this bulletin does not apply. Close C-III plus and refer to ASIST and the ESM for further diagnostic information.

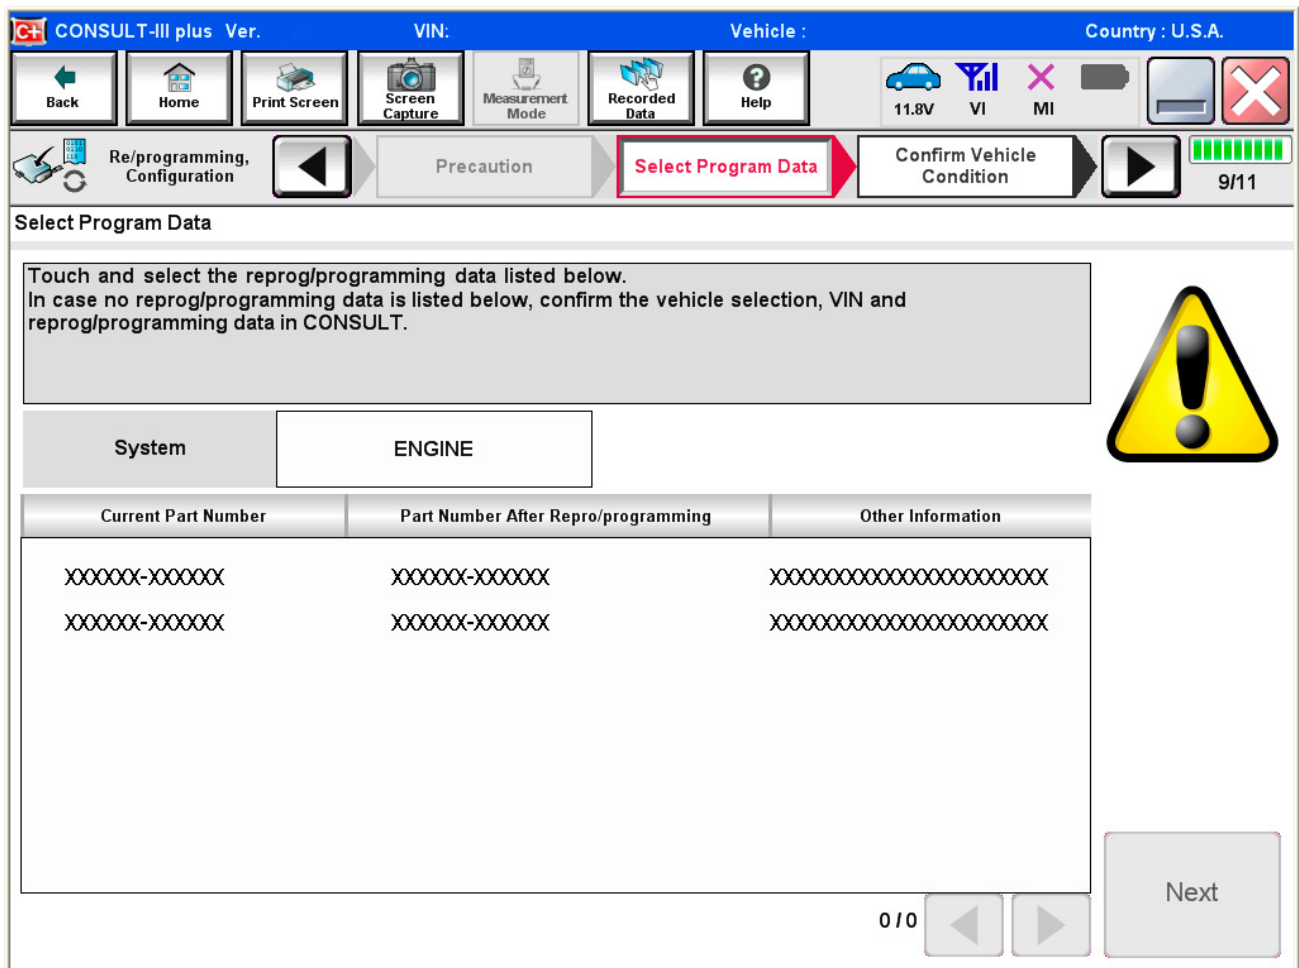
- In some cases, more than one new P/N for reprogramming is available.
 - In this case, the screen in Figure 3 displays.
 - Select and use the reprogramming option that **does not** have the message "Caution! Use ONLY with ITBXX-XXX".
- If you get this screen and it is blank (no reprogramming listed), it means there is no reprogramming available for this vehicle. Close C-III plus and refer back to ASIST for further diagnosis.

7. Follow the on-screen instructions to navigate C-III plus and reprogram the ECM.

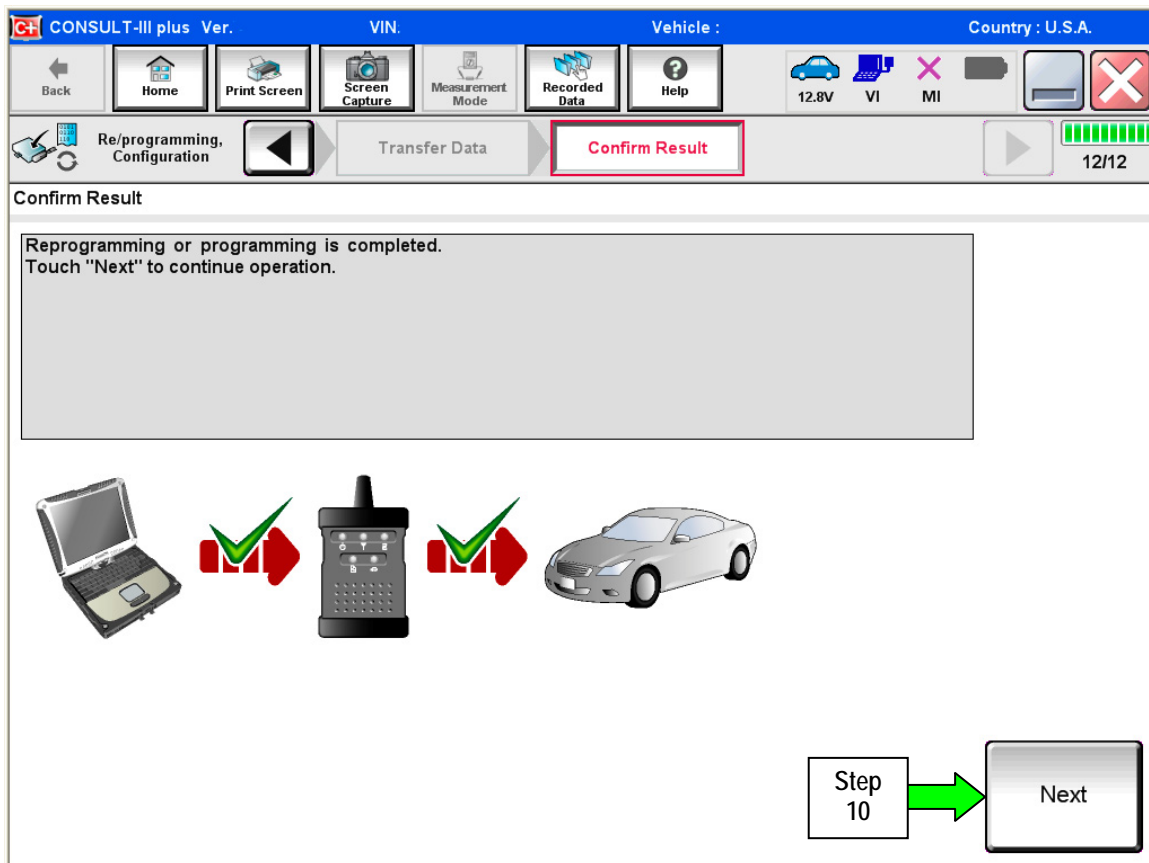
8. When the screen in Figure 4 displays, reprogramming is complete.

NOTE: If the screen in Figure 4 does not display (reprogramming does not complete), refer to the information on page 8.

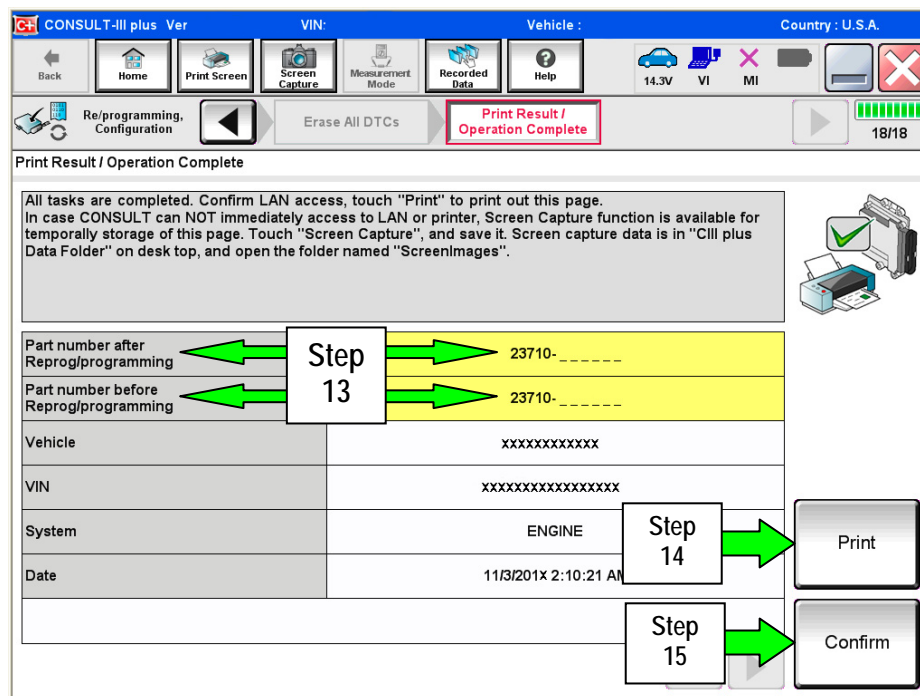
12. When the entire reprogramming process is complete, the screen in Figure 7 will display.
13. Verify the before and after part numbers are different.
14. Print a copy of this screen (Figure 7) and attach it to the repair order for warranty documentation.
15. Select **Confirm**.
