SERVICE BULLETIN

Classification:	Reference:	Date:
EC15-007	NTB15-051	June 12, 2015

2015 ALTIMA, PATHFINDER, AND MURANO; MIL ON AND REAR O2 SENSOR RELATED DTC STORED

APPLIED VEHICLES: 2015 Altima (L33) with V6 engine ONLY
2015 Pathfinder (R52)
2015 Murano (Z52)

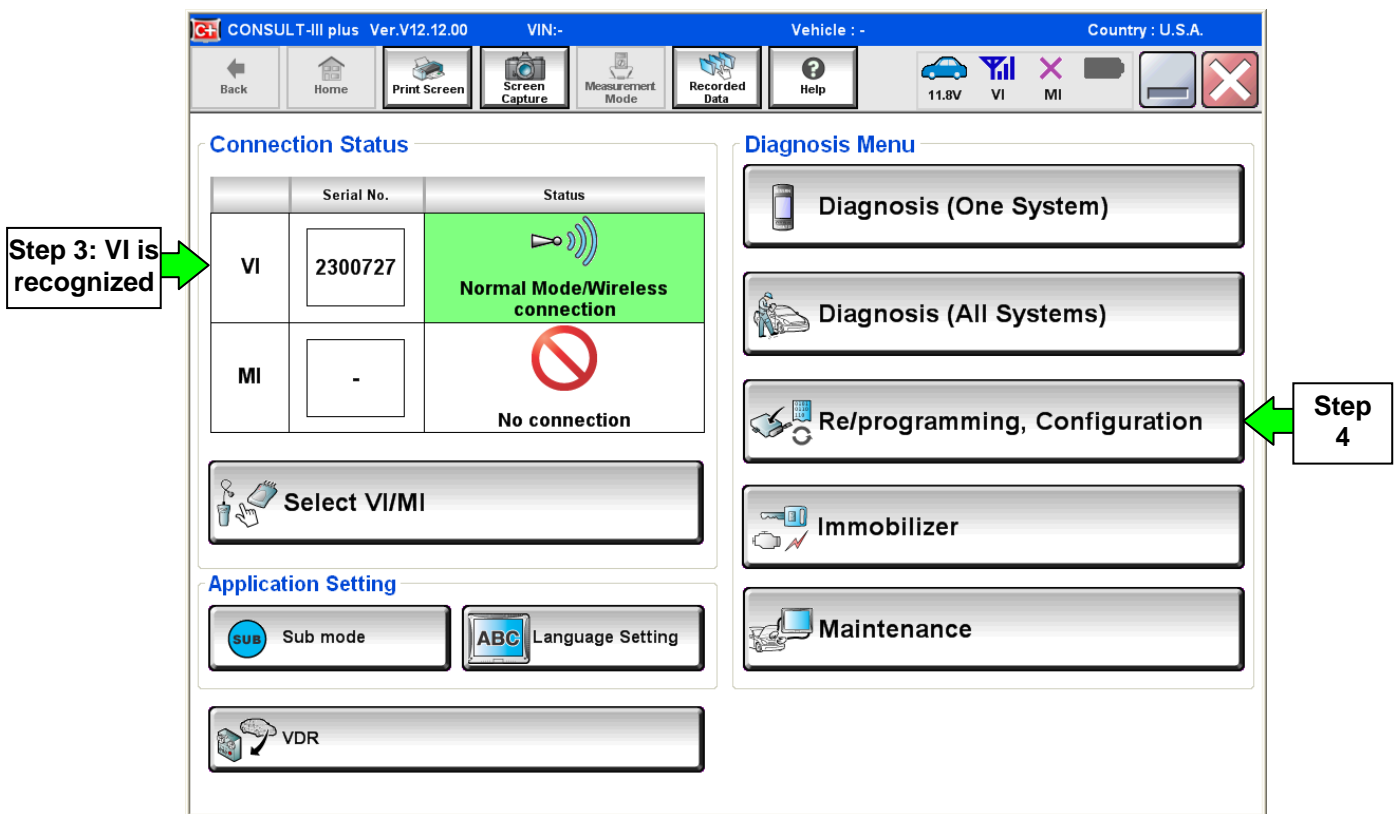
Figure 1

1. **Connect the CONSULT PC** to the vehicle to begin the reprogramming procedure.
2. Open ASIST on the CONSULT PC and start C-III plus.
3. Wait for the plus VI to be recognized / connected.
 - The serial number (**Serial No.**) will display when the plus VI is recognized / connected.
4. Select **Re/programming, Configuration**.

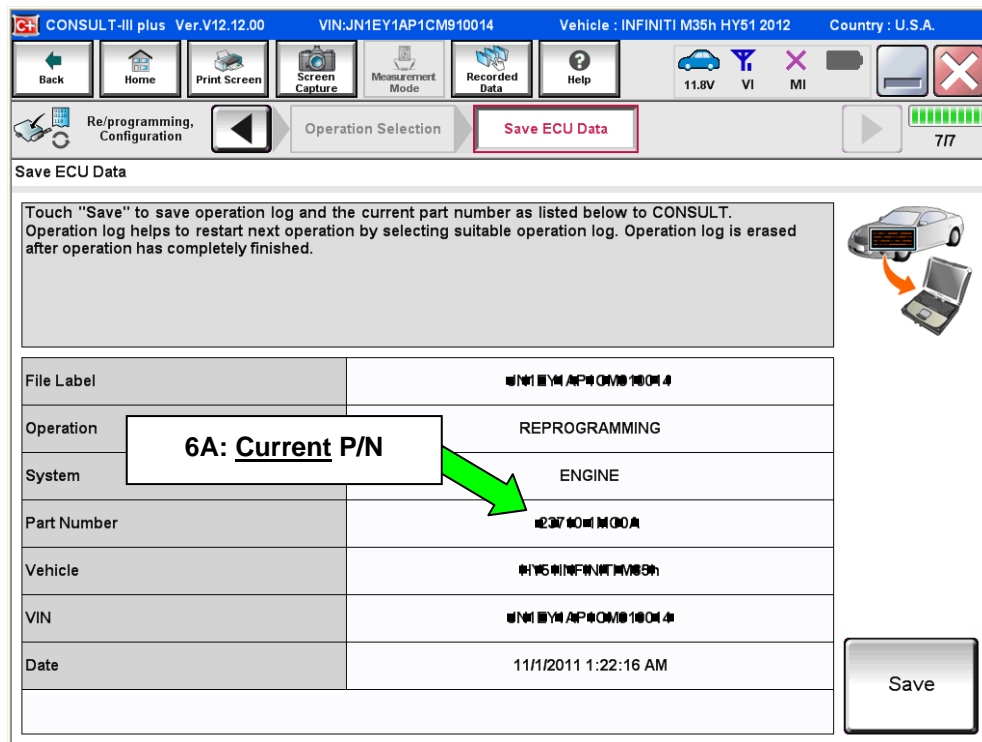
Figure 2

6. When you get to the screen shown in Figure 2, confirm this bulletin applies as follows:

A. Find the ECM (or TCM) **Part Number** and write it on the repair order.

NOTE: This is the current ECM or TCM Part Number (P/N).
ECM preprogramming must be performed first.

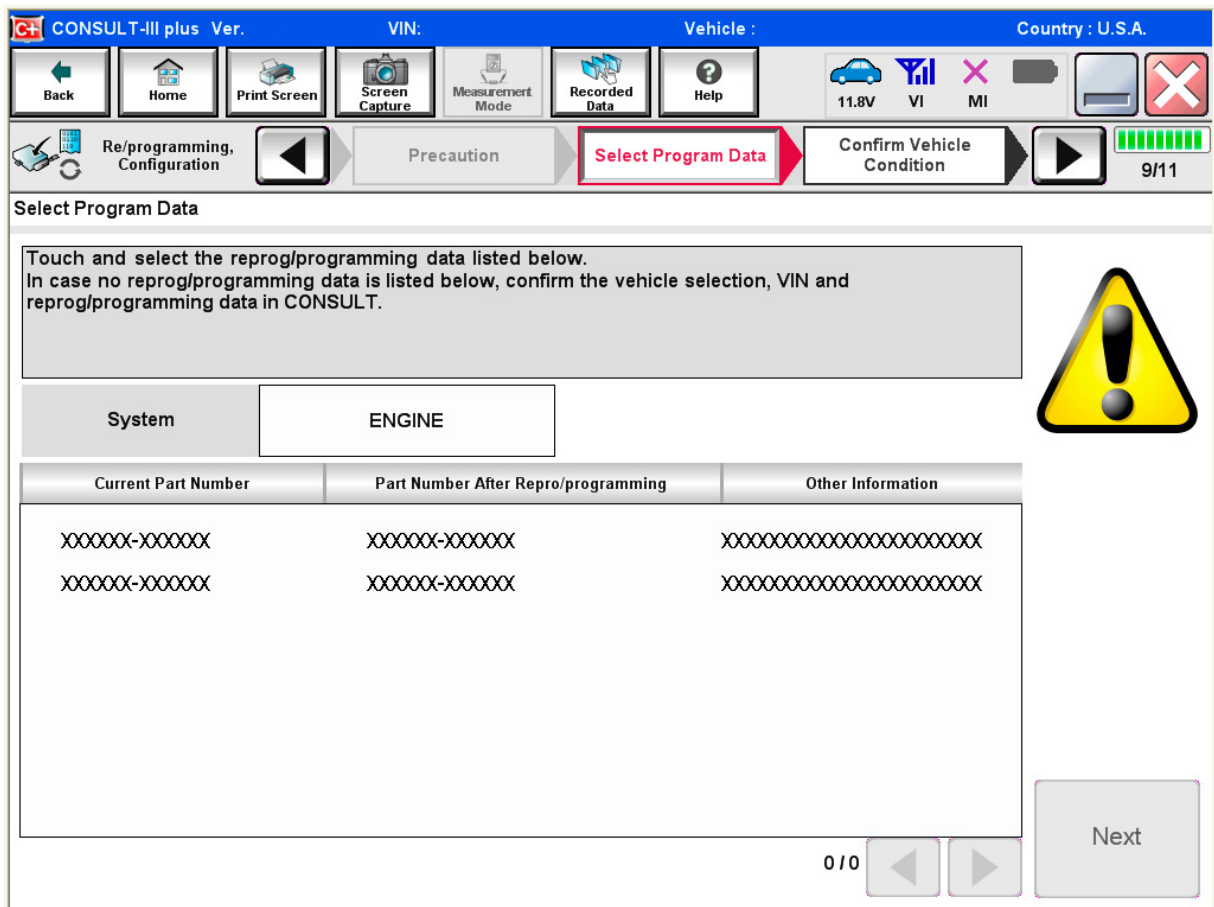
- In some cases, more than one new P/N for reprogramming is available.
 - In this case, the screen in Figure 3 displays.
 - Select and use the reprogramming option that **does not** have the message “Caution! Use ONLY with NTBXX-XXX”.
- If you get this screen and it is blank (no reprogramming listed), it means there is no reprogramming available for this vehicle.

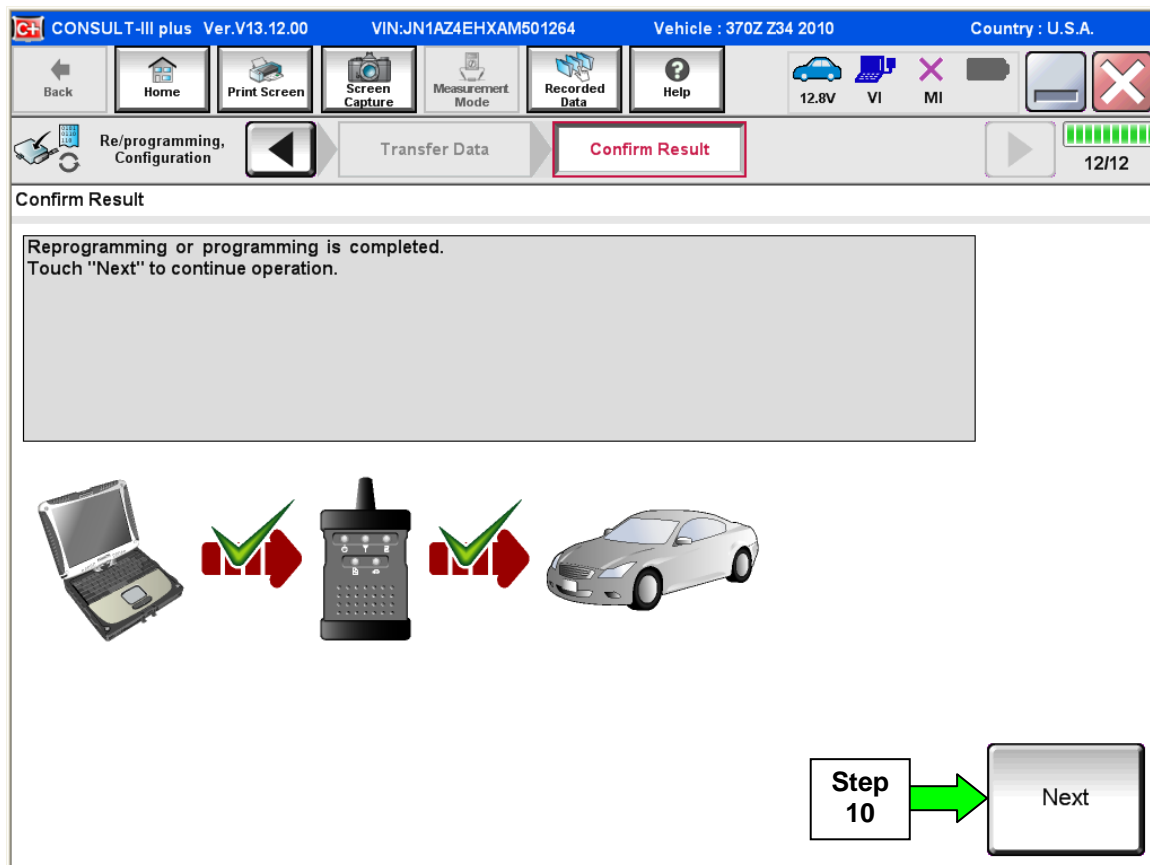
8. When the screen in Figure 4 displays, reprogramming is complete.

NOTE: If the screen in Figure 4 does not display (reprogramming does not complete), refer to the information on the next page.

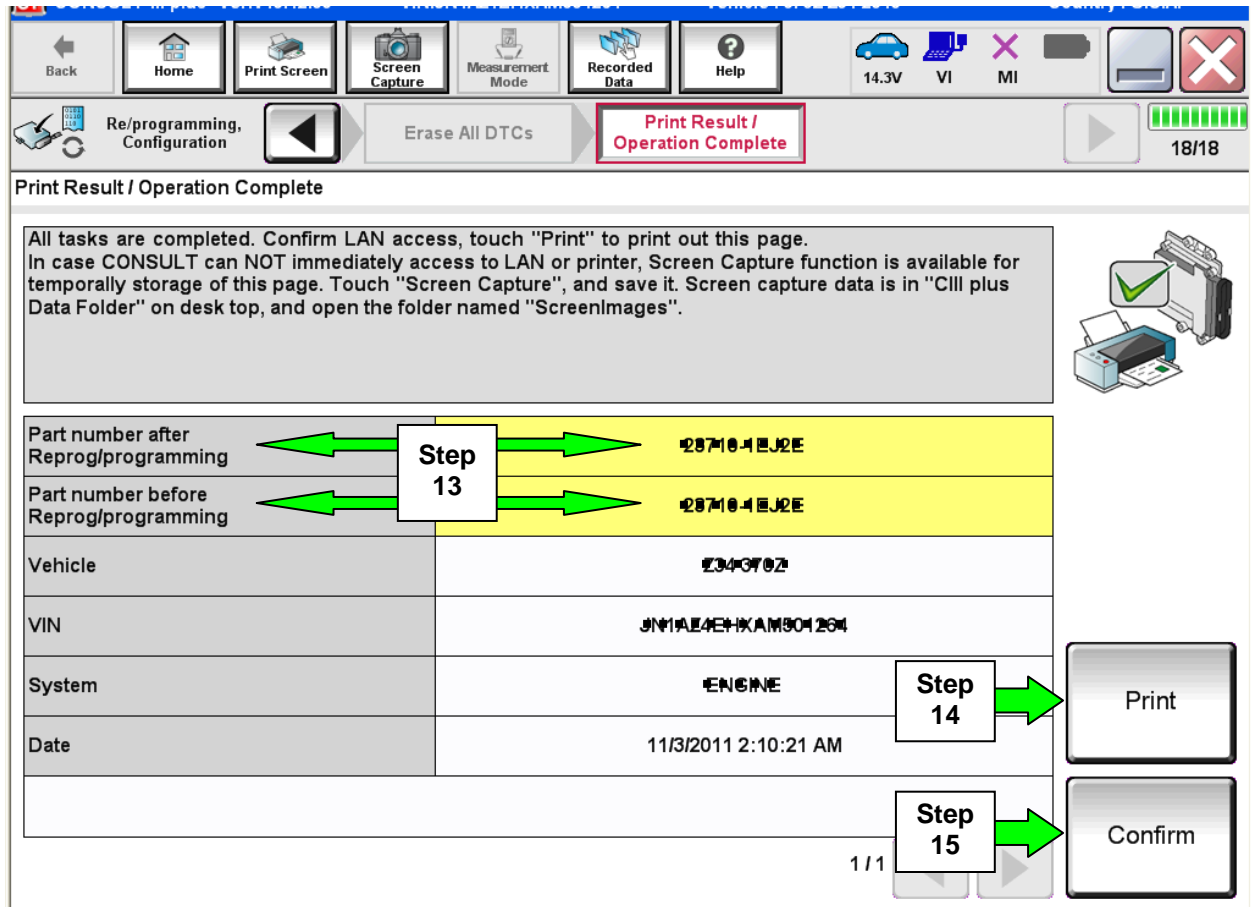
12. When the entire reprogramming process is complete, the screen in Figure 7 will display.
13. Verify the before and after part numbers are different.
14. Print a copy of this screen (Figure 7) and attach it to the repair order for warranty documentation.
15. Select **Confirm**.
