EC15-008

June 12, 2015

2015 QX60; MIL ON WITH REAR O2 SENSOR RELATED DTC STORED

APPLIED VEHICLE: 2015 QX60 (L50)

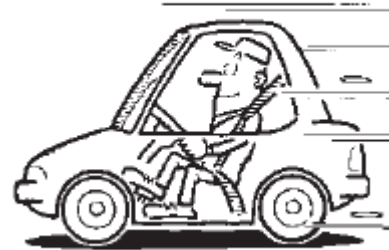
Figure A

- Take the vehicle for a 10 minute drive in order to meet the following Idle Air Volume Learn (IAVL) conditions:
 - Engine coolant temperature: 70 -100°C (158 - 212°F)
 - Battery voltage: More than 12.9V (At idle)
 - Transmission: Warmed up
