**Technical News 165**  
**October 2015**  
**Strictly Confidential**

<b>Contents</b>		
<b>Item</b>	<b>Subject</b>	<b>Model Affected</b>
Item 1.	Mudguard Extension Australia, India and New Zealand Markets Only	Models With A Mudguard Extension

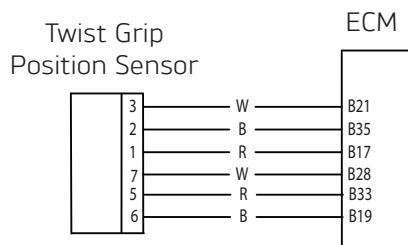
### Circuit Diagram

Fault Code	Possible cause	Action
P2138	Twist grip position sensor 1 correlation error with twist grip position sensor 2	View & note diagnostic tool 'freeze frame' data if available View & note diagnostic tool 'sensor' data Disconnect twist grip position sensor and proceed to pinpoint test 1:

Test	Result	Action
1 Turn the ignition on and measure the Voltage between: - ECM pin B33 and ECM pin B19 - ECM pin B17 and ECM pin B35	5 V DC	Renew the twist grip sensor and proceed to test 2
	Faulty	Rectify fault, proceed to test 2
2 Reconnect harness, clear fault code and run engine to verify fault cleared	OK	Action complete - quit test
	Fault still present	Contact Triumph service
