Polaris Industries Inc.
Product Development Center
 7290 Viking Blvd E
 Wyoming, MN 55092
 T: 651-408-7579
 F: 651-408-7605
 December 3, 2015

RE: 579.5 Notices, bulletins, customer satisfaction campaigns, consumer advisories, and other communications for the month of November, 2015.

Bulletin Number: I-15-04
Model Year(s): 2015-2016

SUBJECT: 2015-2016 Indian Full Size Motorcycles – Rear Master Cylinder Repair

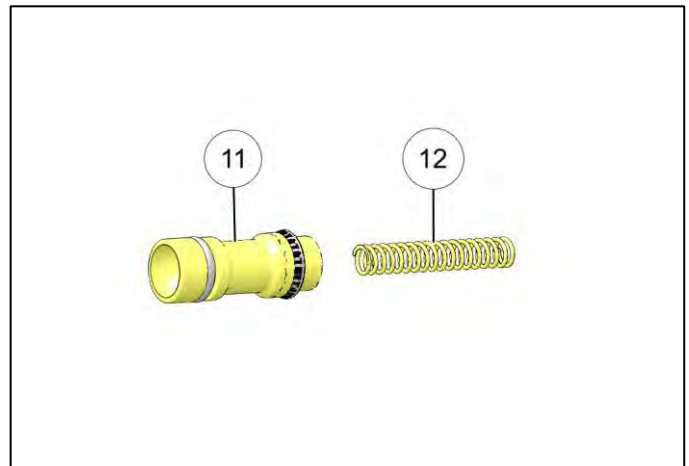
10. Remove piston return spring (12) from piston assembly (11). **NOTE:** Retain and tag piston for warranty parts return.
11. Clean all internal parts with Indian Motorcycle DOT 4 brake fluid or isopropyl alcohol from a sealed container.
12. Inspect cylinder bore and chamfer on front of the bore for corrosion, scratches, scoring or pitting. Replace master cylinder if any of these conditions are evident.
13. Use compressed air to clear fluid holes and passages to verify they are clean and unobstructed.

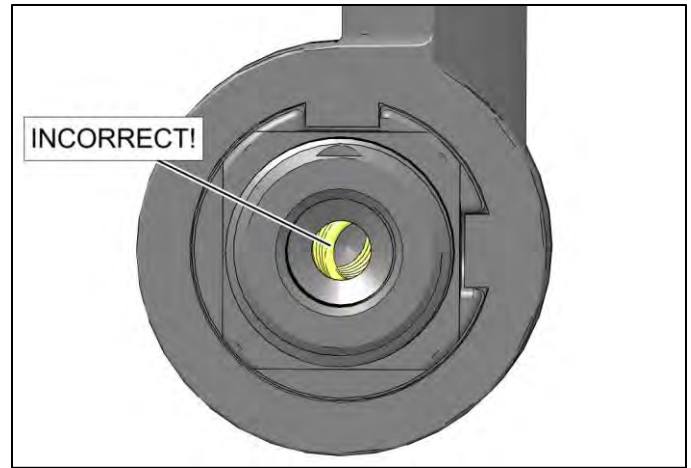
6. Verify the spring is seated correctly in the master cylinder counter bore before fully seating the piston in the master cylinder bore. **NOTE:** Spring is installed **incorrectly** if end is visible through the outlet port (refer to image at right).
7. If spring is seated correctly proceed to step 8. If spring is not seated correctly remove piston assembly and repeat steps 3-7.
