SERVICE INFORMATION BULLETIN

APPLICABILITY: 2018MY Legacy and Outback w/8-inch Navi System
 2017-18MY Impreza with 8-inch Navi System
 2018MY Crosstrek with 8-inch Navi System
 2018MY BRZ with 7-inch Navi System

NUMBER: 15-254-19R

SUBJECT: Map Data Update Procedure for Harman Gen 3.0 Navigation Equipped Head Units (H/U)

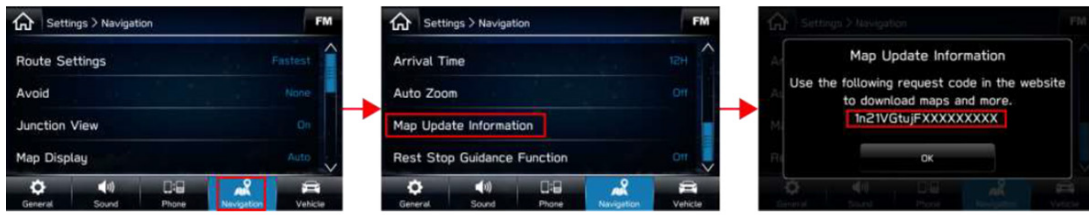
A. How to check Request Code from the vehicle Head Unit

- You can check Request Code. Home>Settings>Navigation>Map Update Information.
- Please take a picture / memo of Request Code.
