Service Bulletin

Bulletin No.: 21-NA-128

Subject: MIL Illuminated- ECM Update for P026C, P20EE, or P11D5

Brand:	Model:	Model Year:		VIN:		Engine:
from	to			Transmission:		from
						to
Chevrolet	Silverado 2500HD/ 3500HD	2021	2021	Before 1GC4YTEY5MF261413		Equipped with 6.6L Engine (RPO L5P)
GMC	Sierra 2500HD/ 3500HD	2021	2021			Equipped with 6.6L Engine (RPO L5P)

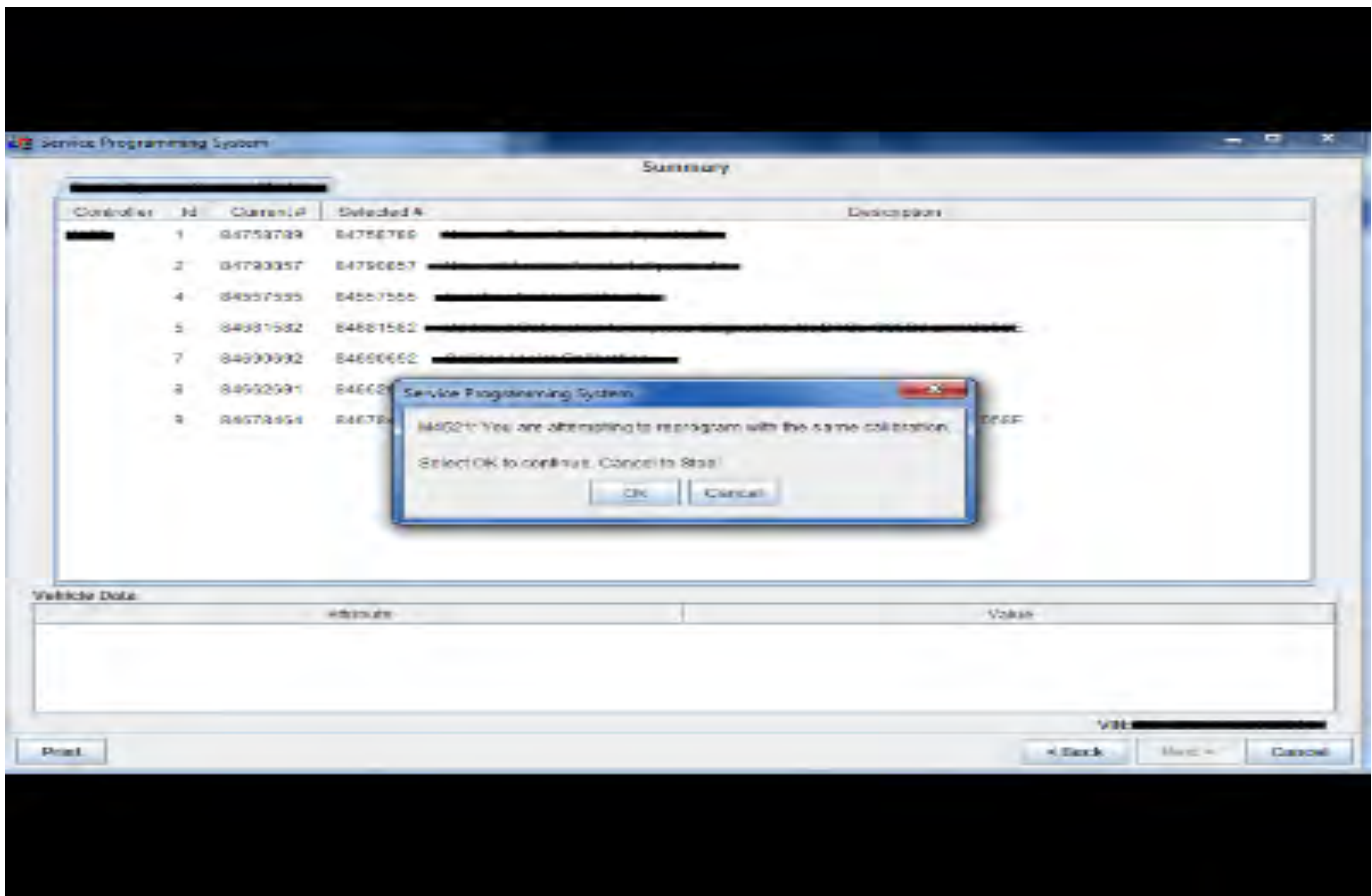
5431207

Important: Techline Connect and TIS2WEB screens shown above.

Important: If the same calibration/software warning is noted on the TLC or SPS Summary screen, select OK and follow screen instructions. After a successful programming event, the WCC is located in the Service

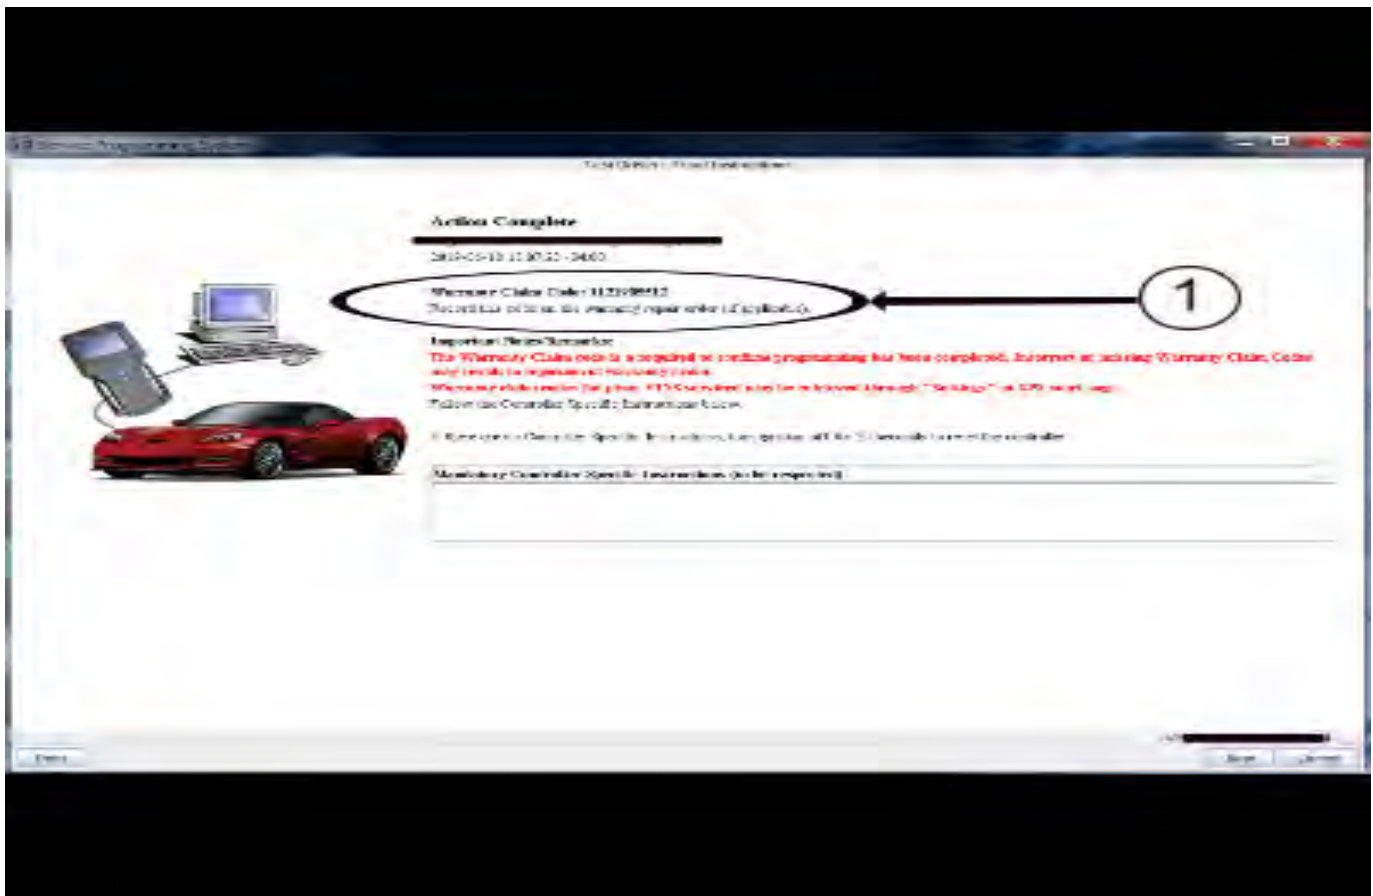
5431209

Note: The screenshots above are an example of module programming and may not be indicative of the specific module that is being programmed. Module selection and VIN information have been blacked out.
