HYUNDAI

Technical Service Bulletin

21-01-048H

WATER TEMPERATURE SENSOR LEAK INSPECTION AND REPAIR
(SERVICE CAMPAIGN T6Q)

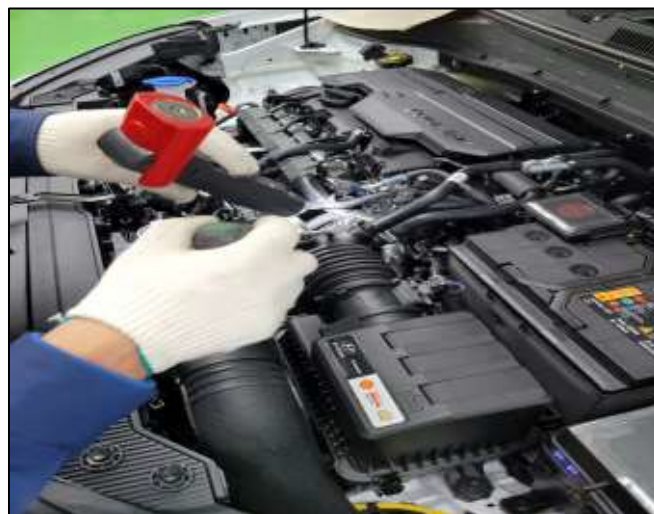
- The area to be inspected for coolant leak is the cylinder head and surrounding portions near the mid-point between the intake manifold and intake hose.
