MOST Bus Network: Overview, Troubleshooting, and Repairs

Year	Model	Trim Level
2018 and later	Odyssey	ALL
2019 and later	Passport	ALL
2019 and later	Pilot	ALL

This job aid contains information on the MOST Bus Network and troubleshooting information for common problems.

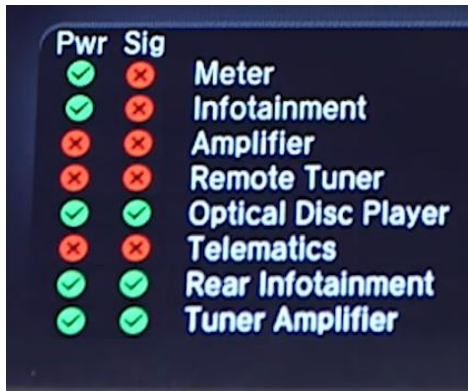
In this first example, the following components reported a power problem and signal problem or just a signal problem.

First, focus on the components that reported both a power and signal problem. Go to the applicable EWD and check to see if these three components are equipped on the model you are working on.

By checking the EWD, the amplifier (stereo amplifier), remote tuner (tuner unit) and telematics (telematics control unit) are not equipped for the model and trim level you are working on and can be ignored. That leaves the meter (gauge control module) and the infotainment (infotainment control unit).

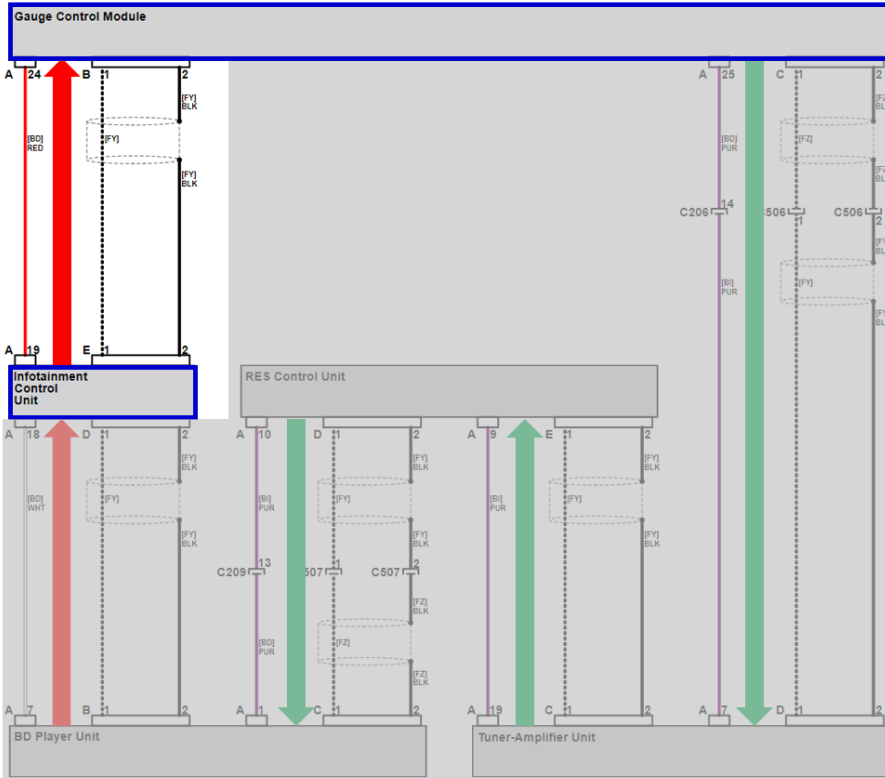
First, the gauge control module reported a problem. Looking at the circuit, the previous component is the infotainment control unit.

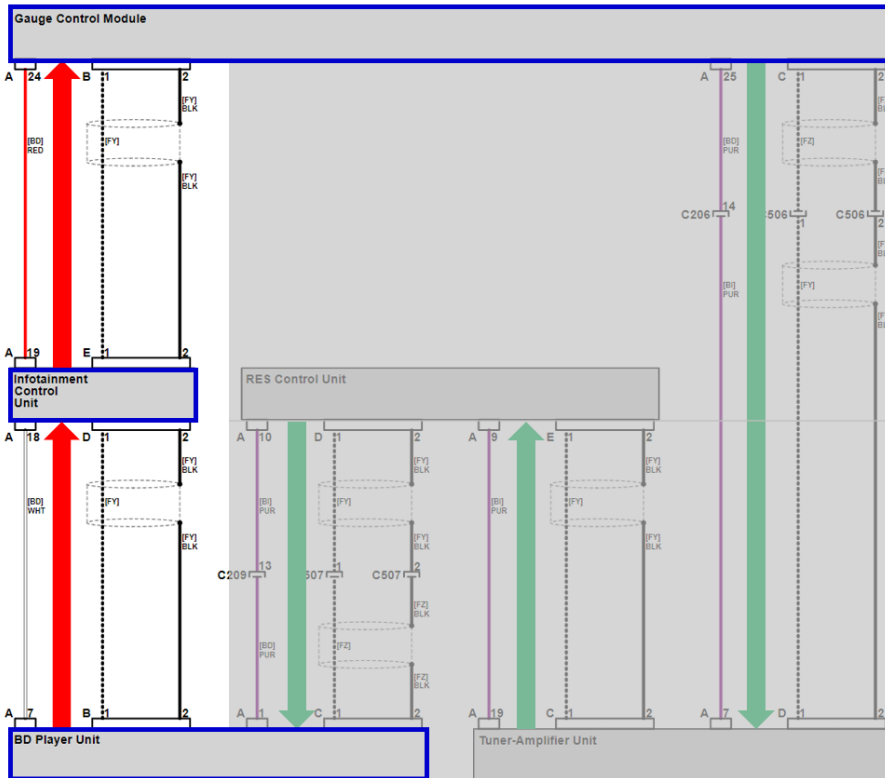
Second, the infotainment control module also reported a problem. Looking at the circuit, the previous component is the BD player. This means that the circuit from the BD player to the gauge control module needs to be checked.

Troubleshooting this circuit revealed a bad connection at the MOST connector in the infotainment control unit.

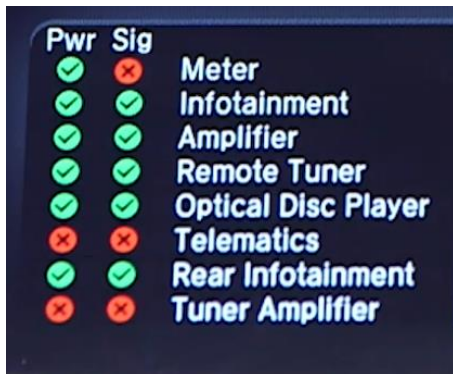
In this next example, the ECL diagnostics results shows the meter, telematics and tuner amplifier reporting problems. After checking the EWD, the telematics (telematic control unit) and the tuner amplifier (tuner-amplifier unit) is not equipped on the vehicle, leaving only the meter (gauge control module).

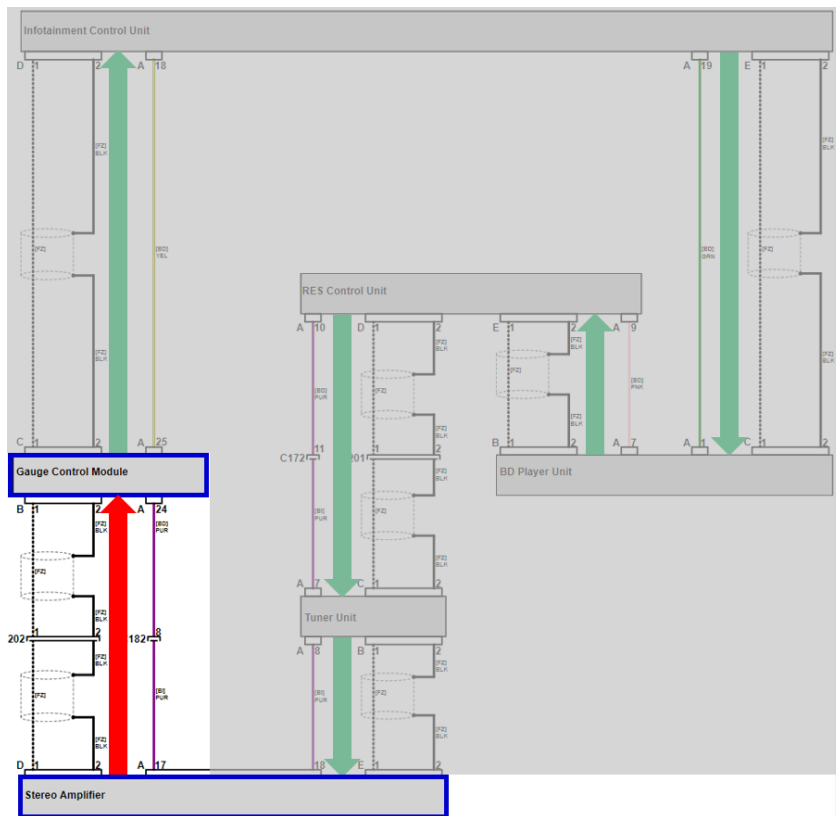
Looking at the EWD, the previous component to the gauge control module is the stereo amplifier.

Troubleshooting this circuit revealed a bad connection at inline connector C202.

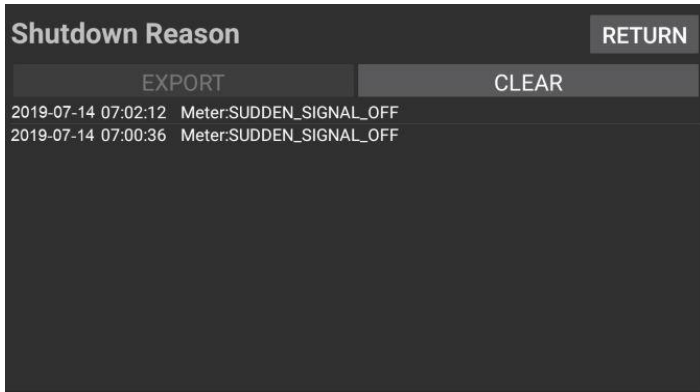
Look for the most recent event on the list. In the example below, the cause of the intermittent failure can be identified as **Meter:SUDDEN_SIGNAL_OFF**, dated 2019-07-14 with a time stamped 07:02:12. There was a complete loss of signal between the gauge control module and the previous transmitting component on the network.

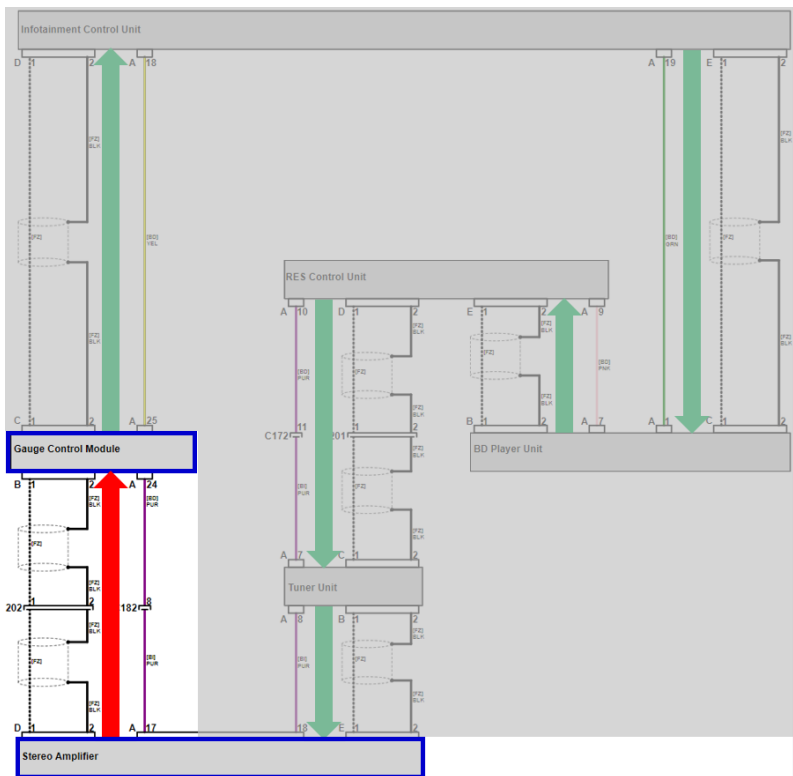
Similar to the MOST Electronic Control Line (ECL) Diagnostic Mode procedure, you must determine the network flow and the previous component to the reported failed component. In this case, the previous component to the gauge control module is the stereo amplifier, and troubleshooting will focus on the circuit between the two components.

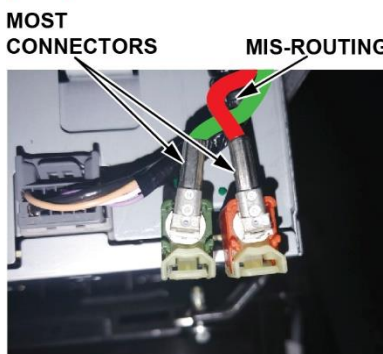
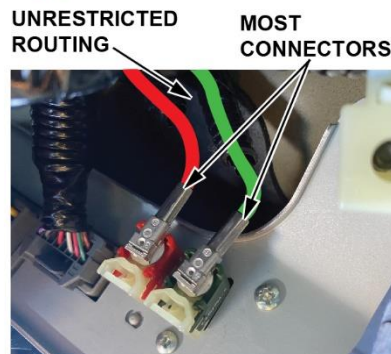
Below are more examples of incorrect harness mis-routing.

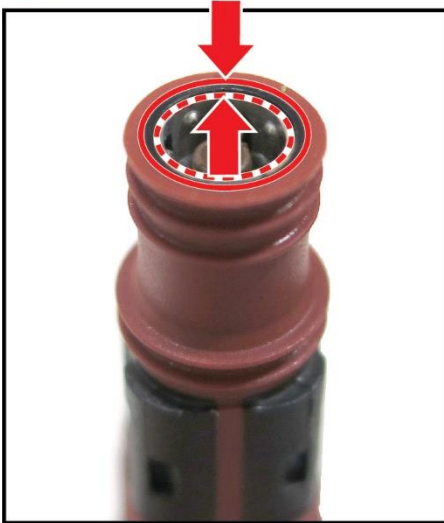
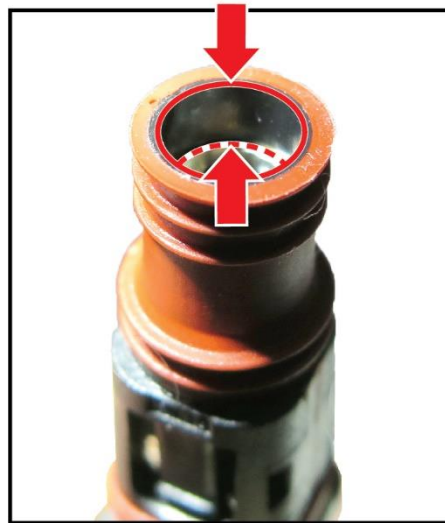
The wire is not fully seated into the new terminal. The edge of the wire must sit with the edge of the updated terminal.

When inserting the wire into the new terminal, make sure you hear a click to ensure it is fully seated.
