<b>HYUNDAI</b> <b>Technical Service Bulletin</b>	GROUP <b>AUTOMATIC TRANSMISSION</b>	NUMBER <b>21-AT-014H</b>
	DATE <b>August, 2021</b>	MODEL(S) <b>TUCSON (TL) 1.6T, SONATA (LFa) 1.6T</b>
<b>SUBJECT: DUAL CLUTCH TRANSMISSION JUDDER DETECTION AND TCU SOFTWARE UPDATE</b>

**This TSB supersedes 20-AT-021H by putting Tucson and Sonata models on their own TSB and provides a revised GDS-M software update for low speed judder.**

**Description:** Certain vehicles (listed below) equipped with 7-speed Double Clutch Transmissions (DCT) may exhibit abnormal vibration at low speeds. This bulletin outlines the procedures for diagnosing clutch judder, updating the Transmission Control Unit (TCU) with revised logic, and/or replacing the Double Clutch.

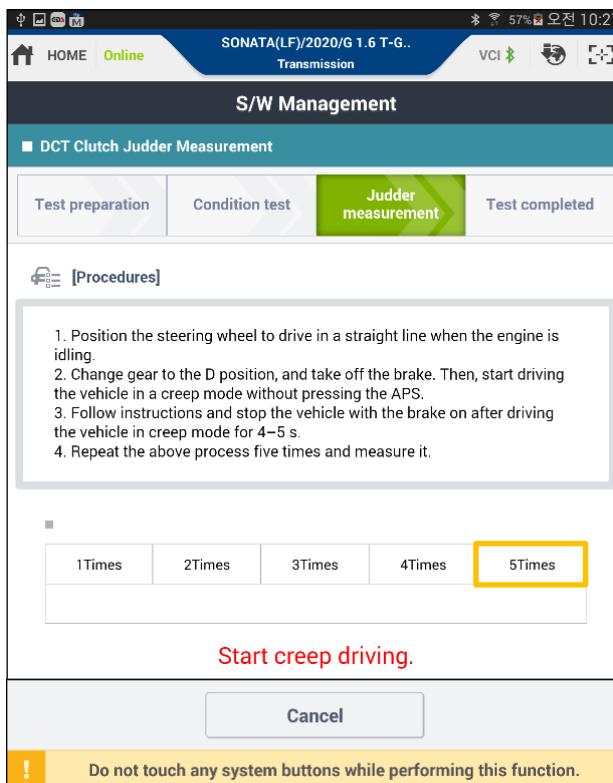
5. Follow the instructions from the Judder Measurement screen to perform the judder clutch inspection.

The inspection is complete when the **5Times** reading appears.
