## Tips & Tricks – All Models

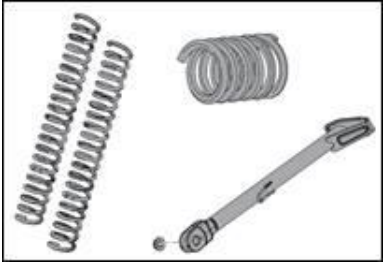
2	<p><b>Monster MY21 (937cc)</b> <u>ONLY</u></p> <p>Standard motorcycle lowering and conversion kits now available</p>	<p>Standard motorcycle lowering and conversion kits</p>	<p>-</p>	<p>We hereby inform you that the following kits are now available:</p> <ul style="list-style-type: none"> <li>- Motorcycle lowering kit part no. 96280801AA</li> <li>- Motorcycle lifting kit part no. 96280821AA</li> </ul> <p>The kits include the following dedicated components:</p> <ul style="list-style-type: none"> <li>• a pair of front fork springs</li> <li>• rear shock absorber spring</li> <li>• side stand</li> <li>• side stand retaining nut</li> </ul> <p>Please follow the procedure outlined in the kit or accessories catalogue and the detailed information in the workshop manual.</p>

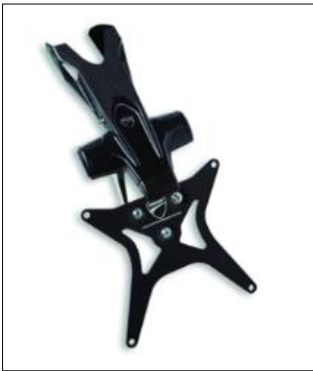
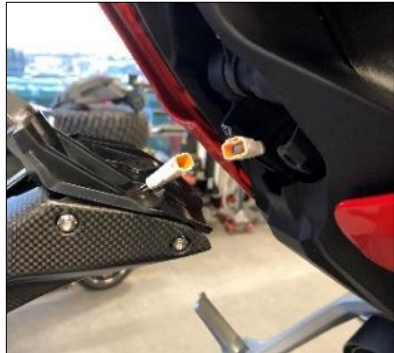
3	<p><u>ONLY</u> <u>Panigale V4</u> <u>(all versions)</u> <u>Panigale V2</u></p> <p>Assembly precautions for Carbon number plate holder kit <b>part no. 97380921A</b></p>	Carbon number plate holder kit <b>part no. 97380921A</b>

<p>We kindly inform you that <u>ONLY</u> when installing the carbon number plate holder kit part no. 97380921A to a Panigale V2 model, it is necessary to purchase wiring <b>part no. 5101H931A</b> to connect the number plate holder connector to motorcycle rear wiring harness connector.</p> <p>We also inform you that the new carbon number plate holder kit <b>part no. 97381161AA</b> is now available. It is specific for Panigale V2 and Streetfighter V4 and will include the above-mentioned wiring.</p>

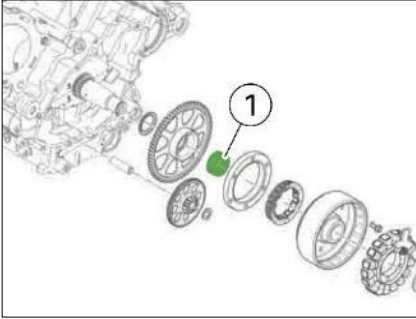
no.	Symptom	Subject	Photo	Notes and Indications - Corrective action
4	<p><u>ONLY</u> <b>Panigale V4</b></p> <p>Starting system update</p>	Starting system	-	<p>To ensure a better starting operation of the engine, we inform you that from engine serial number:</p> <ul style="list-style-type: none"> <li>- ZDM1100W4#<b>007612</b># for EUR version,</li> <li>- AGNK<b>007652</b> for CAL version,</li> </ul> <p>the <b>roller bearing (1)</b> has been introduced instead of the bushing.</p> <p>Please, note that the spare part catalogue has been updated.</p>

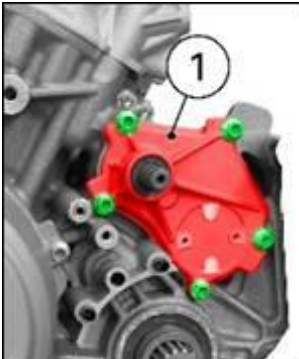
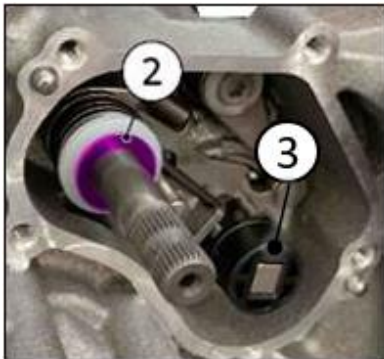
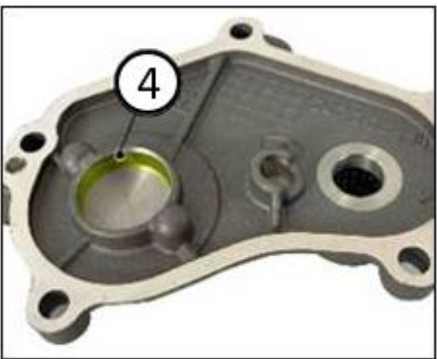
no.	Symptom	Subject	Photo	Notes and Indications - Corrective action
11	<p style="text-align: center;"><u>ONLY</u> <b>959 Panigale</b> <b>(all versions)</b></p> <p>Possible hardening of gear shift control with difficulty in shifting gears when hot</p>	Gear selector	-	<p>We have received some isolated reports about a possible hardening of the gear shift when hot with consequent difficult selection of gear ratios. Based on the analyses carried out, this phenomenon could be due to a hardening between the gearbox sensor magnet plastic support and the relevant seat inside the cover.</p> <p>You are kindly asked to carry out the following operations:</p> <ol style="list-style-type: none"> <li>1) Remove the <b>gear shift cover (1)</b> on motorcycle LH side;</li> <li>2) Check for the presence of <b>shim (2)</b>;</li> <li>3) Mill the end face of the plastic cage for the selector magnet (3) shorter by 0.1 mm maximum and the outer curved edge where it enters the bore of the cover by 0.1 mm maximum, <u>or</u> mill the internal <b>surface (4)</b> of the cover highlighted in the figure and remove 0.1 mm maximum of material from the end and bore of the recess. Ensure the orientation of the magnet is not changed on the shift selector or the gear position will not be able to be determined by the sensor.</li> </ol> <div style="display: flex; justify-content: space-around; margin-top: 10px;">

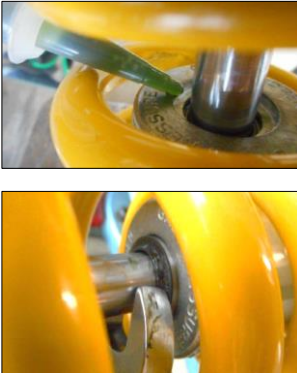
<p>We have received some isolated reports about the possible popping out of the dust seal on the rear shock absorber buffer support plug. <u>Do NOT replace the rear shock absorber.</u></p> <p>To avoid the phenomenon described above it is necessary to:</p> <ul style="list-style-type: none"> <li>- apply a few drops of <b>LOCTITE 638</b> on the plug, at the dust seal seat;</li> <li>- place the dust seal on the plug using an open-end wrench and hold it for a few seconds;</li> <li>- carefully clean any residues of LOCTITE 638 that may have fallen accidentally on the rod and on any other surface.</li> </ul> <p>Please note that the supplier, Sachs, has introduced LOCTITE 638 during the assembly stage from <u>week 29-2020</u> (this information can be found on the sticker on the shock absorber body).</p>

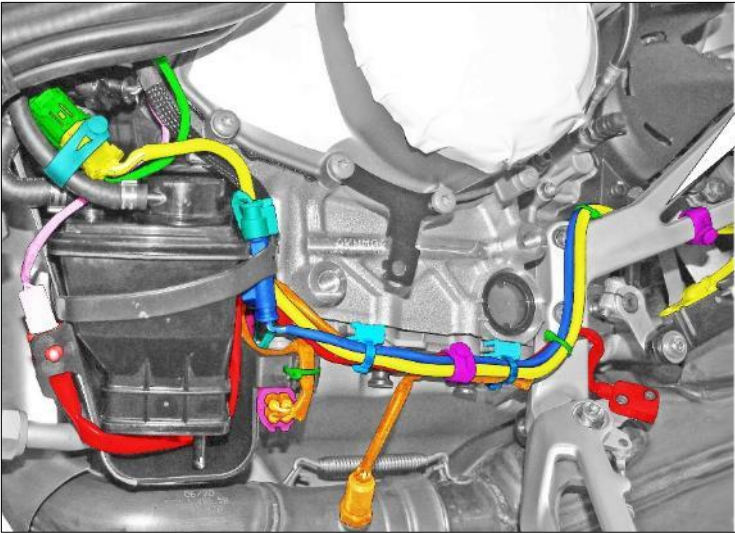
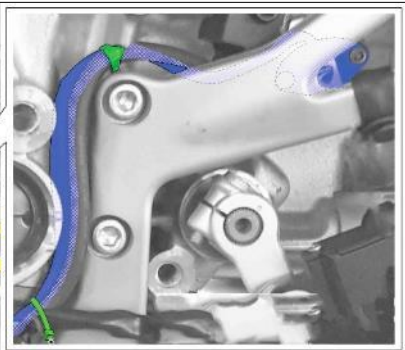
no.	Symptom	Subject	Photo	Notes and Indications - Corrective action
1	Updated layout of motorcycle wiring	Wiring	-	<p>We would like to inform you that the layout of the side stand cable - gear sensor cable - Ducati Quick Shift cable - lambda sensor cable and of the gear sensor connector and cable at the lower crankcase, on the left side of the motorcycle (as shown in the figure) has been updated starting from frame number ZDMFA00AALB003932.</p>

<p>We ask you to respect the new layout of the cables and the gear sensor connector in case of servicing of the mentioned parts.</p>

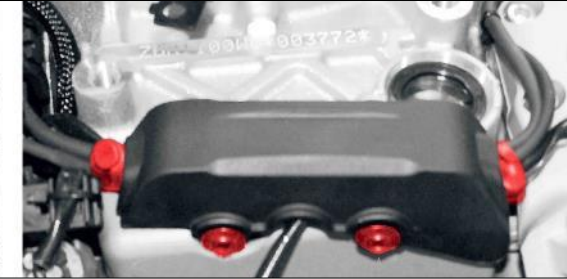
<p>Before installing the wiring cover, apply two L=39mm button ties respecting the dimensions shown in the figure:</p>

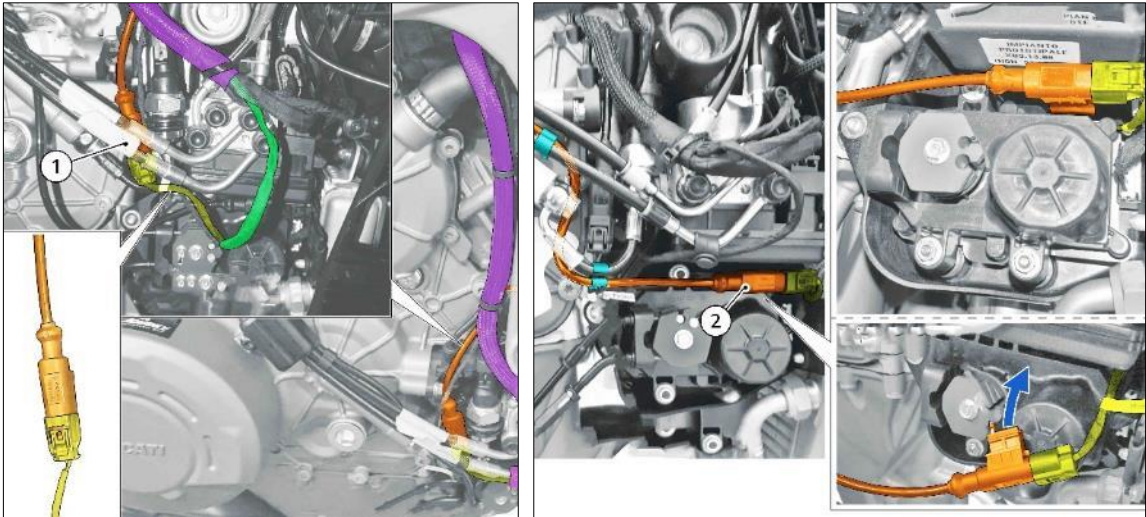
<p>We have received some isolated reports of vehicle speed limitation at values below 50 km/h due to the excessive traction control (DTC) intervention resulting from the installation of the complete titanium exhaust system part no. 96481652AA. The performed analyses have shown that the front and rear speed sensor connections were reversed.</p> <p><u>In case of interventions on the <b>front (1) and rear (2) speed sensor connectors</b>, please take the utmost care to their assembly, as shown in the figure, making sure not to reverse the connections.</u></p>

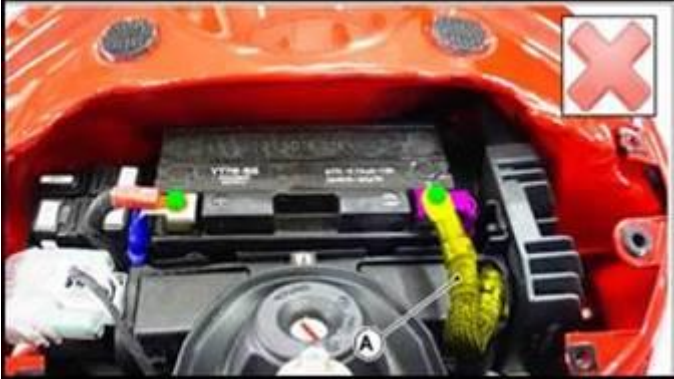
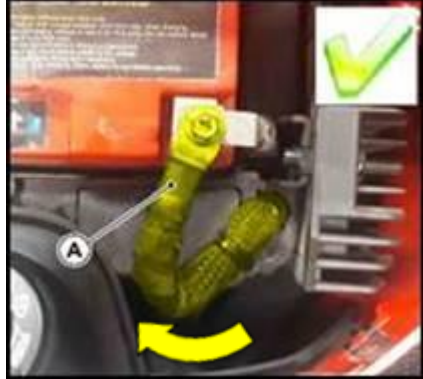
<p>We have received isolated reports of possible interference between the battery negative cable and the battery cover (in particular, the pin fixing the mesh to the cover). We inform you that in order to avoid the contact described above, we have updated the battery fitting procedure and in particular that of the ABS negative cable; it is necessary to connect the <b>ABS negative cable (A)</b> orienting it towards the ignition switch as shown in the figure:</p> <div style="display: flex; justify-content: space-around;">

</div> <p>We ask you to follow the new battery fitting procedure during pre-delivery operations and in any case to always check that the battery is fitted correctly the first time the motorcycle is brought to the workshop. <u>This new battery mounting procedure cancels and replaces the information contained in the model introduction bulletin SRV-SRB-20-002.</u></p>
