SANICON TURBO MACERATOR DIAGNOSIS MY2016-2022

Bulletin Type:	SRP	Publication Date:	September 2021
Bulletin #(s):	21-035	Make(s):	Entegra
Job Code(s):	<i>If affected unit has warranty remaining, submit your claim following the normal process</i>	Model(s):	Embark, Reatta, Reatta XL, Aspire, Anthem, Cornerstone
Flat Rate(s):		Model Year(s):	2016-2022

Incident:	THE MACERATOR WILL NOT RUN OR RUNS BUT WILL NOT PUMP.
Affected Units:	2016-2022 Entegra Embark & Reatta & XL & Aspire & Anthem & Cornerstone
Parts List:	1 EA THETFORD: PUMP (PART #0303362) 1 EA MACERATOR THETFORD SANI-CON TURBO MODEL #97646 WIWHT 30' HOSE/SLEEVE
Misc. Tools & Supplies:	N/A
Parts Return Information:	N/A

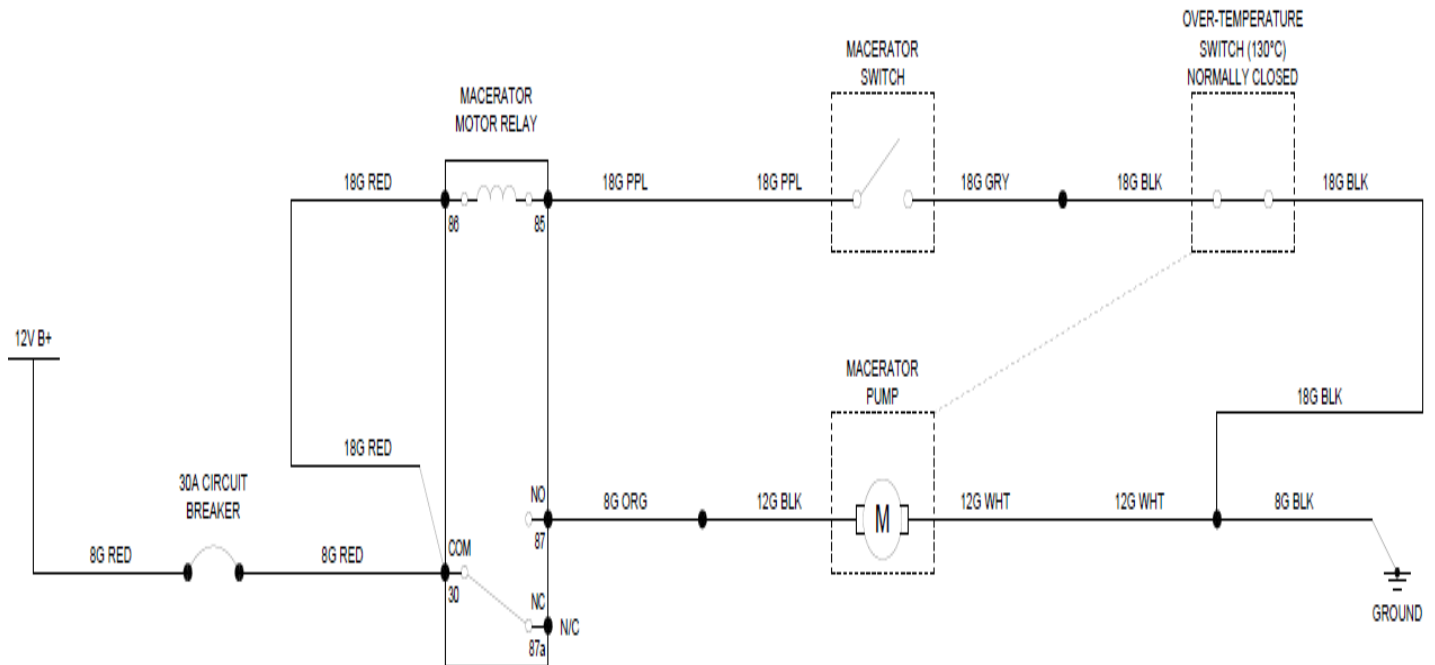
System Schematic

6. **Correction for Cause #2: MY16-2021:** The relay in the wet bay has failed and only clicks without sending power to macerator motor. Test power at relay input and output to the macerator. Replace the relay as needed. See "System Schematic", Fig 16 & 17 for test information.
- a. The relay shown in Fig 15 is located on the right side on the wet bay by behind the cover board shown in Fig 14 near the water hose reel.

7. Spade Terminal layout in Fig 16 & Fig 17.
8. Meter the relay:
 - a. Macerator switch on connected ground to #85.
 - b. Changes 12V B+ from terminal #87A to #87.
