Service Action

Code: 92E3

Subject Heated Washer Jet Wiring Harness

Release Date October 12, 2021

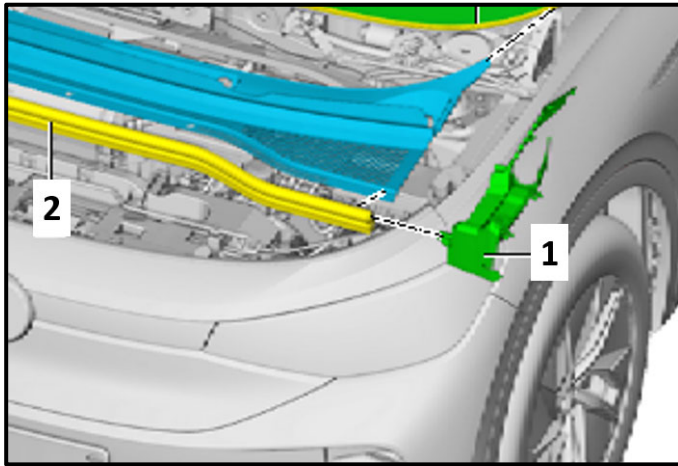
If the plenum chamber cover is damaged or mounted incorrectly, water could flow into the passenger compartment. This can lead to complaints regarding odor coming from the heater/A/C system and/or moisture in the vehicle interior.

Reinstall left (driver) side plenum chamber cover and plenum chamber seal:
