# CAMPAIGN BULLETIN

## Rear Window Defogger Dealer Inventory

Reference: PC814

# PC814 – 2021 ROGUE REAR WINDOW DEFOGGER INSPECTION

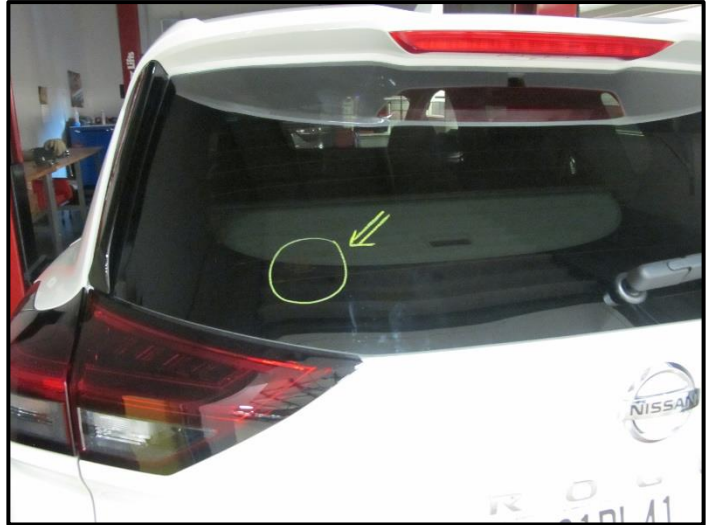
Figure 1

### 1. Locate back door glass date code (Figure 1).

- Found on lower left side of back door glass above the combination lamp
- Use of a small LED light may enhance the date code making it easier to see
- Taping a piece of white paper to the inside glass over the date code will assist with reading the code (Figure 2)

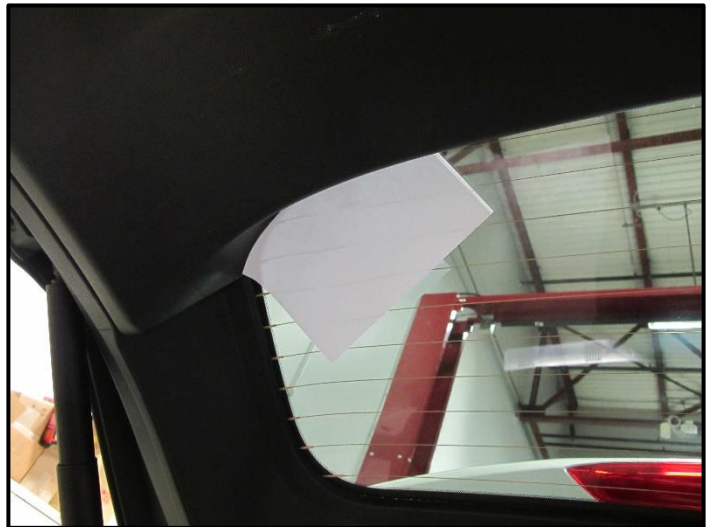
**NOTE:** Figure 2 shows the back door open.

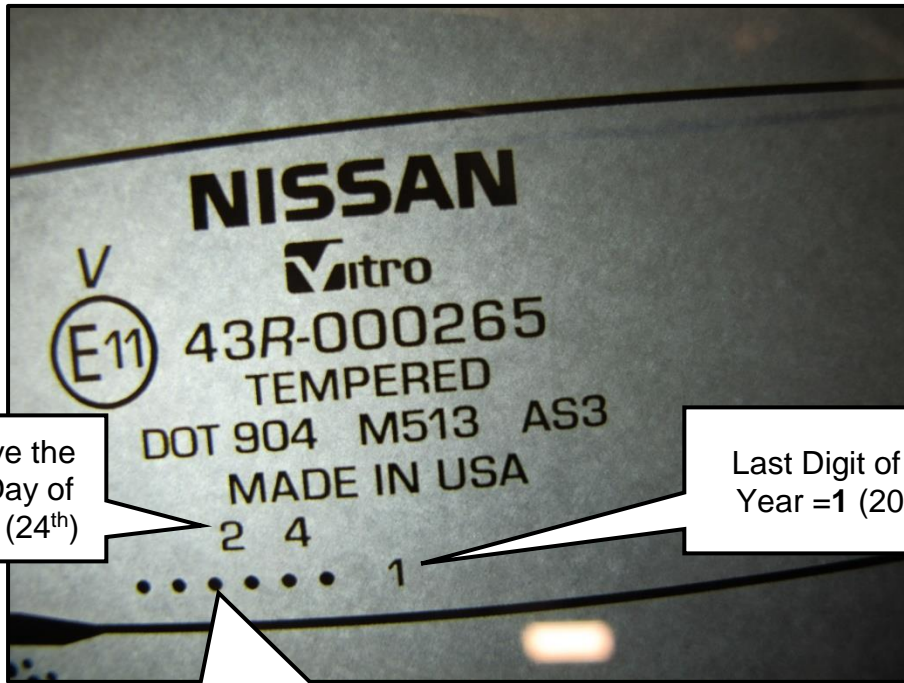
The date code in the Figure 3 example is: **January 24, 2021 (01/24/21)**

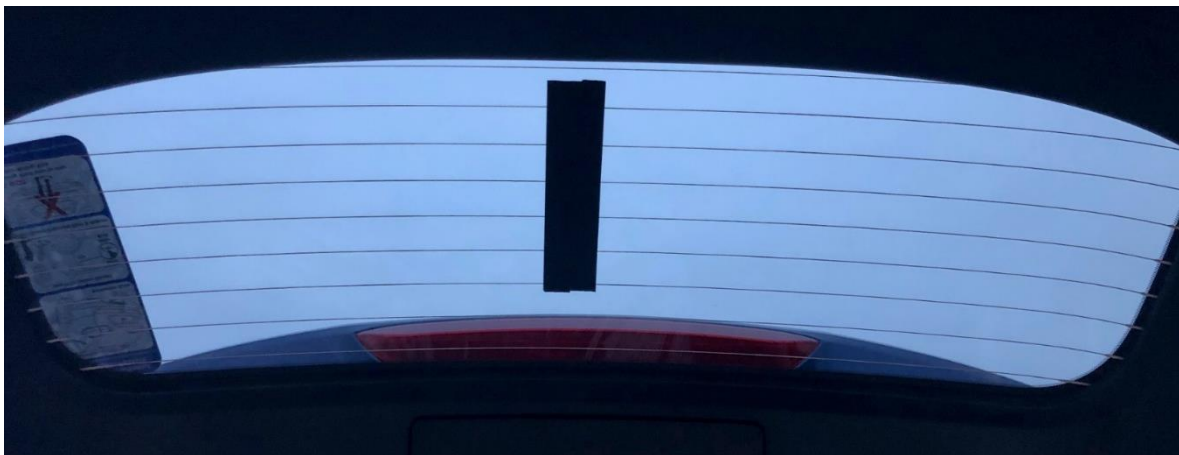
Figure 9

6. After 30 seconds, open back door and apply Gorilla brand duct tape to the rear window defogger heating wires (Figure 9).

- Tape should be approximately 8 inches long and cover (6) heating wires
- Tape should be applied vertically and in the center of the glass
- Tape should be applied with the back door open and on the inside of the glass
- Ensure tape is pressed fully to the glass
