Technical product information

Topic	Rotating Display - Fault Diagnosis
Market area	Bentley: worldwide (2WBE),Hongkong-Macau (5HK)
Brand	Bentley
Transaction No.	2055580/7
Level	EH
Status	Approval
Release date

New Continental GT

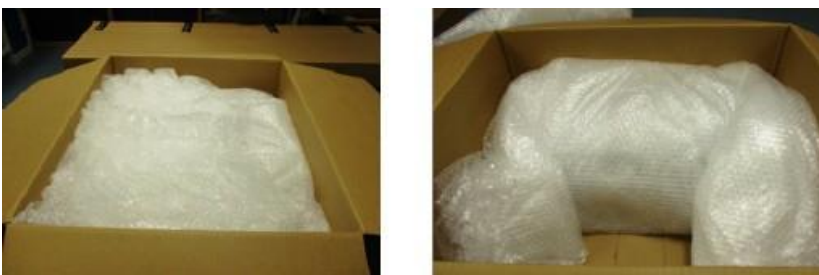
Figure 13

- All returned BRD's must be packaged in the replacements original packaging (Figure 13) to avoid any damage during return transit
