Technical product information

Topic	Rotating screen alignment
Market area	Bentley: worldwide (2WBE),Hongkong-Macau (5HK)
Brand	Bentley
Transaction No.	2051526/8
Level	EH
Status	Approval
Release date

New Continental GT - New Continental GTC and New Flying Spur

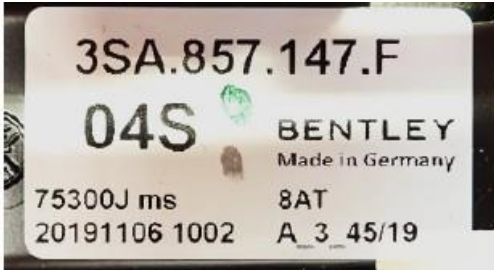
Figure 19

- Take a photo of the BRD prior to packaging (Noting any damage)
- Take a photo of the BRD identification number (Figure 19 as an example)

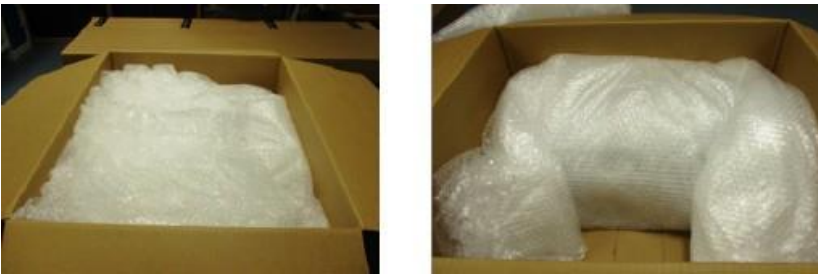
Figure 20

- All returned BRD's must be packaged in the replacements original packaging (Figure 20) to avoid any damage during return transit
