## Tips & Tricks – All Models

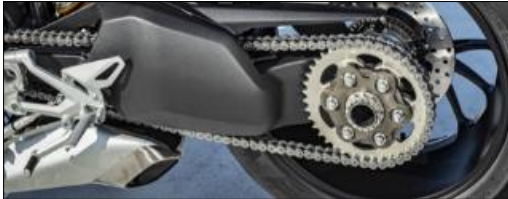
<p>We have received reports of some complaints about rough shifting with DQS, particularly at low rpm. In other words, rough shifting with uncomfortable torque cuts.</p> <p>We have checked that very often <b>the cause is related to an incorrect chain tensioning</b>, especially after the first settling of the chain which takes place at around 200/300 Km (new motorcycle or chain). We therefore invite you to always check the correct tensioning of the final drive chain before making further analysis.</p>

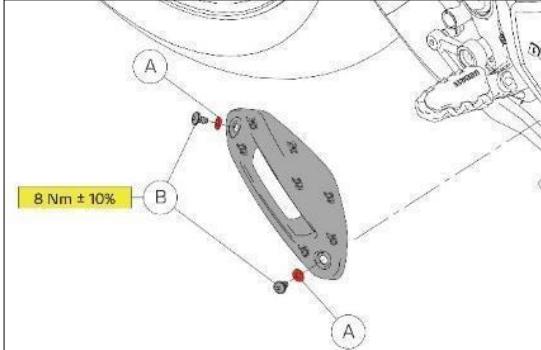
<p>We inform you that the assembly instructions for the carbon horizontal manifold heat guard kit by Ducati Performance part no. 96980251A have been updated. In particular, in order to install the part, <u>you must reuse the 2 washers (A) present on the original heat guard.</u></p> <p>Please always comply with the tightening torque of the 2 screws M6x12 (B) of <b>8 Nm ± 10%.</b></p>

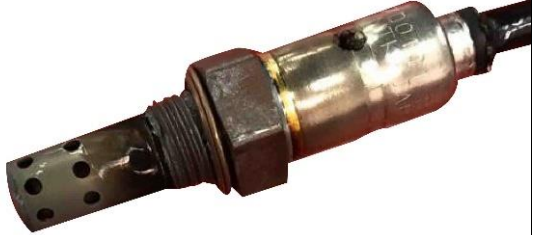
<p><b>Hypermotard 950 Model Year 2020-2021</b></p>

no.	Symptom	Subject	Photo	Notes and Indications - Corrective action
3	<p><u>ONLY</u> <u>Hypermotard 950 MY22</u></p> <p>Possible validation of errors P2A03 Horizontal cylinder lambda sensor (oxygen sensor) [Value out of range] and/or P2A00 Vertical cylinder lambda sensor (oxygen sensor) [Value out of range]</p>	Lambda sensors	-	<p>We have received some isolated reports of the possible validation of the following errors:</p> <ul style="list-style-type: none"> <li>• P2A03 Horizontal cylinder lambda sensor (oxygen sensor) [Value out of range]</li> <li>• P2A00 Vertical cylinder lambda sensor (oxygen sensor) [Value out of range]</li> </ul> <p>after riding only 1000km/600mi.</p> <p>Our analysis has shown that this phenomenon is linked to the possible installation of lambda sensors relating to the previous Model Year (Model Year 2020-2021 EURO4 version) despite having the same connector on the wiring side.</p> <p>We would like to inform you that the production line has made the process more robust in order to avoid this issue.</p> <p>Should you find the above mentioned errors, we ask you to ensure that the dedicated lambda sensors part no.55215021A for the Hypermotard 950 Model Year 2022 are actually installed.</p> <div style="display: flex; justify-content: space-around; align-items: center;"> <div style="text-align: center;">

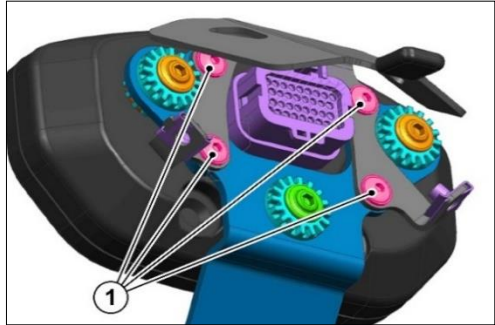
no.	Symptom	Subject	Photo	Notes and Indications - Corrective action
1	<p><u>ONLY</u> <b>Monster Plus MY21 (937cc)</b></p> <p>M5x8 screws are missing from the kit supplied with the vehicle</p>	<p>Kit supplied with the vehicle</p>

<p>We have received a few reports stating that <b>4 M5x8 screws (1)</b> part no. 77240243C required to fix the headlight fairing support bracket to the instrument panel support bracket are missing from the kit supplied with the motorcycle.</p> <p>We would like to inform you that the kits available in stock have all been sorted out.</p> <p>For the headlight fairing assembly procedure and all Pre-delivery operations, please refer to the model introduction bulletin SRV-SRB-21-022.</p>

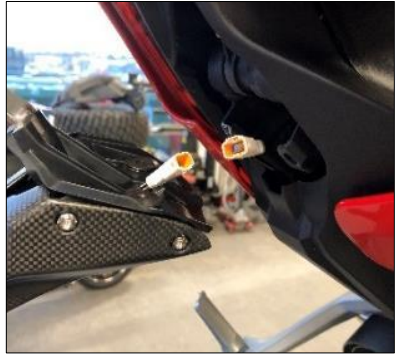
3	<p><u>ONLY</u> <u>Panigale V4</u> <u>(all versions)</u> <u>Panigale V2</u></p> <p>Assembly precautions for Carbon number plate holder kit <b>part no. 97380921A</b></p>	Carbon number plate holder kit <b>part no. 97380921A</b>

<p>We kindly inform you that <u>ONLY</u> when installing the carbon number plate holder kit <b>part no. 97380921A</b> to a Panigale V2 model, it is necessary to purchase wiring <b>part no. 5101H931A</b> to connect the number plate holder connector to motorcycle rear wiring harness connector.</p> <p>We also inform you that the new carbon number plate holder kit <b>part no. 97381161AA</b> is now available. It is specific for Panigale V2 and Streetfighter V4 and will include the above-mentioned wiring.</p>

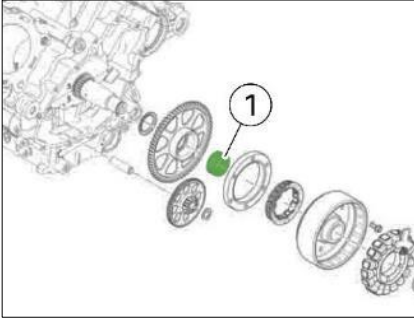
no.	Symptom	Subject	Photo	Notes and Indications - Corrective action
4	<p><u>ONLY</u> <b>Panigale V4</b></p> <p>Starting system update</p>	Starting system	-	<p>To ensure a better starting operation of the engine, we inform you that from engine serial number:</p> <ul style="list-style-type: none"> <li>- ZDM1100W4#<b>007612</b># for EUR version,</li> <li>- AGNK<b>007652</b> for CAL version,</li> </ul> <p>the <b>roller bearing (1)</b> has been introduced instead of the bushing.</p> <p>Please, note that the spare part catalogue has been updated.</p>

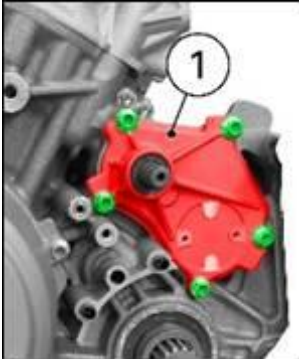
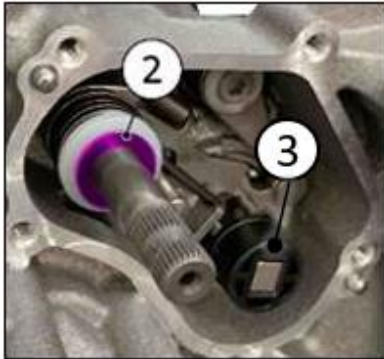
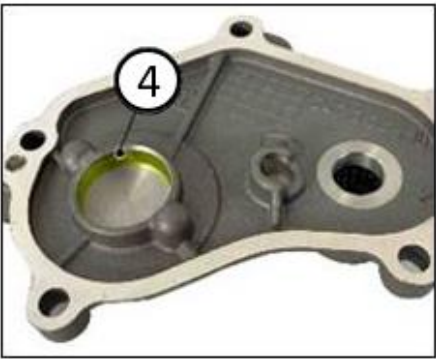
no.	Symptom	Subject	Photo	Notes and Indications - Corrective action
11	<p style="text-align: center;"><u>ONLY</u> <b>959 Panigale</b> <b>(all versions)</b></p> <p>Possible hardening of gear shift control with difficulty in shifting gears when hot</p>	Gear selector	-	<p>We have received some isolated reports about a possible hardening of the gear shift when hot with consequent difficult selection of gear ratios. Based on the analyses carried out, this phenomenon could be due to a hardening between the gearbox sensor magnet plastic support and the relevant seat inside the cover.</p> <p>You are kindly asked to carry out the following operations:</p> <ol style="list-style-type: none"> <li>1) Remove the <b>gear shift cover (1)</b> on motorcycle LH side;</li> <li>2) Check for the presence of <b>shim (2)</b>;</li> <li>3) Mill the end face of the plastic cage for the selector magnet (3) shorter by 0.1 mm maximum and the outer curved edge where it enters the bore of the cover by 0.1 mm maximum, <u>or</u> mill the internal <b>surface (4)</b> of the cover highlighted in the figure and remove 0.1 mm maximum of material from the end and bore of the recess. Ensure the orientation of the magnet is not changed on the shift selector or the gear position will not be able to be determined by the sensor.</li> </ol> <div style="display: flex; justify-content: space-around; margin-top: 10px;">

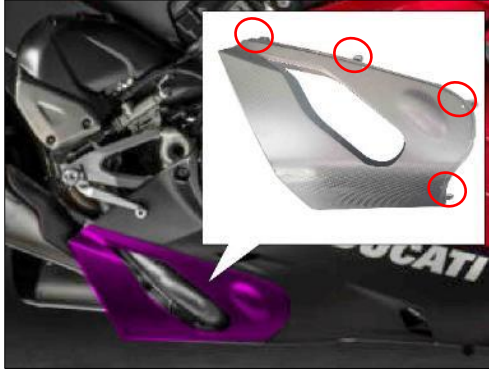
<p>We have received some isolated reports about an incorrect coupling between the silencer covers and the side half fairings in case the complete Akrapovic racing titanium exhaust system, supplied with the motorcycle, is installed. In fact, it is possible to find a misalignment between the mounting holes of the components.</p> <p>To improve this coupling, it is possible to slot-drill the 4 mounting holes of the silencer covers by using a column drill with a <u>6 mm drill bit</u> and setting a high rotation speed to prevent the fiber from flaking off.</p>

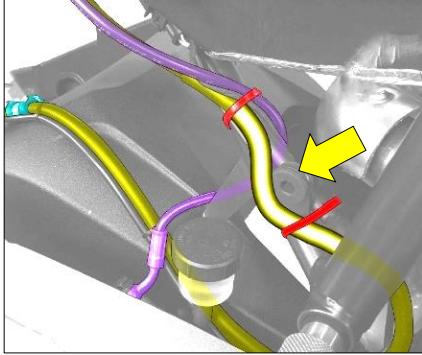
no.	Symptom	Subject	Photo	Notes and Indications - Corrective action				
1	<p><u>ONLY Scrambler 800 (all model versions and MY, excluding Desert Sled model version)</u></p> <p>Precautions when routing the rear brake caliper hose</p>	Rear brake hose	-	<p>We have found that sometimes, during maintenance operations, the rear brake caliper hose is not correctly positioned along the frame due to incorrect installation by the technician during service.</p> <p>Make sure that the rear brake caliper hose (yellow), passes outside the left side cover mounting bracket with respect to the motorcycle centerline and is fixed with the two self-locking ties (red) as shown in the figure.</p> <p>The operation of inspection and possible repositioning is very simple and involves the disassembly of the left side cover only.</p>

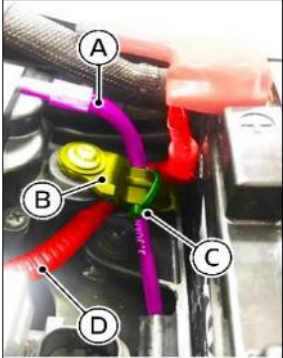
4	<p><u>ONLY</u>  <u>Scrambler 1100</u>  <u>Model Year 2020</u>  <u>(all model versions)</u></p> <p>Precautions during PDI: installation of the battery on the vehicle</p>	Battery assembly	-	<p>During the installation of the battery on the vehicle and, in any case, when the motorcycle first comes to the workshop for a service, we ask you to always check the correct positioning of the <b>exhaust butterfly valve cable (A)</b> under the <b>retainer (B)</b> and the presence of the <b>self-locking tie (C)</b>.</p> <p>Make sure the <b>motorcycle positive cable (D)</b> is positioned under the <b>exhaust butterfly valve cable (A)</b>.</p>

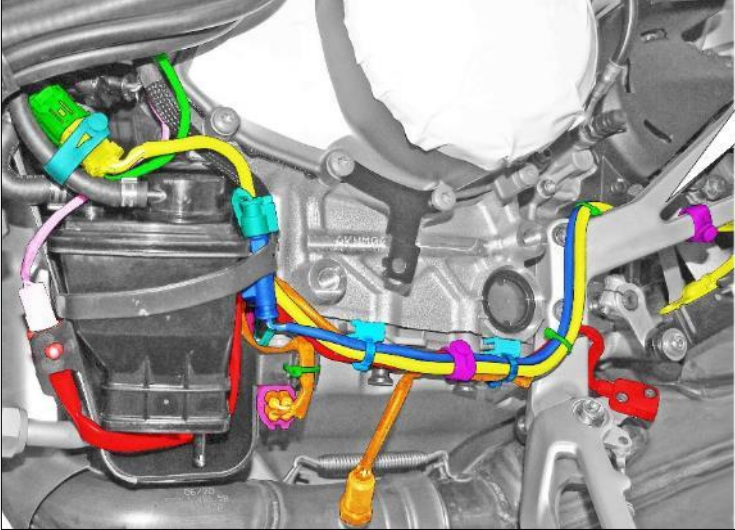
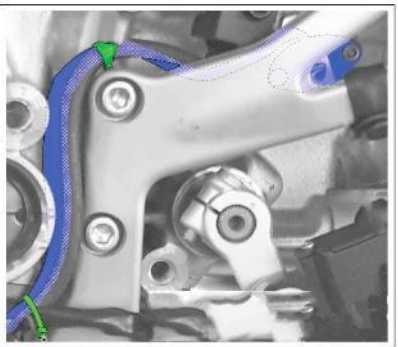
no.	Symptom	Subject	Photo	Notes and Indications - Corrective action
1	Updated layout of motorcycle wiring	Wiring	-	<p>We would like to inform you that the layout of the side stand cable - gear sensor cable - Ducati Quick Shift cable - lambda sensor cable and of the gear sensor connector and cable at the lower crankcase, on the left side of the motorcycle (as shown in the figure) has been updated starting from frame number ZDMFA00AALB003932.</p>

<p>We ask you to respect the new layout of the cables and the gear sensor connector in case of servicing of the mentioned parts.</p>

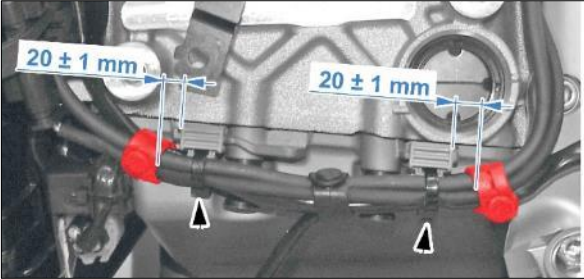
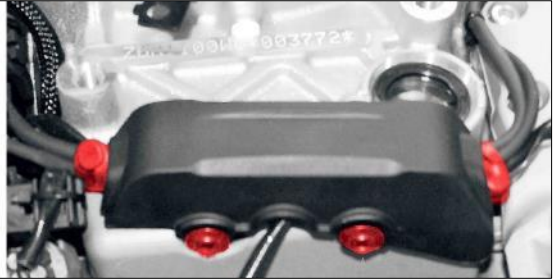
<p>Before installing the wiring cover, apply two L=39mm button ties respecting the dimensions shown in the figure:</p>

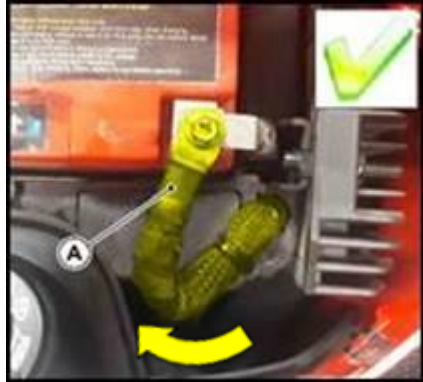
<p>We have received isolated reports of possible interference between the battery negative cable and the battery cover (in particular, the pin fixing the mesh to the cover). We inform you that in order to avoid the contact described above, we have updated the battery fitting procedure and in particular that of the ABS negative cable; it is necessary to connect the <b>ABS negative cable (A)</b> orienting it towards the ignition switch as shown in the figure:</p> <div style="display: flex; justify-content: space-around;">

</div> <p>We ask you to follow the new battery fitting procedure during pre-delivery operations and in any case to always check that the battery is fitted correctly the first time the motorcycle is brought to the workshop. <u>This new battery mounting procedure cancels and replaces the information contained in the model introduction bulletin SRV-SRB-20-002.</u></p>

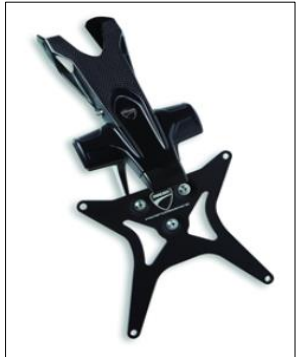
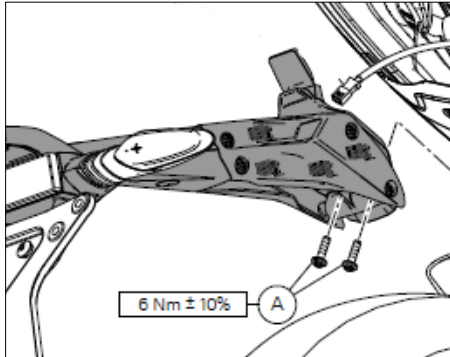
8	Precautions for the assembly of Ducati Performance carbon number plate holder kit part no. 97381161CA	Ducati Performance carbon number plate holder kit part no. 97381161CA

<p>When assembling the Ducati Performance carbon number plate holder unit part no. 97381161CA, we remind you to always apply <b>LOCTITE 243</b> on the threads of the <b>2 screws (A)</b> for fixing the unit to the rear subframe and tighten them to the specified torque of <b>6 Nm ± 10%</b> as indicated in the relevant instructions.</p>
