MULTISTRADA: > Right-hand switch button backlighting  
> Possible appearance of stains and white dots on the instrument panel  
> Possible malfunction of the heated passenger seat  
> Upcoming Infotainment and HMI improvements

## ← Tips & Tricks – All models

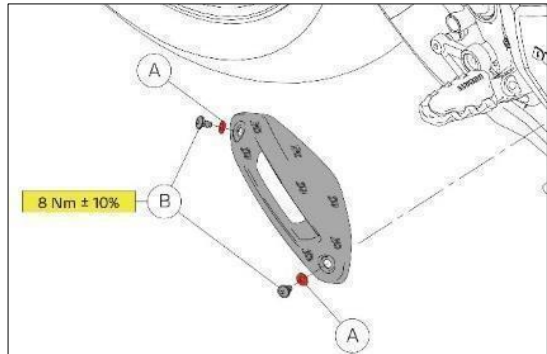
<p>We inform you that the assembly instructions for the carbon horizontal manifold heat guard kit by Ducati Performance part no. 96980251A have been updated. In particular, in order to install the part, <u>you must reuse the 2 washers (A) present on the original heat guard.</u></p> <p>Please always comply with the tightening torque of the 2 screws M6x12 (B) of <b>8 Nm ± 10%</b>.</p>

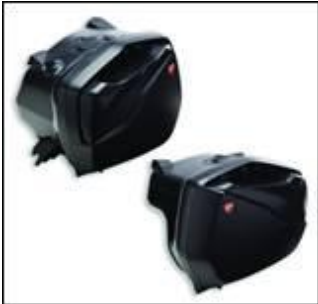
no.	Symptom	Subject	Photo	Notes and Indications - Corrective action
10	<p><b>ONLY Multistrada V4 (all model versions)</b></p> <p>Difficulties in opening the side panniers part no. 96781551AA</p>	Side panniers part no. 96781551AA

<p>We have received a few isolated reports of possible difficulties in opening the side panniers due to the “vacuum” effect that occurs when travelling with significant changes in altitude.</p> <p>To avoid this phenomenon, it is necessary to drill a venting hole with a maximum diameter of Ø 2 mm at the bottom of the bag, between the ribs near the rear hinge as shown in the figure.</p> <p><b><u>DO NOT drill through the second internal wall of the bag.</u></b></p> <p>This modification has also been implemented by the supplier and does not affect the water tightness.</p>

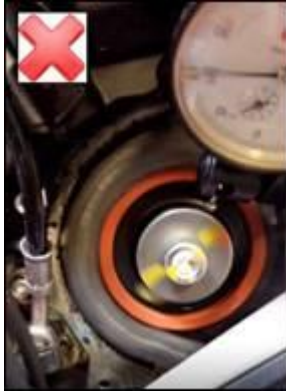
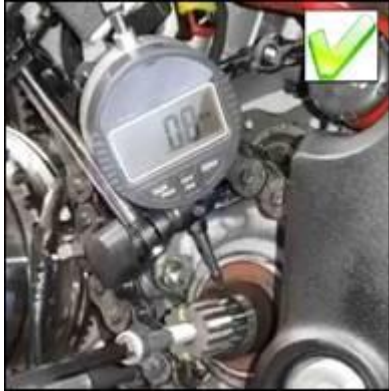
no.	Symptom	Subject	Photo	Notes and Indications - Corrective action
19	<p><b>ONLY</b> <b><u>Multistrada V4</u></b> <b><u>(all model versions)</u></b></p> <p>Possible oscillation of the final drive chain (non-uniform sliding)</p>	Gearbox secondary shaft	-	<p>We have received some isolated reports about a possible oscillation of the final drive chain even if the chain is correctly tensioned. In these cases the customer may complain an uneven sliding of the chain at constant speed.</p> <p>In these cases, you are asked to check for a possible deformation of the gearbox secondary shaft by removing both the chain and the sprocket and taking the measurement with a dial gauge directly on spacer Part no. 713P0011C, as shown in the figure (the measurement should NOT be taken on the sprocket since an uneven wear of the rubber material may occur during the first few kilometers): by slowly rotating the shaft, the value taken with the dial gauge must be at most 0.1 mm.</p> <div style="display: flex; justify-content: space-around;">

</div> <p>a) If the measurement shows values below 0.1 mm, replace the sprocket only.  a) If the measurement shows a value greater than 0.1mm, fill out a <b>Youtech</b> service request.</p>

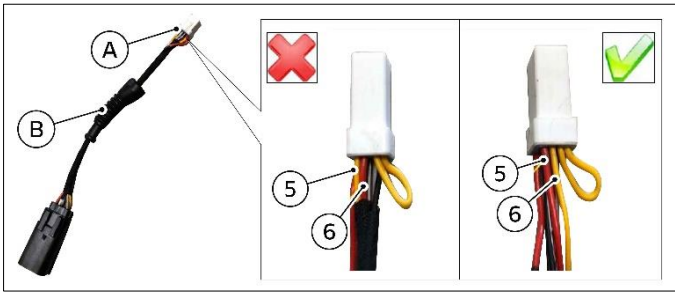
<p>We have received some reports concerning the difficulty in securing the Top Case (Kit Part no. 96781531AA) to the top plate Part no. 8291M033A due to a machining error of the supplier. In particular, the locking tooth on the upper plate Part no. 8291M033A shows a hole 2mm narrower than specified. To eliminate this defect, the locking tooth of the plate must be milled by <u>2mm in the upper area</u> using a flat file, as shown in the figure.</p> <p>We inform you that the upper plates present inside the kits in stock have been restored.</p>
27	Anti-theft system kit Part no. 96681081AA malfunction	Anti-theft system kit Part no. 96681081AA

<p>Follow the procedure described below:</p> <ol style="list-style-type: none"> <li>1) uncover <b>connector (A)</b> by moving <b>sheath (B)</b> backward;</li> <li>2) uncover the wiring by removing a portion of insulating tape to make operations easier;</li> <li>3) check the arrangement of <b>Pins 5 and 6</b> and the relevant color on the 8-pin connector. If the pin arrangement is not correct, extract them working from the front side with a needle inside the groove so as to lift the retainer and invert them.</li> <li>4) restore the cloth tape previously removed and the position of the protective <b>sheath (B)</b>.</li> </ol>

<p>The kits currently in stock have been restored.</p>

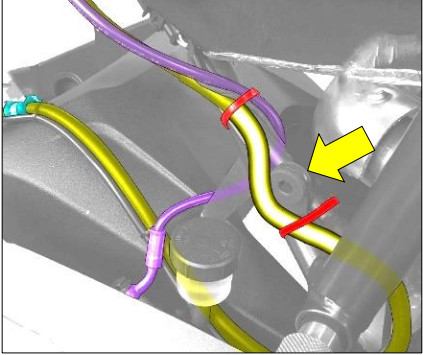
no.	Symptom	Subject	Photo	Notes and Indications - Corrective action				
1	<p><u>ONLY Scrambler 800 (all model versions and MY, excluding Desert Sled model version)</u></p> <p>Precautions when routing the rear brake calliper hose</p>	Rear brake hose	-	<p>We have found that sometimes, during maintenance operations, the rear brake caliper hose is not correctly positioned along the frame due to incorrect installation by the technician during service.</p> <p>Make sure that the rear brake caliper hose (yellow), passes outside the left side cover mounting bracket with respect to the motorcycle centerline and is fixed with the two self-locking ties (red) as shown in the figure.</p> <p>The operation of inspection and possible repositioning is very simple and involves the disassembly of the left side cover only.</p>

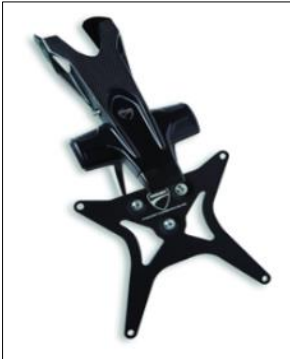
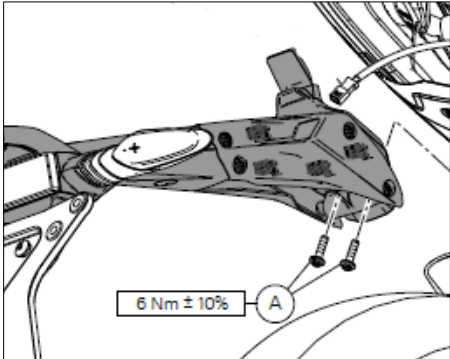
8	Precautions for the assembly of Ducati Performance carbon number plate holder kit Part no.97381161CA	Ducati Performance carbon number plate holder kit Part no.97381161CA

<p>When assembling the Ducati Performance carbon number plate holder unit part no. 97381161CA, we remind you to always apply <b>LOCTITE 243</b> on the threads of the <b>2 screws (A)</b> for fixing the unit to the rear subframe and tighten them to the specified torque of <b>6 Nm ± 10%</b> as indicated in the relevant instructions.</p>

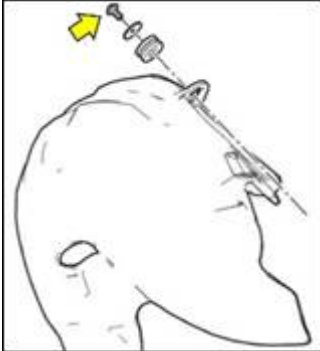
10	Possible loosening of the screw retaining the heat guard	Screw 77244163B retaining the rear bank exhaust manifold heat guard	-	<p>We have received a few reports about a possible loosening of the screw retaining the rear bank exhaust manifold heat guard.</p> <p>The issue is being investigated, therefore, we kindly ask you to check the correct tightening of the above-mentioned screw (part no. 77244163B) when coming to the workshop (the prescribed tightening torque is <b>5 Nm ± 10%</b>).</p>
