Instructions for navigating the document

NEW TOPICS 3

NEW TOPICS

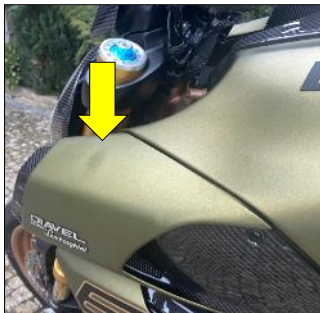
no.	Symptom	Subject	Photo	Notes and Indications - Corrective action
1	<p><u>ONLY</u> <u>Diavel Lamborghini</u></p> <p>Possible indentation of RH and/or LH outer cover of the air conveyor</p>	RH and LH air conveyor covers

<p>We have received some isolated reports about a possible indentation of the RH and/or LH outer cover of the air conveyor.</p> <p>To avoid this phenomenon, it is necessary to position washer (1) 4x14x1 Part no. 85240171A between outer cover (2) and carbon air conveyor (3) in the upper fixing point, as shown in the figure.</p>

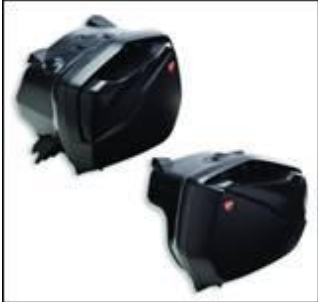
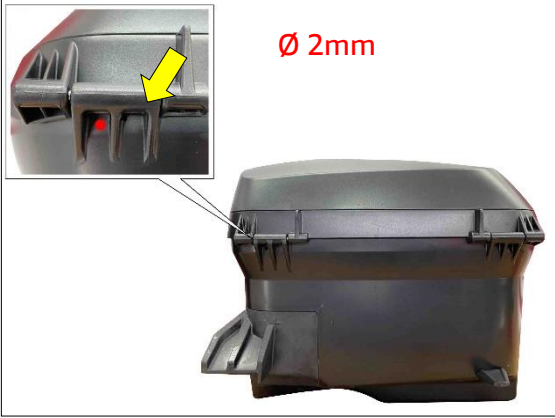
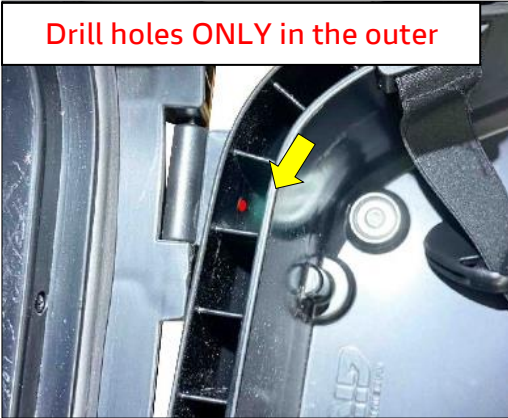
no.	Symptom	Subject	Photo	Notes and Indications - Corrective action
10	<p>ONLY Multistrada V4 (all model versions)</p> <p>Difficulties in opening the side panniers part no. 96781551AA</p>	<p>Side panniers part no. 96781551AA</p>

<p>We have received a few isolated reports of possible difficulties in opening the side panniers due to the “vacuum” effect that occurs when travelling with significant changes in altitude.</p> <p>To avoid this phenomenon, it is necessary to drill a venting hole with a maximum diameter of Ø 2 mm at the bottom of the bag, between the ribs near the rear hinge as shown in the figure.</p> <p style="text-align: center;"><u>DO NOT drill through the second internal wall of the bag.</u></p> <p>This modification has also been implemented by the supplier and does not affect the water tightness.</p> <div style="display: flex; justify-content: space-around;"> <div data-bbox="1055 619 1608 1038">

<p style="color: red; font-weight: bold;">Ø 2mm</p> </div> <div data-bbox="1630 619 2136 1038">

<p style="color: red; font-weight: bold;">Drill holes ONLY in the outer</p> </div> </div>

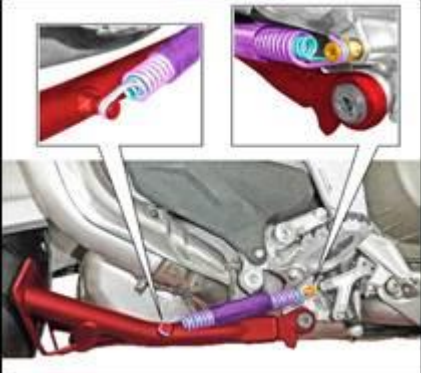
11	<p>ONLY Multistrada V4 (all model versions)</p> <p>Possible interference between external central stand return spring and footpeg holder plate</p>	<p>Central stand</p>

<p>We have received a few isolated reports of possible interference between the external central stand return spring and the footpeg holder plate when the central stand is closed.</p> <p>We kindly ask you to check that the two side stand return springs are correctly installed and aimed as shown in the figure.</p>

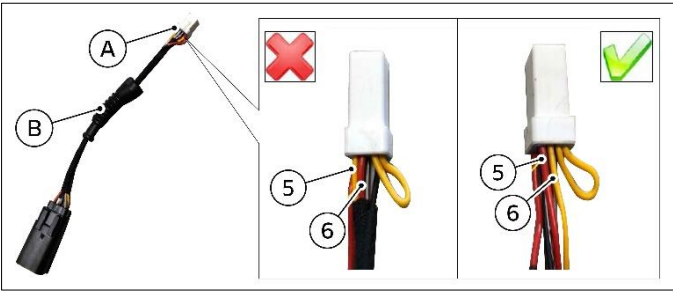
<p>We have received some reports concerning the difficulty in securing the Top Case (Kit Part no. 96781531AA) to the top plate Part no. 8291M033A due to a machining error of the supplier. In particular, the locking tooth on the upper plate Part no. 8291M033A shows a hole 2mm narrower than specified. To eliminate this defect, the locking tooth of the plate must be milled by <u>2mm in the upper area</u> using a flat file, as shown in the figure.</p> <p>We inform you that the upper plates present inside the kits in stock have been restored.</p>
27	Anti-theft system kit Part no. 96681081AA malfunction	Anti-theft system kit Part no. 96681081AA

<p>Follow the procedure described below:</p> <ol style="list-style-type: none"> 1) uncover connector (A) by moving sheath (B) backward; 2) uncover the wiring by removing a portion of insulating tape to make operations easier; 3) check the arrangement of Pins 5 and 6 and the relevant color on the 8-pin connector. If the pin arrangement is not correct, extract them working from the front side with a needle inside the groove so as to lift the retainer and invert them. 4) restore the cloth tape previously removed and the position of the protective sheath (B).

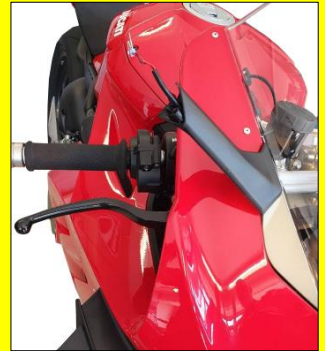
<p>We received some isolated claims about the possible breakage of the rear-view mirror arm due to minor impacts.</p> <p>We would like to inform you that to avoid the phenomenon described above, new, stronger rear-view mirrors have been introduced and can be ordered using the following part numbers:</p> <ul style="list-style-type: none">• LH rear-view mirror: Part no. 523S0645A• RH rear-view mirror: Part no. 523S0655A <p>In the event of rear-view mirror arm breakage due to minor impacts, we ask you to send a YouTech service request and then proceed with replacement of the component under warranty unless otherwise advised by your reference Service Area Manager.</p>

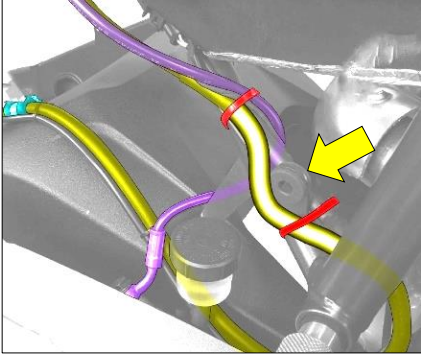
no.	Symptom	Subject	Photo	Notes and Indications - Corrective action				
1	<p><u>ONLY Scrambler 800 (all model versions and MY, excluding Desert Sled model version)</u></p> <p>Precautions when routing the rear brake calliper hose</p>	Rear brake hose	-	<p>We have found that sometimes, during maintenance operations, the rear brake caliper hose is not correctly positioned along the frame due to incorrect installation by the technician during service.</p> <p>Make sure that the rear brake caliper hose (yellow), passes outside the left side cover mounting bracket with respect to the motorcycle centerline and is fixed with the two self-locking ties (red) as shown in the figure.</p> <p>The operation of inspection and possible repositioning is very simple and involves the disassembly of the left side cover only.</p>

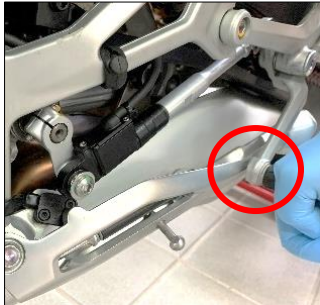
no.	Symptom	Subject	Photo	Notes and Indications - Corrective action
2	Interference between gearchange lever and side stand	Gearchange lever/ side stand

<p>As a result of continuous quality tests on the product, we have found a slight interference between the gear shift control lever and the side stand. This contact is very slight, does not give rise to functional or aesthetic problems and can only occur in the overtravel phase, when engaging the first gear.</p> <p>We inform you that no corrective actions are available so far.</p>
3	Assembly precautions for the complete titanium exhaust system part no.96481652AA	Complete titanium exhaust system part no.96481652AA

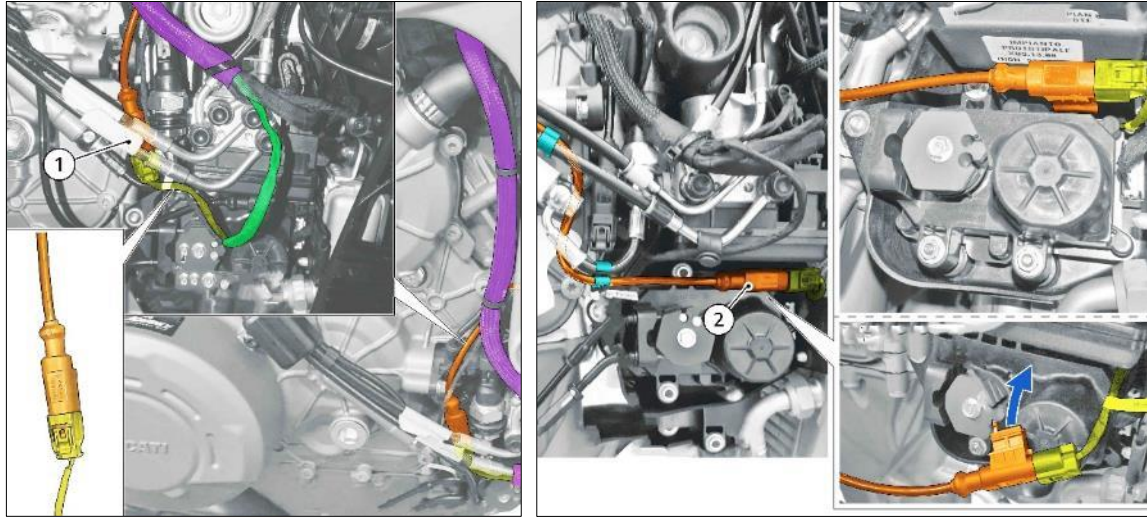
<p>We have received some isolated reports of vehicle speed limitation at values below 50 km/h due to the excessive traction control (DTC) intervention resulting from the installation of the complete titanium exhaust system part no. 96481652AA. The performed analyses have shown that the front and rear speed sensor connections were reversed.</p> <p><u>In case of interventions on the front (1) and rear (2) speed sensor connectors, please take the utmost care to their assembly, as shown in the figure, making sure not to reverse the connections</u></p>

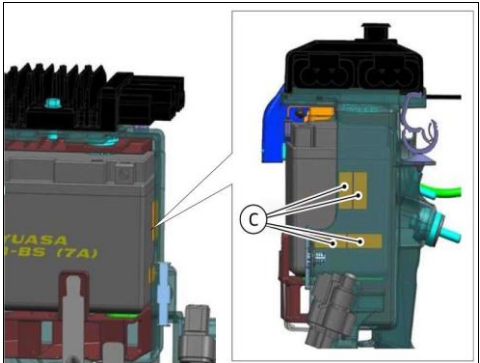
<p>The ongoing tests on the product have revealed the possibility of contact between the battery and its support, which causes marks on both surfaces due to vibration. These marks do NOT affect the correct operation of the electric system and therefore of the vehicle.</p> <p>In order to prevent such marks, 4 adhesive pads (C) in rubber 9X23X1.4 part no. 86612791A have been introduced in the production line to be applied inside the battery support.</p>
