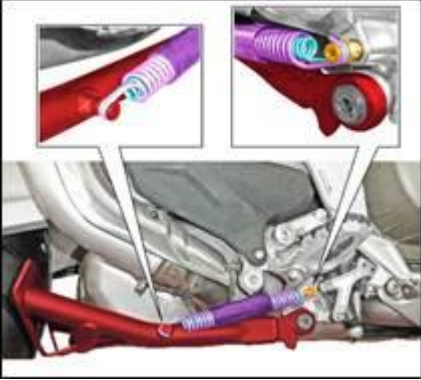
11	<p>ONLY Multistrada V4 (all model versions)</p> <p>Possible interference between external central stand return spring and footpeg holder plate</p>	Central stand

<p>We have received a few isolated reports of possible interference between the external central stand return spring and the footpeg holder plate when the central stand is closed.</p> <p>We kindly ask you to check that the two side stand return springs are correctly installed and aimed as shown in the figure.</p>

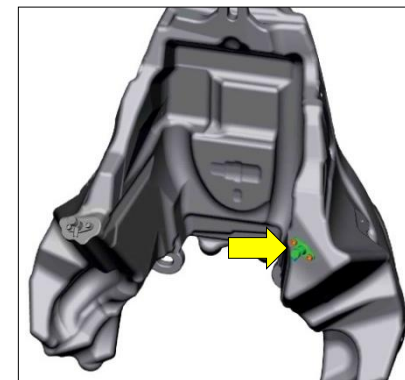
18	<p>ONLY <u>Multistrada V4</u> <u>(all model versions)</u></p> <p>Incorrect residual fuel in the tank</p>	Fuel tank	-	<p>In some cases, we have found that the tap on the right-hand side of the fuel tank is completely closed instead of open; this leads to an incorrect remaining range when there are only a few liters of fuel in the tank (fuel reserve conditions).</p> <p>If the above-mentioned event occurs, we ask you to ensure that the tap on the right-hand side of the fuel tank is fully open</p>

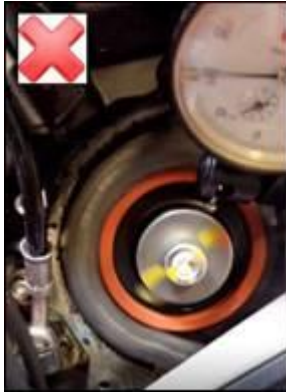
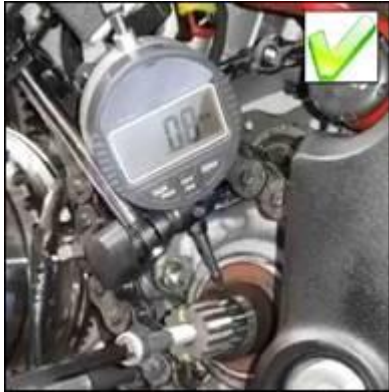
no.	Symptom	Subject	Photo	Notes and Indications - Corrective action
19	<p>ONLY <u>Multistrada V4</u> <u>(all model versions)</u></p> <p>Possible oscillation of the final drive chain (non-uniform sliding)</p>	Gearbox secondary shaft	-	<p>We have received some isolated reports about a possible oscillation of the final drive chain even if the chain is correctly tensioned. In these cases the customer may complain an uneven sliding of the chain at constant speed.</p> <p>In these cases, you are asked to check for a possible deformation of the gearbox secondary shaft by removing both the chain and the sprocket and taking the measurement with a dial gauge directly on spacer Part no. 713P0011C, as shown in the figure (the measurement should NOT be taken on the sprocket since an uneven wear of the rubber material may occur during the first few kilometers): by slowly rotating the shaft, the value taken with the dial gauge must be at most 0.1 mm.</p> <div style="display: flex; justify-content: space-around;">

</div> <p>a) If the measurement shows values below 0.1 mm, replace the sprocket only. a) If the measurement shows a value greater than 0.1mm, fill out a Youtech service request.</p>

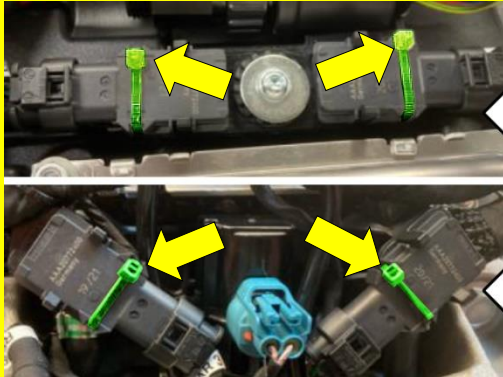
<p>We have received a few isolated reports of erratic engine operation at idle, hard starting, the possibility of the MIL warning light on the instrument panel coming on and/or memorized MAP sensor errors or P061B Torque Monitoring error.</p> <p>Our analysis has shown that this phenomenon could be due to the MAP sensors not fitting perfectly in their seats; we therefore ask you to check the correct installation of the MAP sensors if the symptoms described above should occur, and to fix them properly using self-locking ties positioned as shown in the figure.</p> <p>Create a Youtech for any cases found in your dealership. Attach PDF copy of the DDS Fault Report (with freeze frame parameters) and photos of the MAP sensor(s) as discovered during inspection and after with self-locking ties.</p>

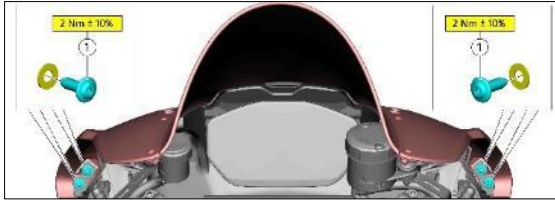
<p>We received some isolated claims about the possible breakage of the top fastener retaining the LH side half-fairing to the headlight fairing.</p> <p>During PDI and whenever removing the side half-fairings, we remind you to pay utmost attention to the tightening of the 2 screws M5x0.8 (1) retaining the upper LH and RH half-fairings to the headlight fairing; always comply with the specified tightening torque of 2 Nm ± 10%.</p>

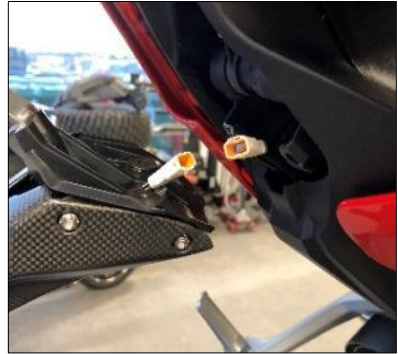
3	<p><u>ONLY</u> <u>Panigale V4</u> <u>(all versions)</u> <u>Panigale V2</u></p> <p>Installation precautions Carbon number plate holder kit part no. 97380921A</p>	Carbon number plate holder kit part no. 97380921A

<p>We kindly inform you that <u>ONLY</u> when installing the carbon number plate holder kit part no. 97380921A to a Panigale V2 model, it is necessary to purchase wiring part no. 5101H931A to connect the number plate holder connector to motorcycle rear wiring harness connector.</p> <p>We also inform you that the new carbon number plate holder kit part no. 97381161AA is now available. It is specific for Panigale V2 and Streetfighter V4 and will include the above-mentioned wiring.</p>
