**AMA2 - Replacing Seat Occupancy Detection System for Passenger Seat (USA/Canada)  
(Recall Campaign)**

Revision: This bulletin replaces bulletin Group 6 50/21 AMA2, dated November 4, 2021.

Model Line: **Macan**

Concerns: **Seat occupancy detection system for passenger seat**

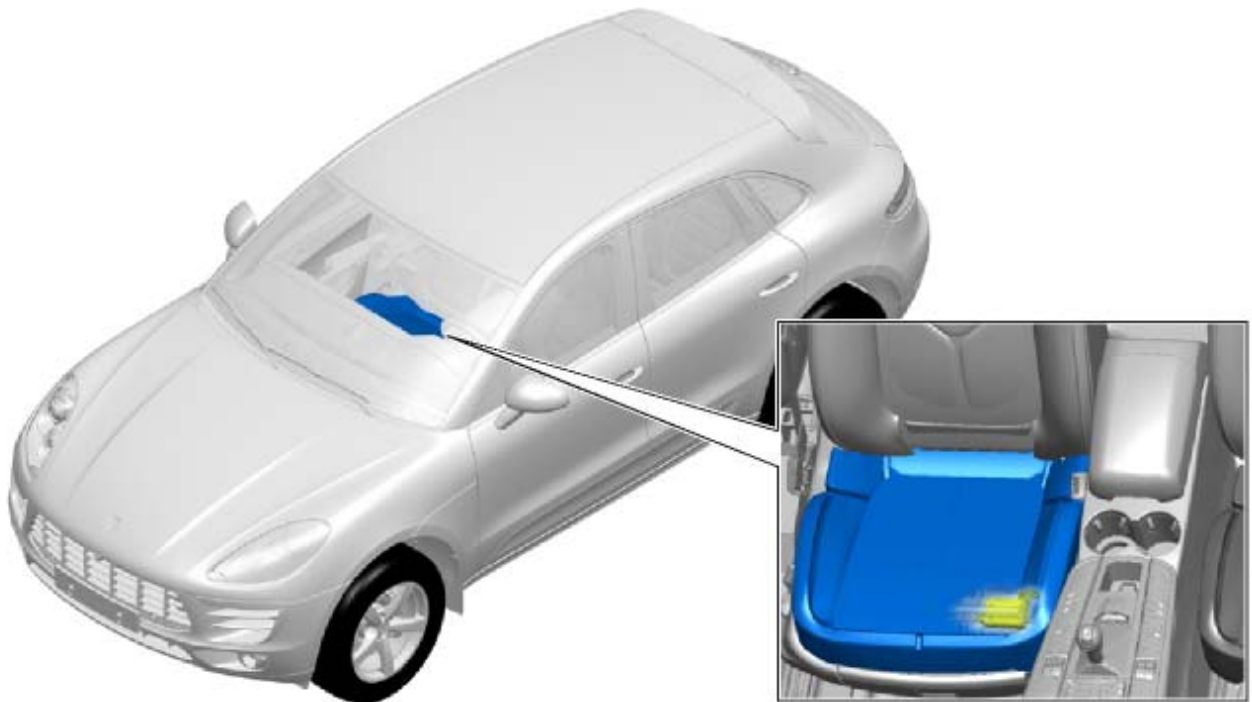
*Installation position of seat occupancy detection system for passenger seat*

Information: **Sensor mats for seat occupancy detection, on which the conductive fabric can break, were installed in the passenger seat on the affected vehicles.**

If the conductive fabric breaks, the front airbags on the passenger's side will be deactivated because correct seat occupancy detection can no longer be guaranteed. The airbag warning light and Passenger Airbag OFF light will be activated in order to alert the driver.

Action required: Replace the seat occupancy detection system according to the campaign scope assigned to the respective vehicle.

- 4 Replace padding for front seat including sensor mat. ⇒ *Workshop Manual '741055 Replacing padding for front seat'*

- 5 Replace occupant detection control unit. ⇒ *Workshop Manual '696819 Removing and installing occupant detection control unit'*
