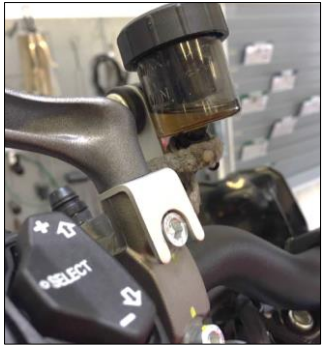
| no. | Symptom | Subject | Photo | Notes and Indications - Corrective action |
|---|---|---|--|--|
| 6 | <p><u>ONLY</u> <u>models equipped with</u> <u>hydraulically controlled</u> <u>clutch lever</u></p> <p>Possible reduction of the clutch fluid level inside its reservoir</p> | Hydraulic clutch control | | <p>We received a few claims concerning a reduction of the clutch fluid level inside its reservoir. We would like to inform you that it is not sufficient to carry out the bleeding procedure or top up the clutch fluid inside the reservoir. We suggest, at a preliminary stage, to check:</p> <ul style="list-style-type: none">• the play between the clutch master cylinder and the lever• if the clutch pushrod is worn or damaged in the area of contact with the clutch slave cylinder (ball)• the condition of the clutch slave cylinder protective diaphragm, which must not be torn. <p>According to our analyses, this phenomenon is due to a DOT4 leakage from the primary seal of the clutch slave cylinder (missing fluid in the reservoir builds up in-between the clutch slave cylinder diaphragms); in some cases, this phenomenon is also accompanied by wear of the clutch pushrod. We therefore ask you to replace the slave cylinder with a new part no. 19540091D featuring a new gasket in order to prevent the phenomenon described above.</p> <p>If the clutch pushrod is damaged as shown in the figure, replace it as well.</p> <div data-bbox="1227 715 2024 1015"></div> |

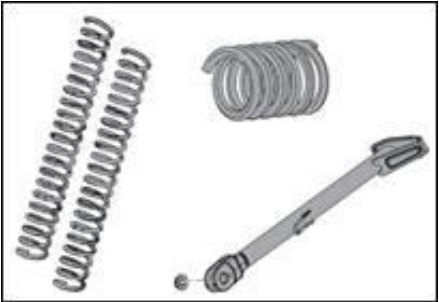
| no. | Symptom | Subject | Photo | Notes and Indications - Corrective action |
|---|---|---|--|---|
| 2 | <p>Monster MY21 (937cc) <u>ONLY</u></p> <p>Standard motorcycle lowering and conversion kits now available</p> | <p>Standard motorcycle lowering and conversion kits</p> | <p>-</p> | <p>We hereby inform you that the following kits are now available:</p> <ul style="list-style-type: none"> - Motorcycle lowering kit part no. 96280801AA - Motorcycle lifting kit part no. 96280821AA <p>The kits include the following dedicated components:</p> <ul style="list-style-type: none"> • a pair of front fork springs • rear shock absorber spring • side stand • side stand retaining nut <p>Please follow the procedure outlined in the kit or accessories catalogue and the detailed information in the workshop manual.</p> |

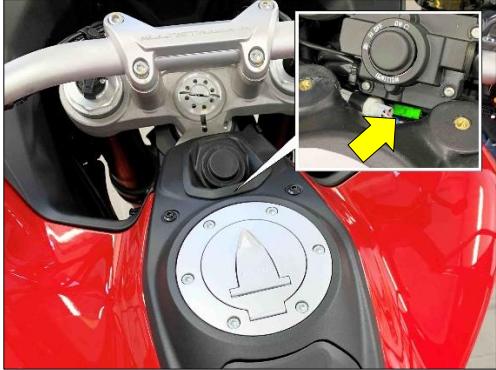
| no. | Symptom | Subject | Photo | Notes and Indications - Corrective action |
|---|--|--|--|---|
| 5 | <p>ONLY <u>Multistrada V4</u> <u>(all model versions)</u></p> <p>Precaution during the installation of the heated handgrip kit part no. 96680702A</p> | <p>Heated handgrip kit part no. 96680702A</p> | | <p>We inform you that for the installation of the heated handgrip kit part no. 96680702A, the main wiring harness connectors where to connect the heated handgrips, are positioned below the ignition switch cover as shown in the figure.</p> |

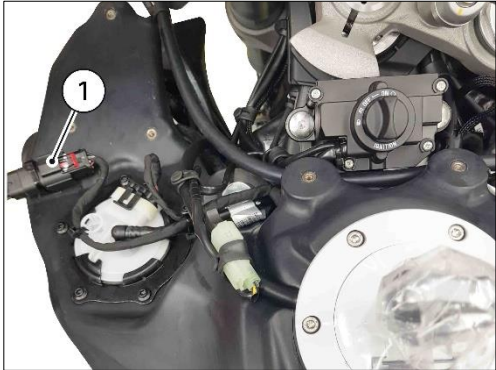
| no. | Symptom | Subject | Photo | Notes and Indications - Corrective action |
|---|--|--|--|---|
| 6 | <p>ONLY <u>Multistrada V4</u> <u>(all model versions)</u></p> <p>Assembly precaution for the anti-theft system kit part no. 96681081AA</p> | <p>Anti-theft system kit part no. 96681081AA</p> | | <p>We inform you that for the installation of the anti-theft system kit part no. 96681081AA, the main wiring connector (1) where to connect the anti-theft device, is positioned near the fuel pump flange, in the front left area of the fuel tank.</p> |

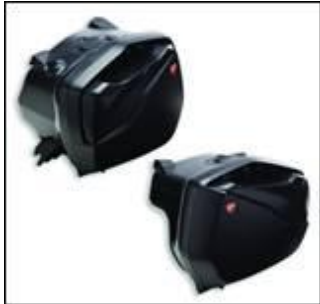
| no. | Symptom | Subject | Photo | Notes and Indications - Corrective action |
|---|---|--|--|--|
| 10 | <p>ONLY Multistrada V4 (all model versions)</p> <p>Difficulties in opening the side panniers part no. 96781551AA</p> | <p>Side panniers part no. 96781551AA</p> | | <p>We have received a few isolated reports of possible difficulties in opening the side panniers due to the “vacuum” effect that occurs when travelling with significant changes in altitude.</p> <p>To avoid this phenomenon, it is necessary to drill a venting hole with a maximum diameter of Ø 2 mm at the bottom of the bag, between the ribs near the rear hinge as shown in the figure.</p> <p><u>DO NOT drill through the second internal wall of the bag.</u></p> <p>This modification has also been implemented by the supplier and does not affect the water tightness.</p> <div style="display: flex; justify-content: space-around;"> <div data-bbox="1055 616 1608 1035"> <p style="color: red; font-weight: bold;">Ø 2mm</p> </div> <div data-bbox="1626 616 2136 1035"> <p style="color: red; font-weight: bold;">Drill holes ONLY in the outer</p> </div> </div> |

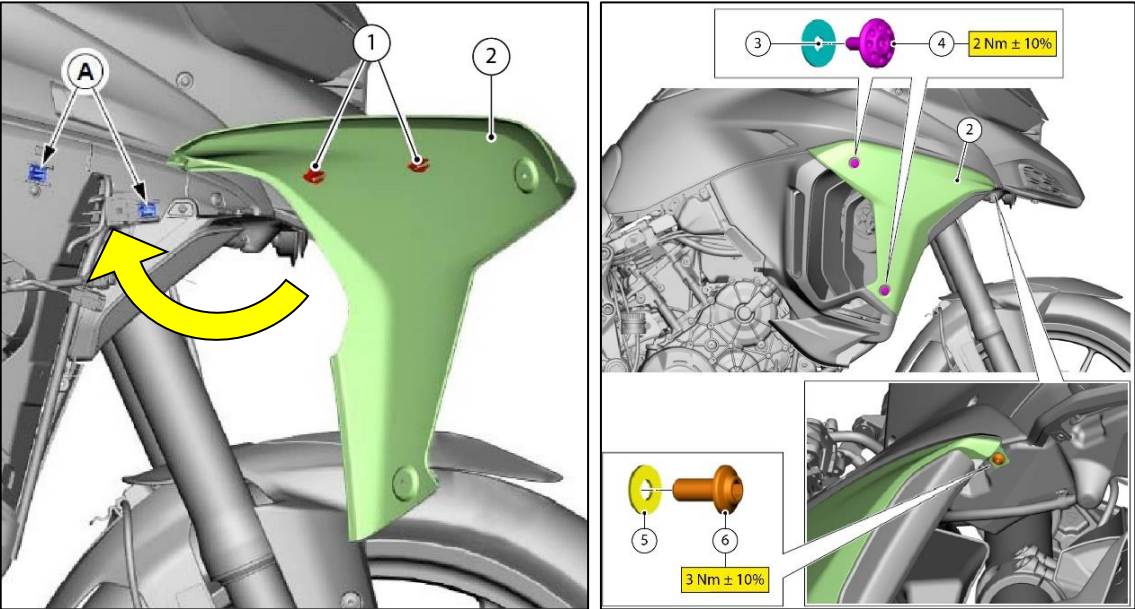
| <p>We would like to inform you that from approx. 1 Nov 2021, in order to avoid transport damage to the cowlings of the Multistrada V4, the kit supplied will also include the RH side cowling, the LH side cowling and the relevant hardware, which you must install during PDI. For this reason we also updated the PDI Checklist SRV-SRB-20-049_PDI Checklist for Multistrada V4 Rev.02.</p> <p>The additional kit will include:</p>

<p>When assembling, fit clips (1) on brackets of cowlings (2). Install cowlings (2) and engage clips (1) in the corresponding housings (A). Tighten the special screws (4) to 2 Nm ±10% and the screw (6) to 3 Nm ± 10%.</p>

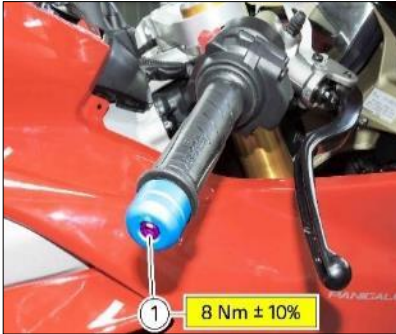
| no. | Symptom | Subject | Photo | Notes and Indications - Corrective action |
|---|---|--|--|---|
| 2 | <p><u>ONLY</u> <u>Panigale V4</u></p> <p>Precautions during PDI: installation of the balancing weights on the handlebar</p> | Balancing weights on handlebar | | <p>We received some isolated claims about the possible triggering of a longitudinal crack on the handlebar, on balancing weight side. Our laboratory analyses found that said crack is due to an excessive tightening torque applied when installing the balancing weights.</p> <p>When installing balancing weights on the handlebar, please comply with the tightening torque specified for the M6x55 screw to 8 Nm ± 10%, as indicated on the bulletin introducing the model and on the Workshop Manual.</p> |

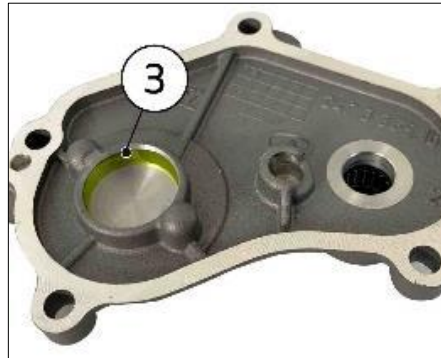
| no. | Symptom | Subject | Photo | Notes and Indications - Corrective action | | | | | | | | | |
|---|---|---|---|---|---|---|---|---|---|---|---|---|---|
| 12 | <p><u>ONLY</u> 959 Panigale (all versions)</p> <p>Possible hardening of gear shift control with difficulty in shifting gears when hot</p> | Gear selector | - | <p>We have received some isolated reports about a possible hardening of the gear shift when hot with consequent difficult selection of gear ratios. Based on the analyses carried out, this phenomenon could be due to a hardening between the gearbox sensor magnet plastic support and the relevant seat inside the cover.</p> <p>You are kindly asked to carry out the following operations:</p> <ol style="list-style-type: none"> 1) Remove the gear shift cover (1) on motorcycle LH side 2) Check for the presence of shim (2) 3) Mill the end face of the plastic cage for the selector magnet (3) shorter by 0.1 mm maximum and the outer curved edge where it enters the bore of the cover by 0.1 mm maximum, <u>or</u> mill the internal surface (4) of the cover highlighted in the figure and remove 0.1 mm maximum of material from the end and bore of the recess. Ensure the orientation of the magnet is not changed on the shift selector or the gear position will not be able to be determined by the sensor. <div style="display: flex; justify-content: space-around;">

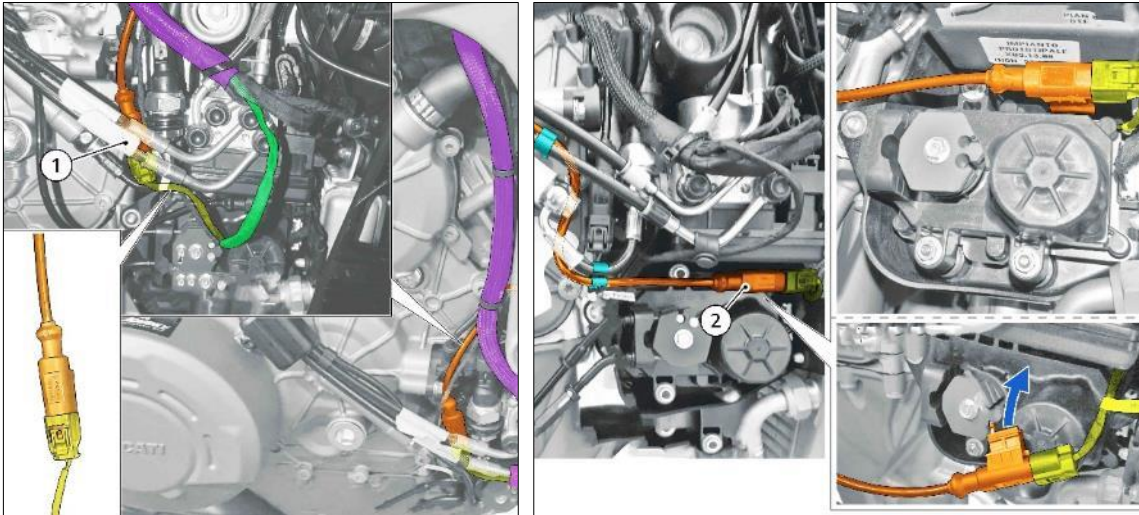
| no. | Symptom | Subject | Photo | Notes and Indications - Corrective action |
|---|--|---|---|--|
| 3 | Assembly precautions for the complete titanium exhaust system part no.96481652AA | Complete titanium exhaust system part no.96481652AA | | <p>We have received some isolated reports of vehicle speed limitation at values below 50 km/h due to the excessive traction control (DTC) intervention resulting from the installation of the complete titanium exhaust system part no. 96481652AA. The performed analyses have shown that the front and rear speed sensor connections were reversed.</p> <p><u>In case of interventions on the front (1) and rear (2) speed sensor connectors, please take the utmost care to their assembly, as shown in the figure, making sure not to reverse the connections</u></p> |
