# Technical Service Bulletin

## 35 Oil leak from the transmission input shaft

35 22 41 2051719/4 January 7, 2022. Supersedes Technical Service Bulletin Group 35 number 18-36 dated December 17, 2018 for reasons listed below.

Model(s)	Year	VIN Range	Vehicle-Specific Equipment
A3 e-tron	2016 – 2018	All	Not Applicable

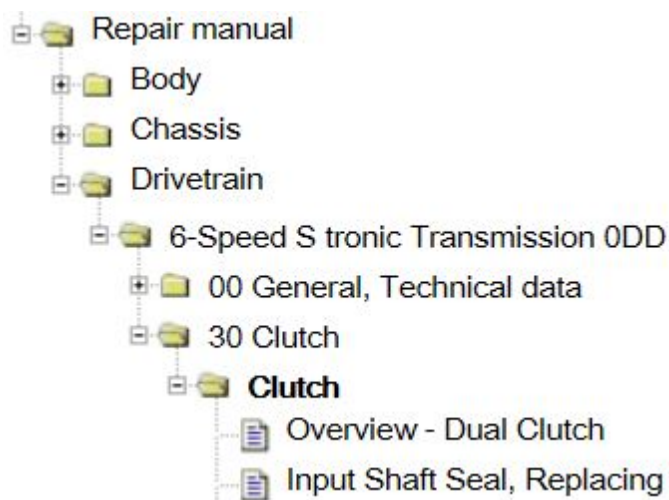
Figure 3. Location of repair manual directions.

2. Replace the oil seal according to the repair manual. Located in ELSA under *Drivetrain >> 6-Speed S tronic Transmission ODD >> 30 Clutch >> Input Shaft Seal, Replacing* (Figure 3)
